Biofuels Impact on DPF Durability

Michael J. Lance, Todd J. Toops, Andrew A.
Wereszczak, John M.E. Storey, Dane F.
Wilson, Bruce G. Bunting, Samuel A. Lewis
Sr., and Andrea Strzelec

Oak Ridge National Laboratory

May 11th, 2011

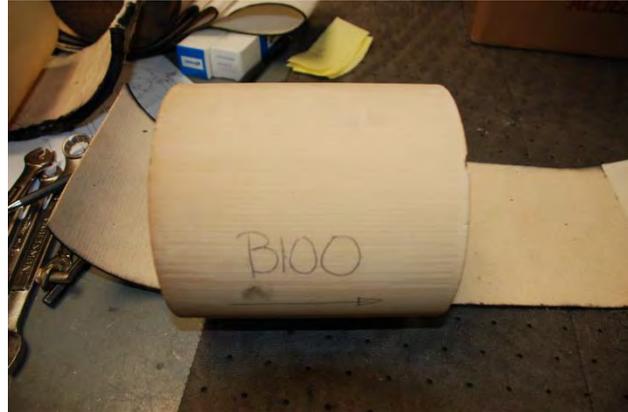
Attempt to Reproduce Filter Degradation

- Four DPFs were loaded with soot using the same Mercedes engine that produced initial DPF degradation. Engine was operated at 1500 rpm and 2.6 bar.
- Initial degradation occurred with Soy Gold but this test used SME fuel from Renewable Energy Group (REG) which was certified by Southwest Research Institute (SWRI) and GC-MS at Oak Ridge.
- The surface of the DPF after being exposed to certified B100 exhaust and storage for 3 months showed no degradation.

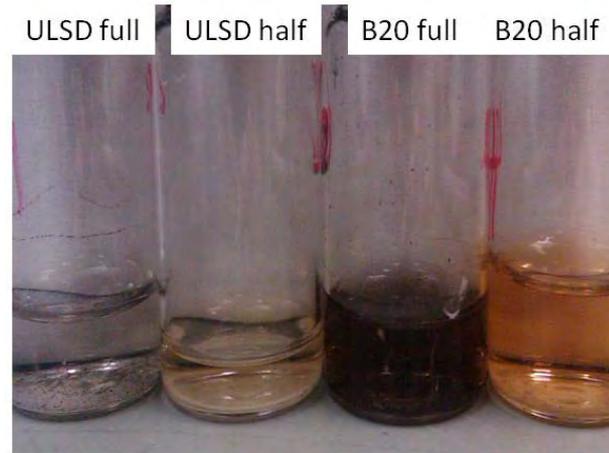
Water extract from the PM collected from Hatz engine test

- The B20 full-load PM appears to be more soluble in water (hence the darker appearance of the extract above).
- GC-MS showed more polar species present in the B20 soot than the ULSD, which would explain its hydrophilic behavior.
- Biodiesel PM is able to retain water better than the ULSD PM thereby allowing aqueous corrosion to occur in the filter.

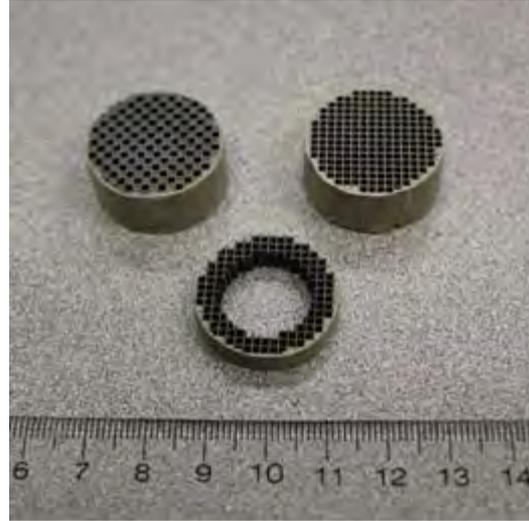
SiC test specimen

- Substrate fracture strength and elastic modulus are sensitive to DPF degradation modes such as micro-cracking and grain boundary attack that are difficult to observe with chemical or microscopic techniques.
- Our approach uses widely-available 1" by 3" DPF cores that can be run in an engine test and later sectioned and tested to determine if the DPF material has degraded.
- O-ring and ring-on-ring biaxial flexure test geometries separately test the outer skin and the interior channels, respectively.
