Demonstration Assessment of Light-Emitting Diode (LED) Retrofit Lamps

Host Site: InterContinental Hotel, San Francisco, California

Final Report prepared in support of the U.S. DOE Solid-State Lighting Technology Demonstration GATEWAY Program

PNNL-20019

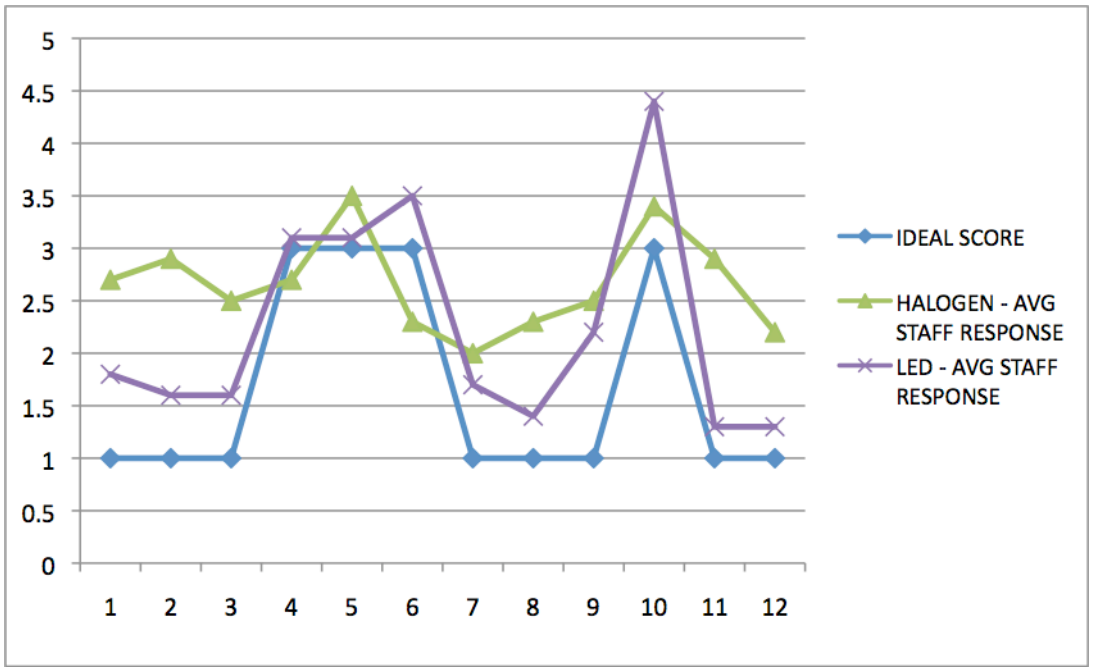
Figure C.1. Plot of Staff Responses to Before (Halogen) and After (LED) Lamping of the Registration Desk Area. Horizontal axis numbers correspond to survey question numbers, vertical axis to survey responses.
