PV Module Failures Observed in the Field

Kazuhiko Kato

Research Center for Photovoltaic Technologies (RCPVT)

Many failures have been found in PV modules!

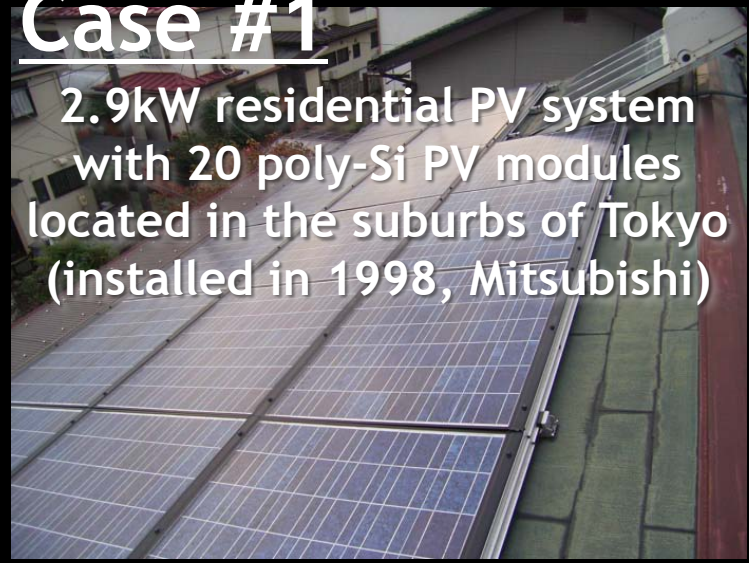
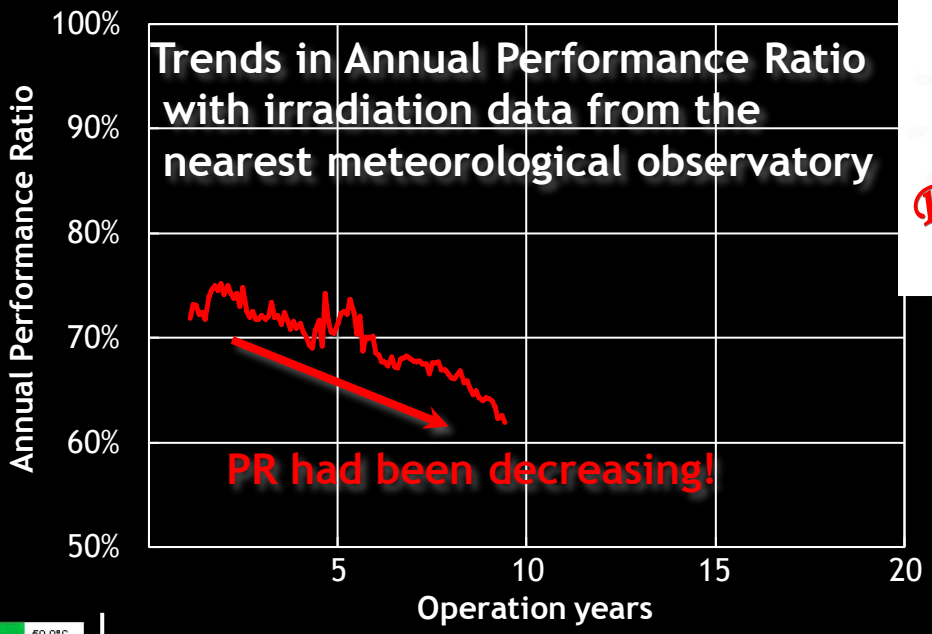
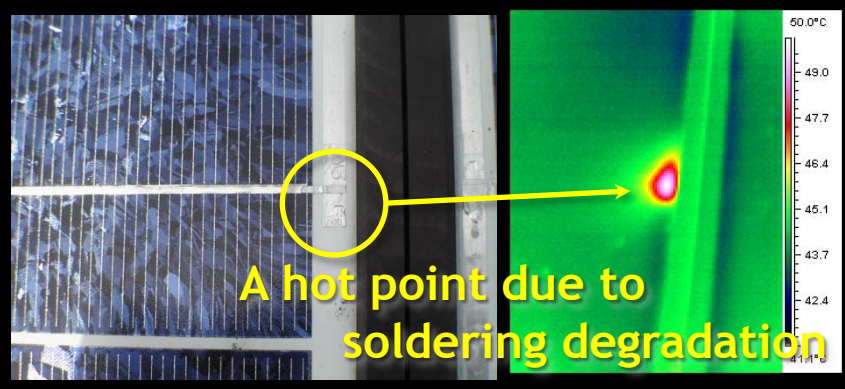
Case #1

2.9kW residential PV system with 20 poly-Si PV modules located in the suburbs of Tokyo (installed in 1998, Mitsubishi)

- Inspection by the installer reported **“No roblem”**.
- The survey by PVResQ! Judged that 10 of 20 PV modules had **serious failures**.
- The **10 modules were replaced** by the manufacturer with no charge in the end.
- The others were not (the manufacturer said they would never have any problems.)

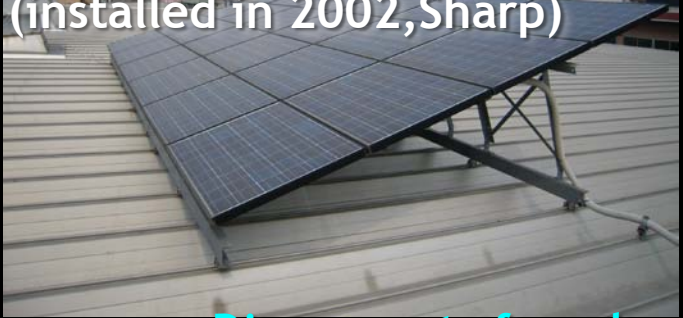
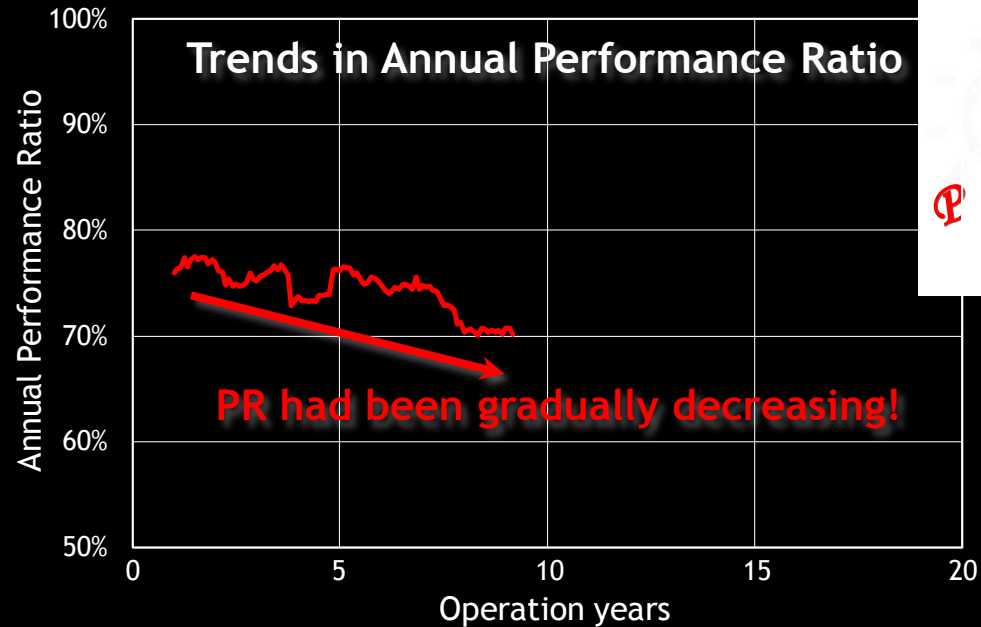
Case #2

3.0kW residential PV system with 24 poly-Si PV modules located in Gifu prefecture (installed in 2002, Sharp)

Disconnects found by the circuit fault detector

Hot spot cells

- PV RessaQ! survey found failures in many PV modules.
- Discussion about module replacement is in preparation.

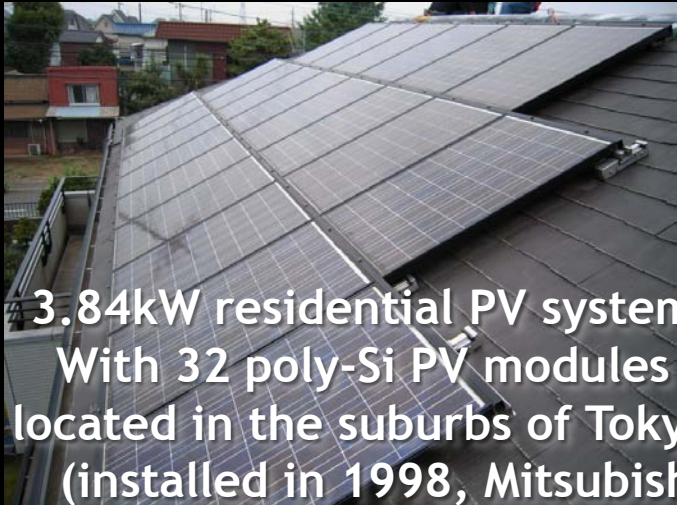
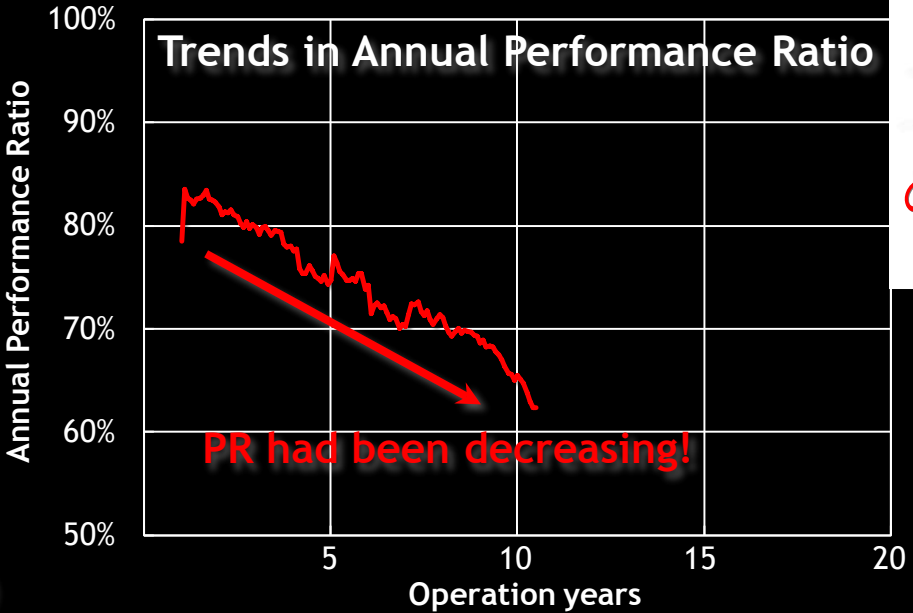
Case #3

3.84kW residential PV system
With 32 poly-Si PV modules
located in the suburbs of Tokyo
(installed in 1998, Mitsubishi)

PR had been decreasing!

- PVResQ! survey found **15 PV modules had serious failures.**
- Though the warranty period (10 years) was over, all the PV modules were replaced with no charge.

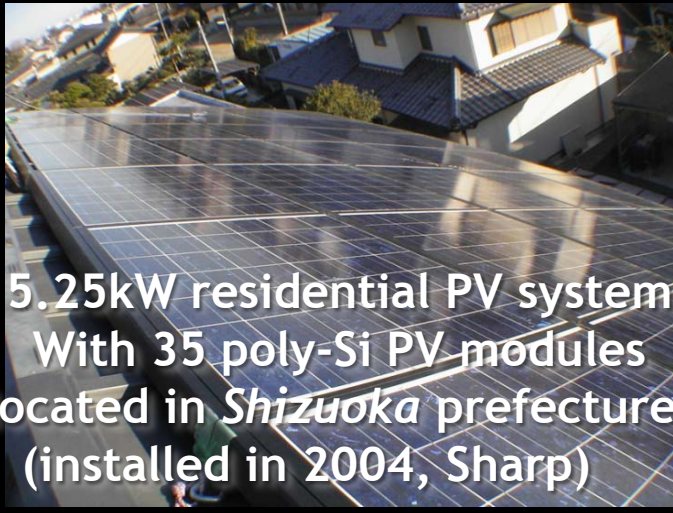
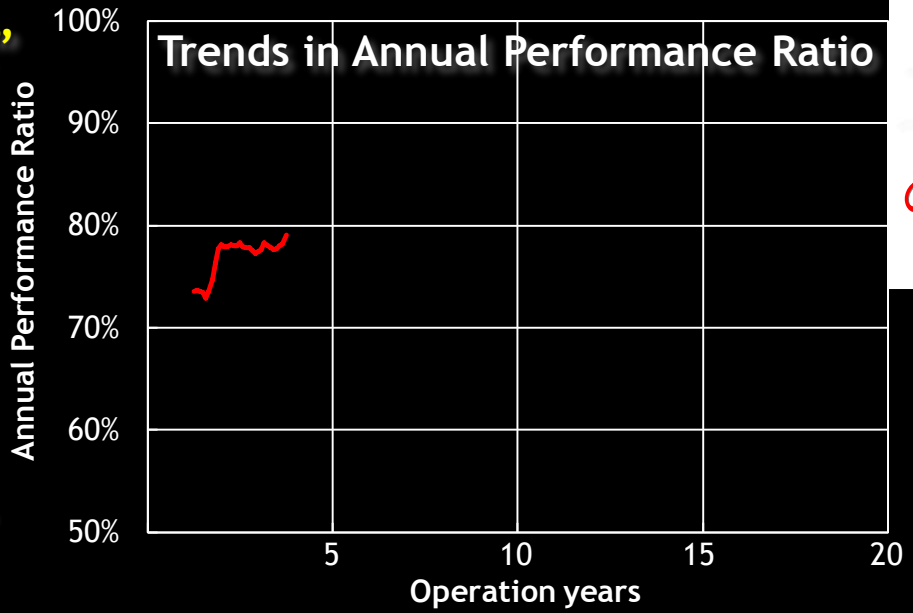
Case #4 "Sharp ND-150AM"

Four PV modules were replaced,
though high performance ratio and short operation years.

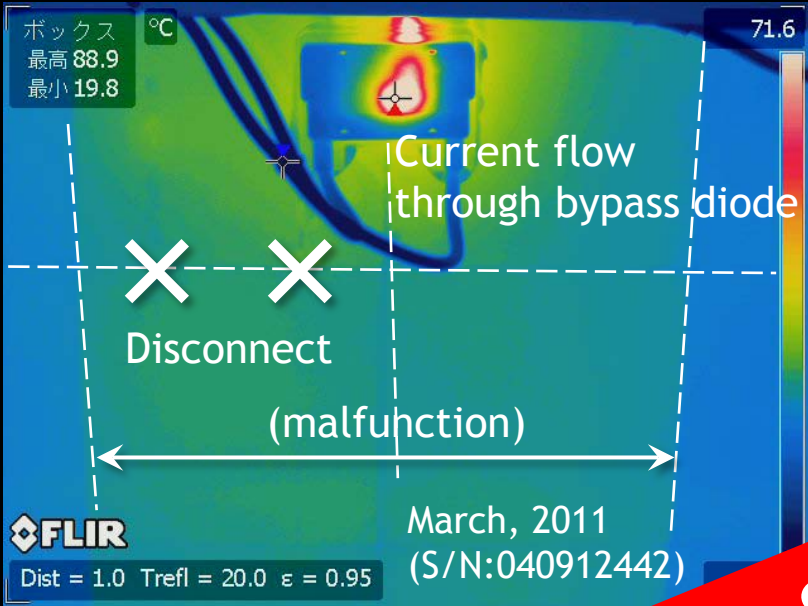
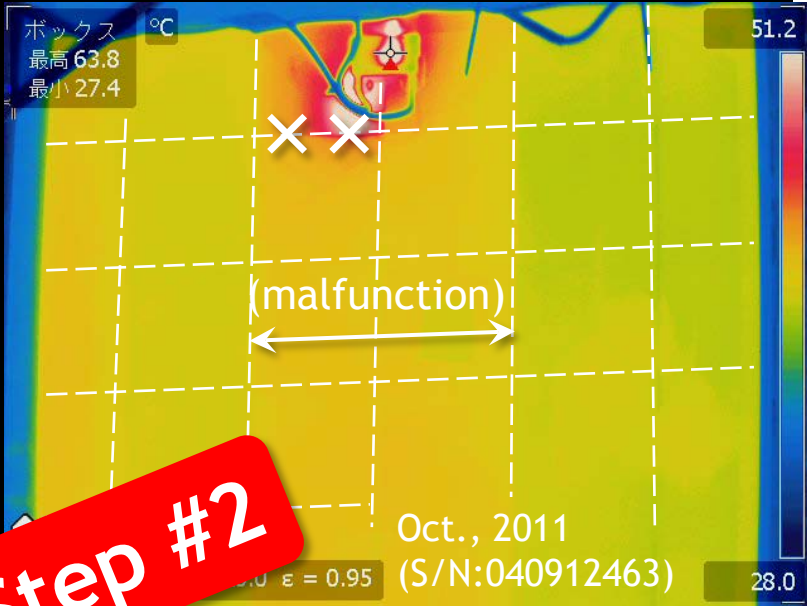
Failure Step #2

**STC power(measured)
=0.54*nominal value**

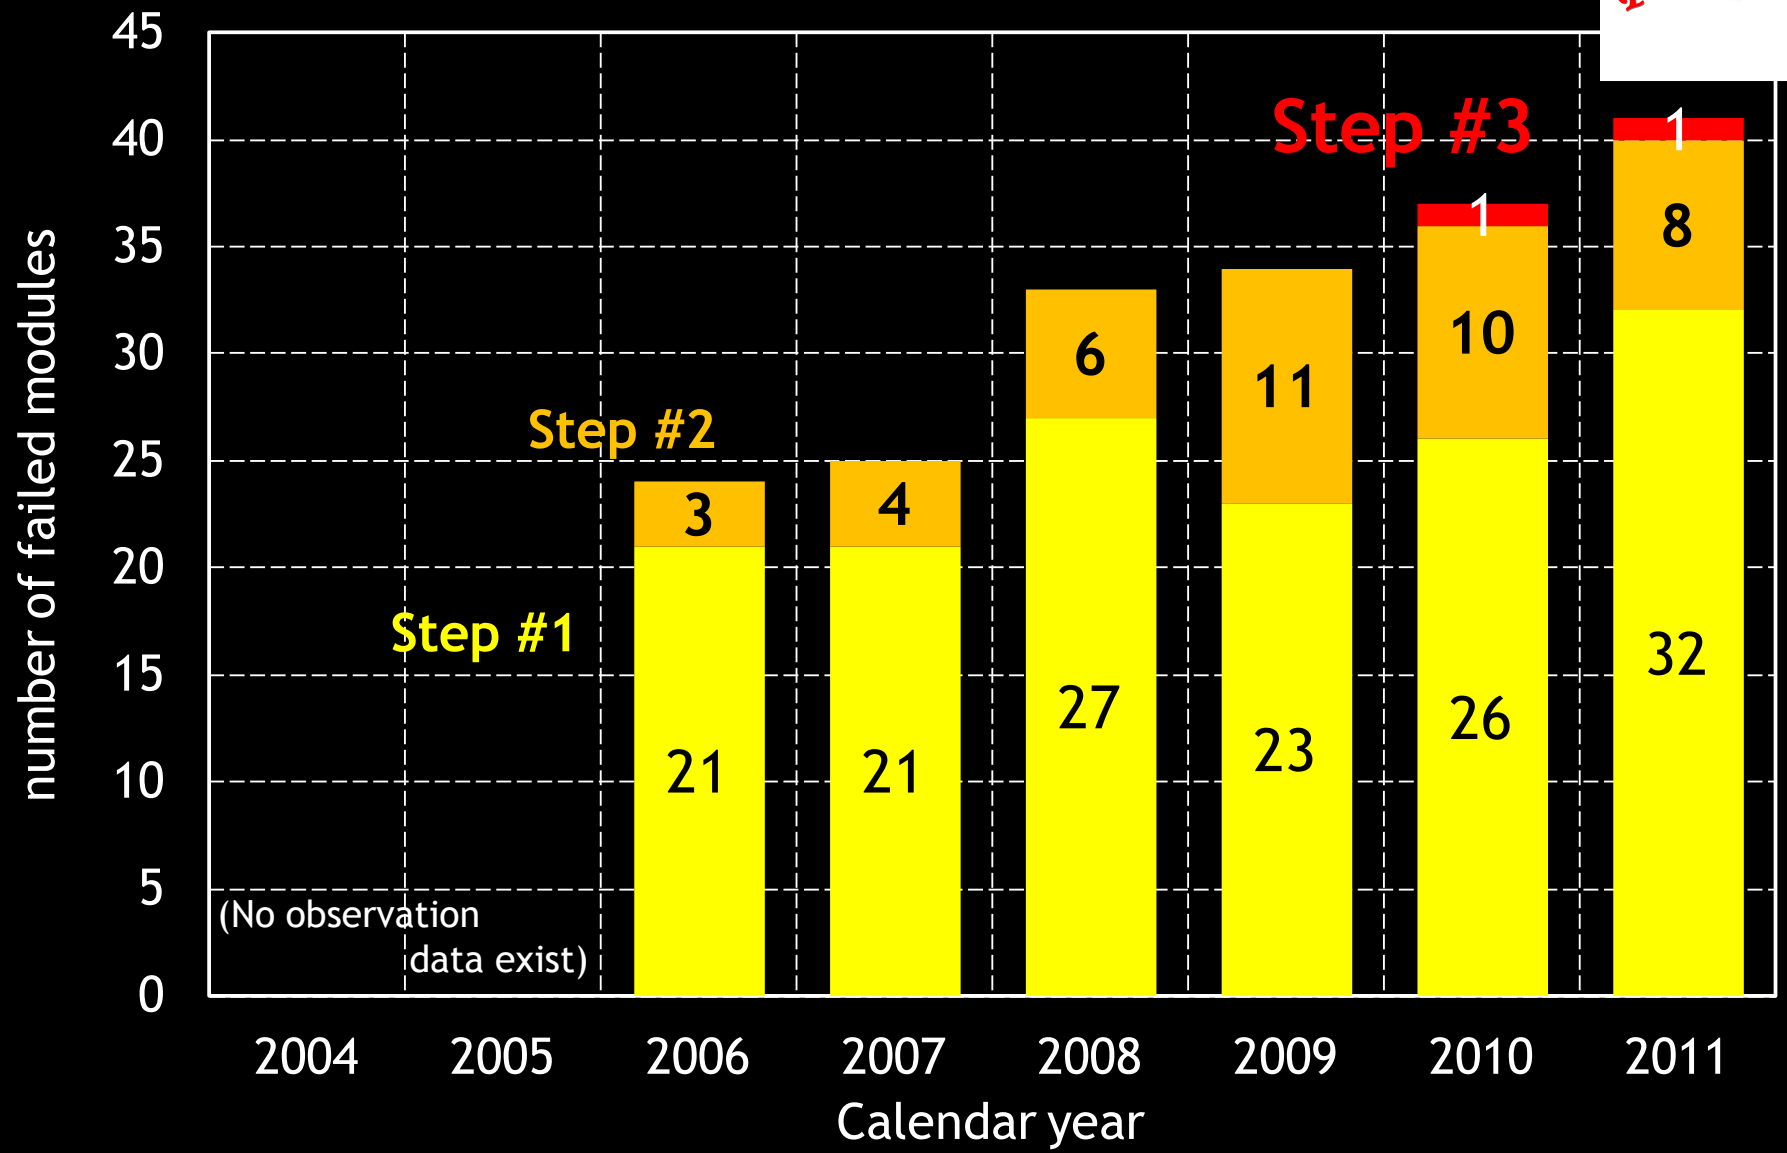
Trend in number of failed modules (out of 1,080 in total)

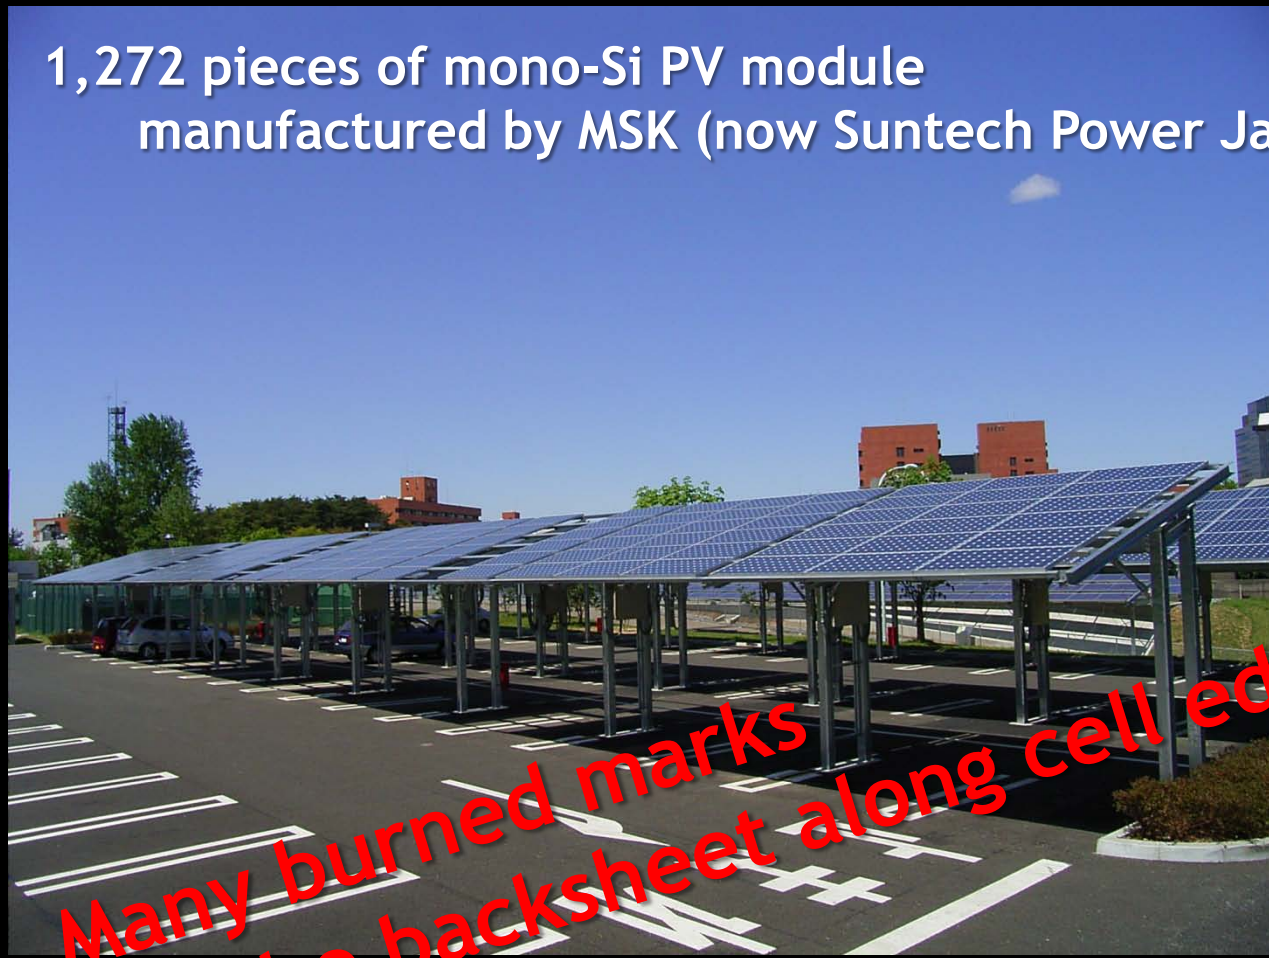
1,272 pieces of mono-Si PV module manufactured by MSK (now Suntech Power Japan)

Many burned marks on the backsheet along cell edges!

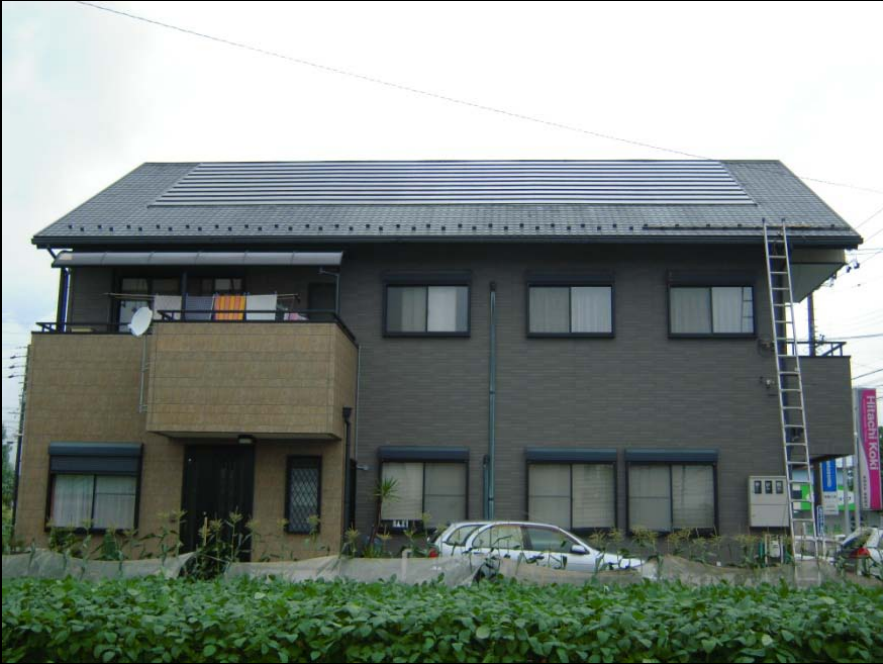
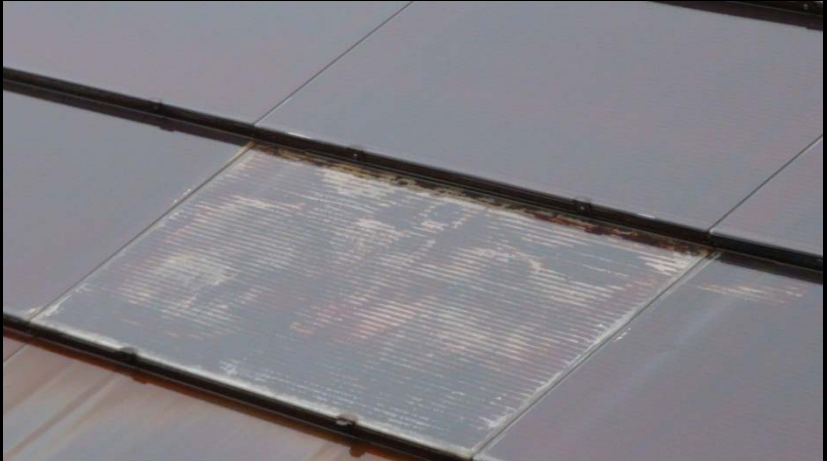
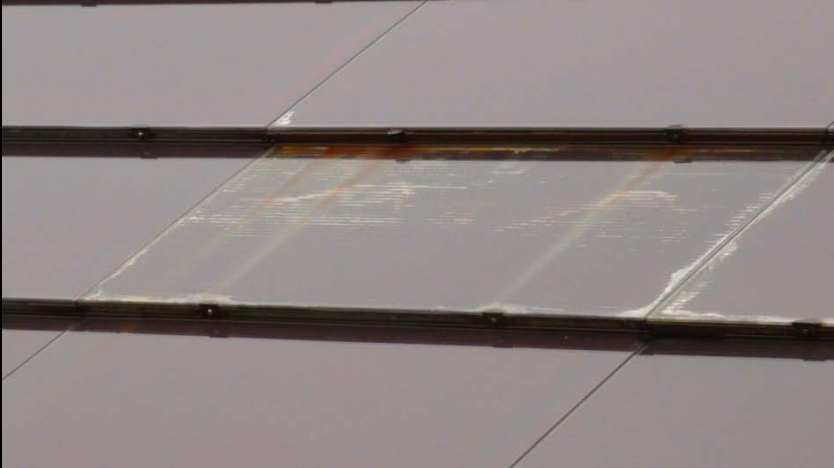
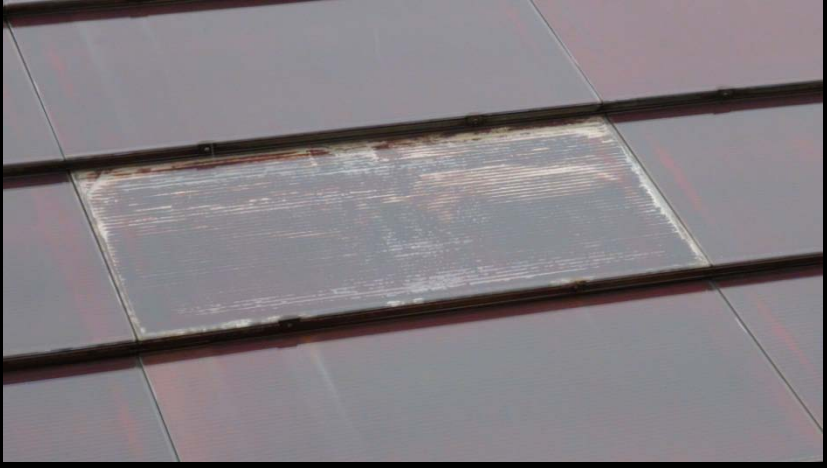
PVRessQ! tackling thin-film PV modules now

No experience, no info, no instrument...no solution.
