Materials Issues Associated with EGR Systems

Michael J. Lance and C. Scott Sluder
Oak Ridge National Laboratory
June 10th, 2010

PM009

Project Objective: Provide information to industry specialists about fouling deposit properties

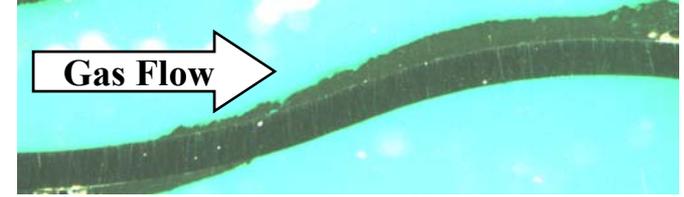
Erosion of Deposit

- The deposit is being eroded on the leading edge of the sinusoidal peak of each fin.
- The erosion is uneven and forms channels or grooves in the deposit, presumably from the action of the flowing exhaust gas and/or snowballing.
- This microstructure has been observed on most of the coolers.
