# Yakama Nation Housing Authority, Adams View: System Retrofit Research Report and Case Study Summary

February 23, 2004–January 15, 2005

**CARB (Consortium for Advanced Residential Buildings)**  
*Norwalk, Connecticut*

*Subcontract Report*  
NREL/SR-550-38263  
November 2005

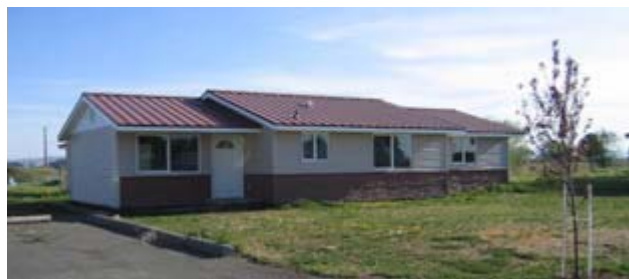
**Figure 4. Finished Unit #303**

CARB visited the Adam's View community during the first week of May 2005 to do performance testing on three of the six completed rehab units. Unit #303 (two-bedroom; Figure 4) and units #207 and #204 (three-bedroom) were inspected and tested to quantify the benefit of the improvements being made to these rehabs.
