Balancing Hydronic Systems in Multifamily Buildings

Russell Ruch, Peter Ludwig, and
Tessa Maurer

Partnership for Advanced Residential Retrofit

July 2014

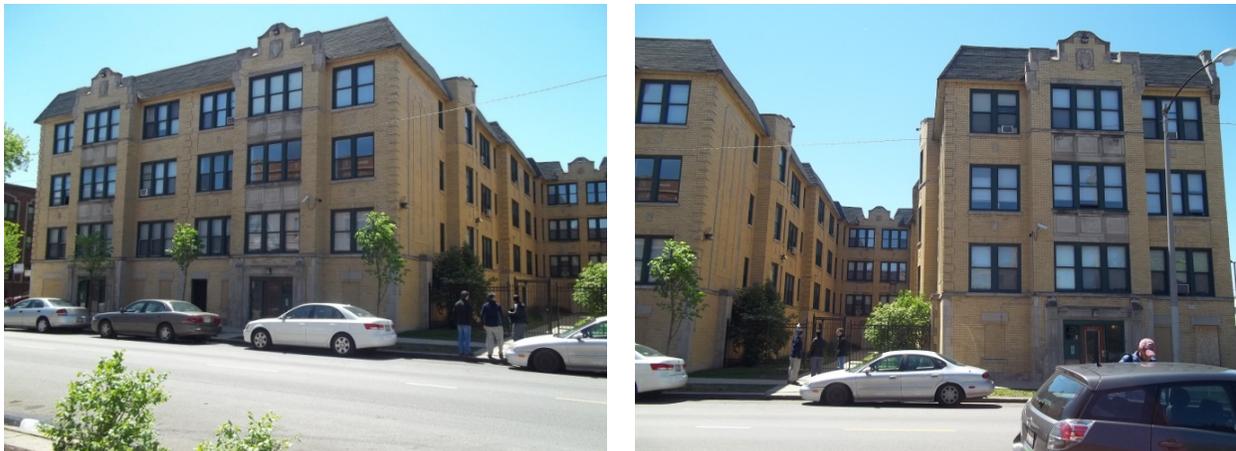
Figure 8. Photograph of Building A: northeast corner (left); northwest corner (right)

Building A (Figure 8) was built in 1920 in an “S” shape typical of Chicago multifamily buildings of that era. Originally outfitted for a steam boiler, the building was converted in the late 1990s to a centrally metered hydronic system with baseboard radiators and multiple sequenced boilers.⁵ This new system was piped for only two zones, west and east, and the distribution piping was undersized. This resulted in chronic underheating issues in the north and west units, which were located furthest away from the boiler room (Figure 9).

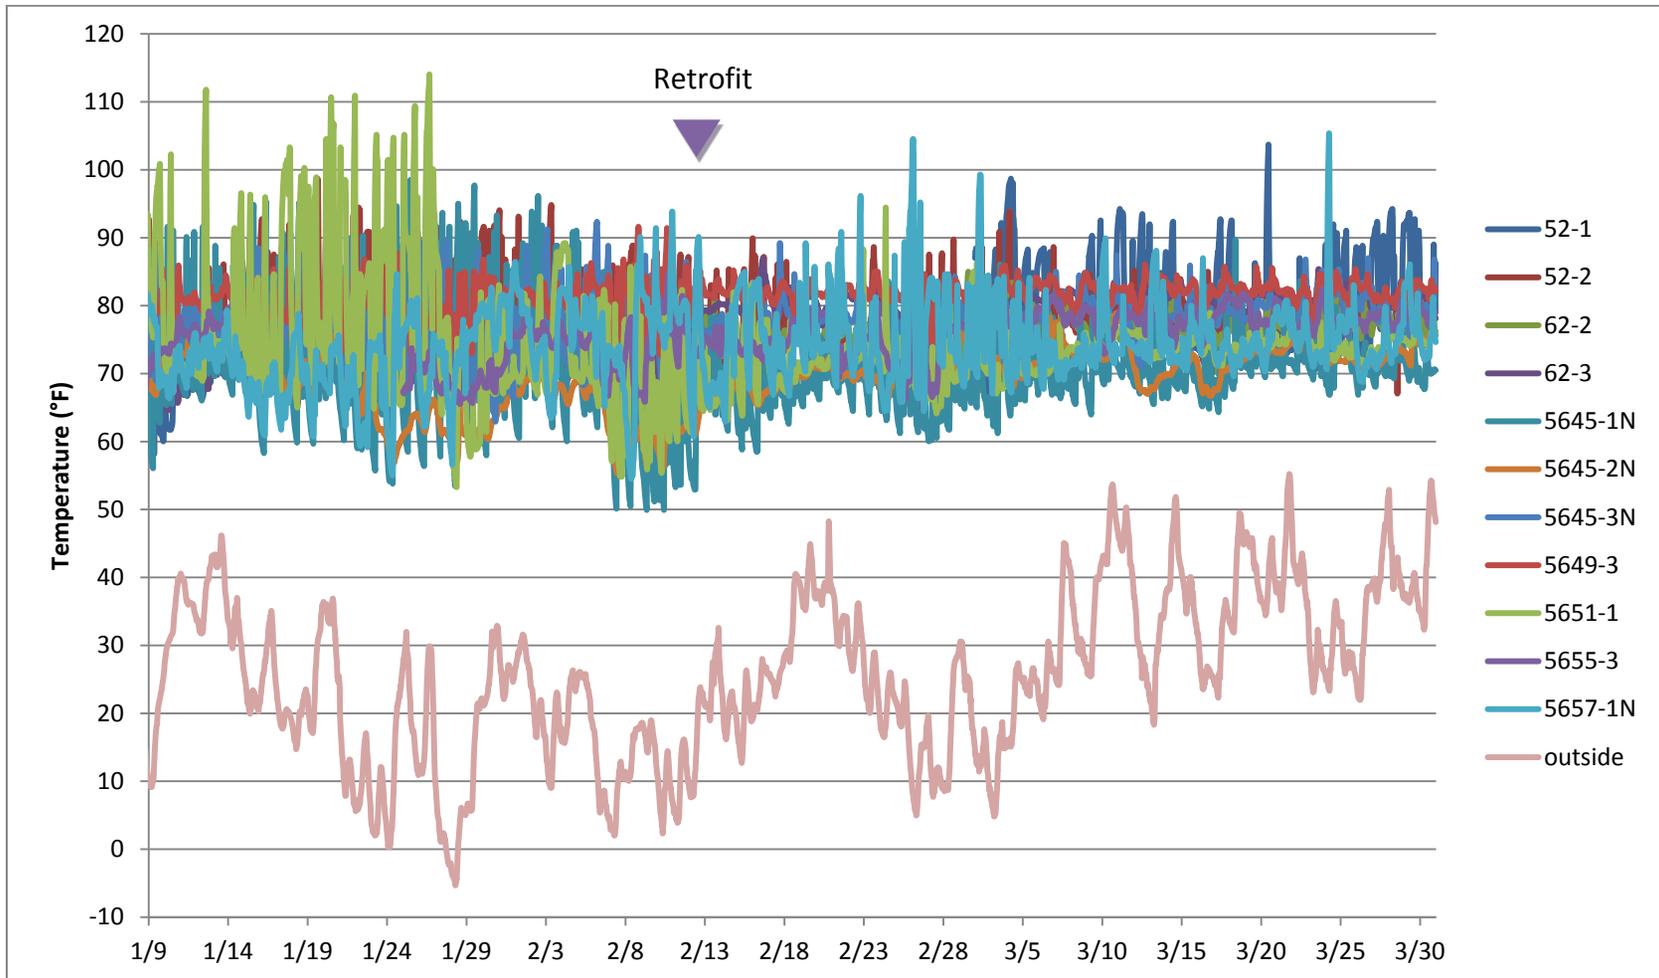
Figure 11. Building A in-unit and outdoor temperatures, pre- and post-retrofit

Temperature in the pre-retrofit week oscillates widely within a range of 66°–111°F, cycling one to three times a day. Temperature in the post-retrofit week rises and falls within a relatively narrower range of 66°–86°F, and only rises above 81°F during a single cycle. Outdoor temperatures during these weeks were comparable.

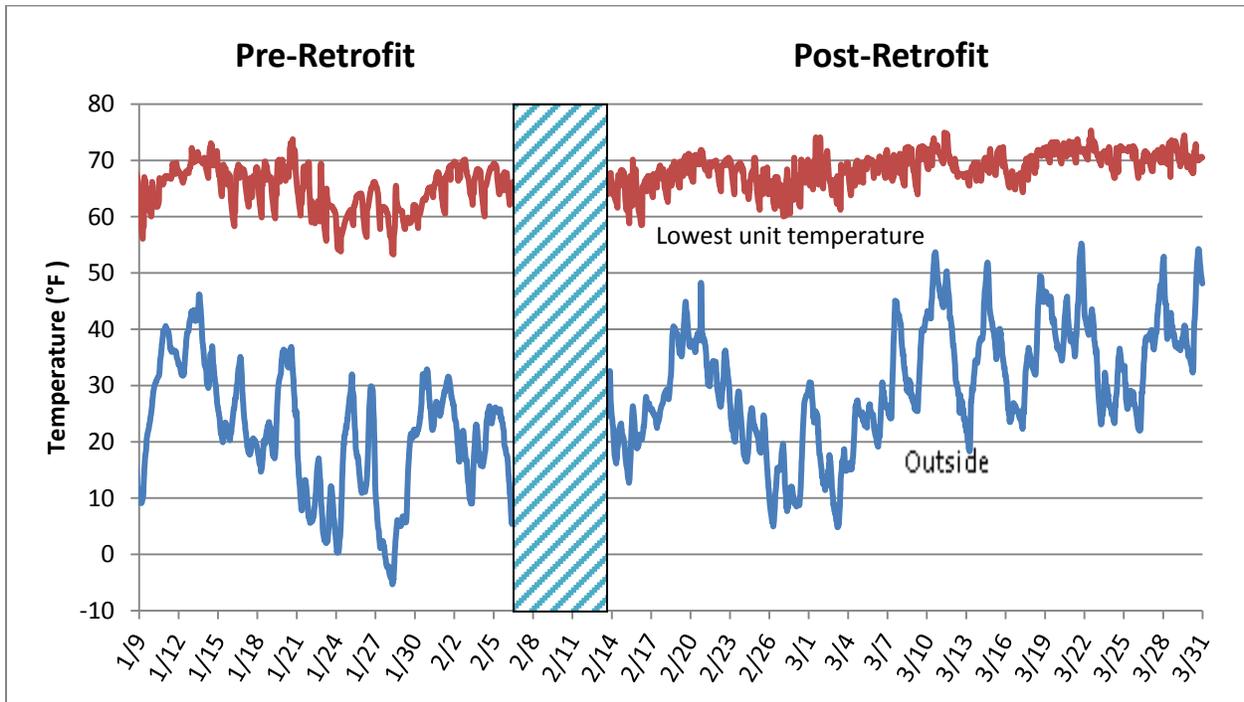
Figure 13. Lowest unit temperature at Building A versus outside temperature

units. On average, unit minimum temperature rose by 4.9°F after the retrofit, with the greatest improvement in the west wing unit 5651-1 (9.8°F). Figure 13 plots the minimum recorded unit temperature in Building A at each 30-minute interval over the course of the study period.

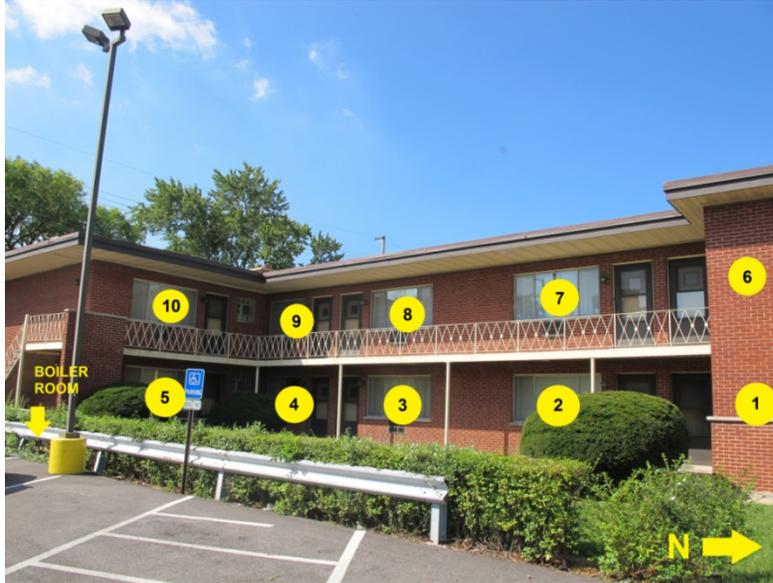
Figure 15. Building B: note location of boiler room

Building B is a 10-unit, two-story, California style building constructed in 1961. Roughly arranged in an “L” shape with five units on each floor (Figure 15), the building uses an underfloor radiant heating system with individual zones for each apartment. The boiler room is located in a basement in the southeast corner.¹¹

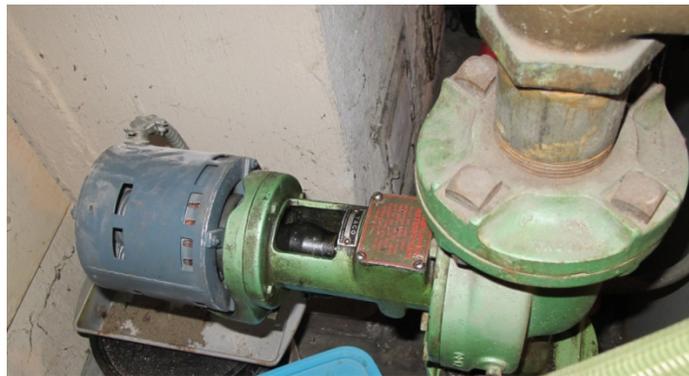
Figure 16. Primary circulator at Building B

At the start of this study, the original 435 MBH boiler from the 1960s was still in use. Apartment unit temperatures were controlled by Honeywell wall thermostats. A Tekmar indoor/outdoor temperature controller was set for the return temperature at 130°F and the outdoor cutout was set at 55°F. A Taco 121-3 pump served as the primary circulator (Figure 16). The owner had also installed a Grundfos UP 15-42 F booster pump on the second floor, to increase flow to the two furthest units. This single-speed pump was controlled by a thermostat in one of those two units, where the tenant had agreed not to change the thermostat setting. As at Building A, centrally metered natural gas energy use intensity was calculated for the building using gas bill analysis and weather normalization. The building averaged 66 kBtu/ft²/year for the 2 years prior to this study, better than 59% of other hot water heated multifamily buildings built after 1960 in the Elevate Buildings program.

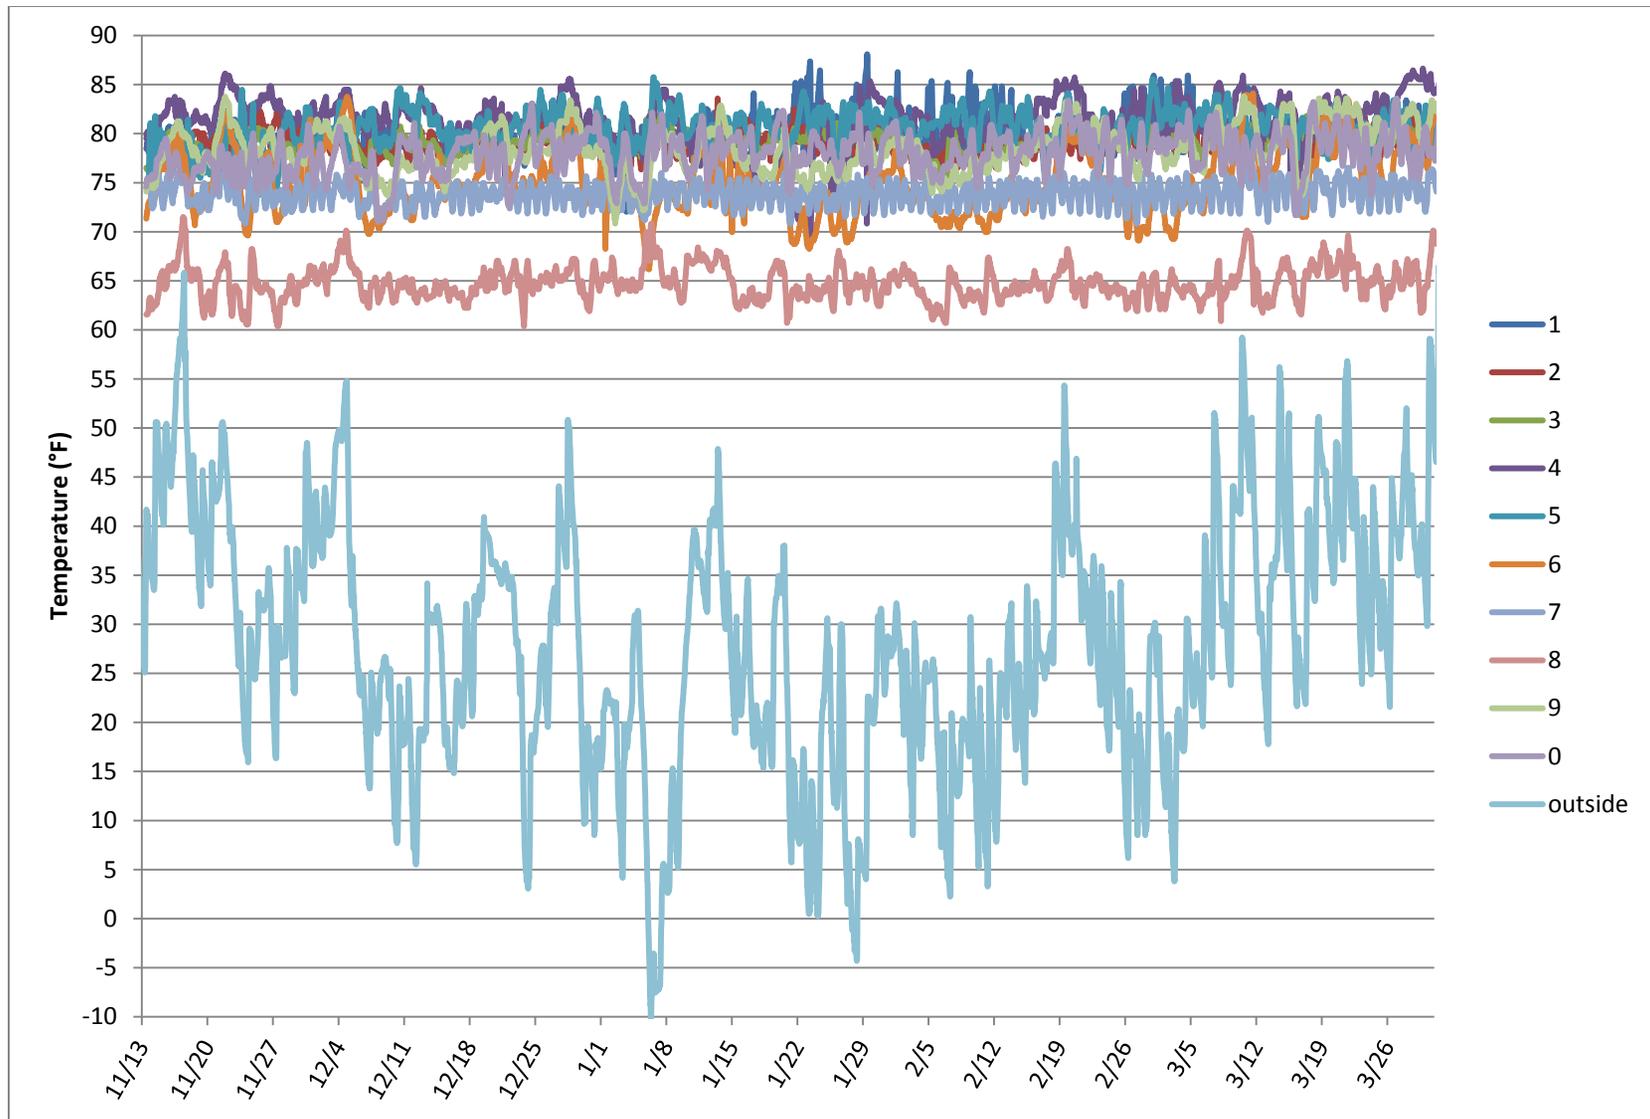
Figure 17. Temperatures collected at Building B

Temperatures at Building B were significantly less volatile and wide ranging than those at Building A (Figure 17). The narrower band of temperatures in building B can be attributed to various factors, including the separate zones for each unit, more appropriately sized piping, its smaller building footprint, and the overall higher level of attention and maintenance paid by the owner of Building B to the heating system there.

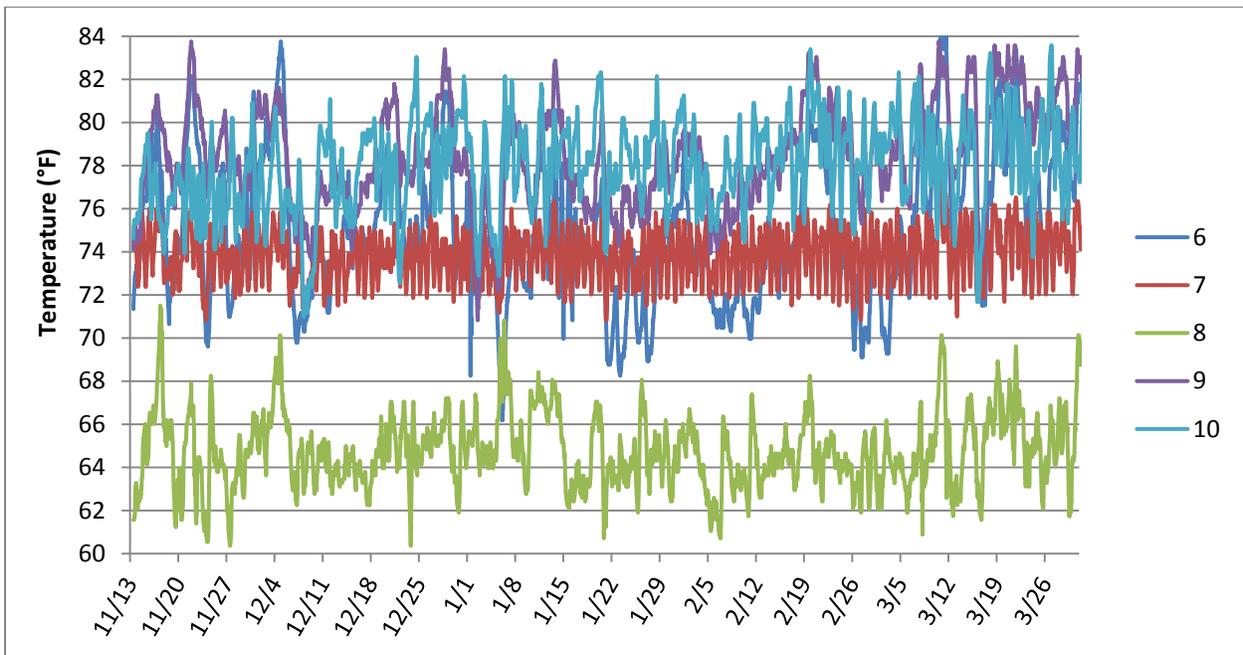
Figure 19. Temperatures in second floor units of Building B

In line with the owner’s concern, the first floor did regularly experience higher temperatures than the second floor during the sample period. First floor unit readings were generally ranged between 76°F and 85°F (Figure 18), while on the second floor temperature tended to oscillate between 72°F and 82°F (Figure 19). Note that second floor unit #8 read especially low because the tenant there preferred to set the thermostat at 60°F.

These figures confirm the higher first floor temperatures seen in Figure 18 and Figure 19. Median temperatures in the first floor units were 79.2°–81.6°F (mean 80.1°F), while the second floor unit medians were 64.7°–78.3°F (mean 73.9°F). These ranges indicate a moderate temperature disparity between floors, but they are not proof of imbalance. Since units were individually zoned, it is possible that first floor tenants could have had higher thermostat set points than those on the second floor. Set points are dealt with in Section 3.4.3.3.

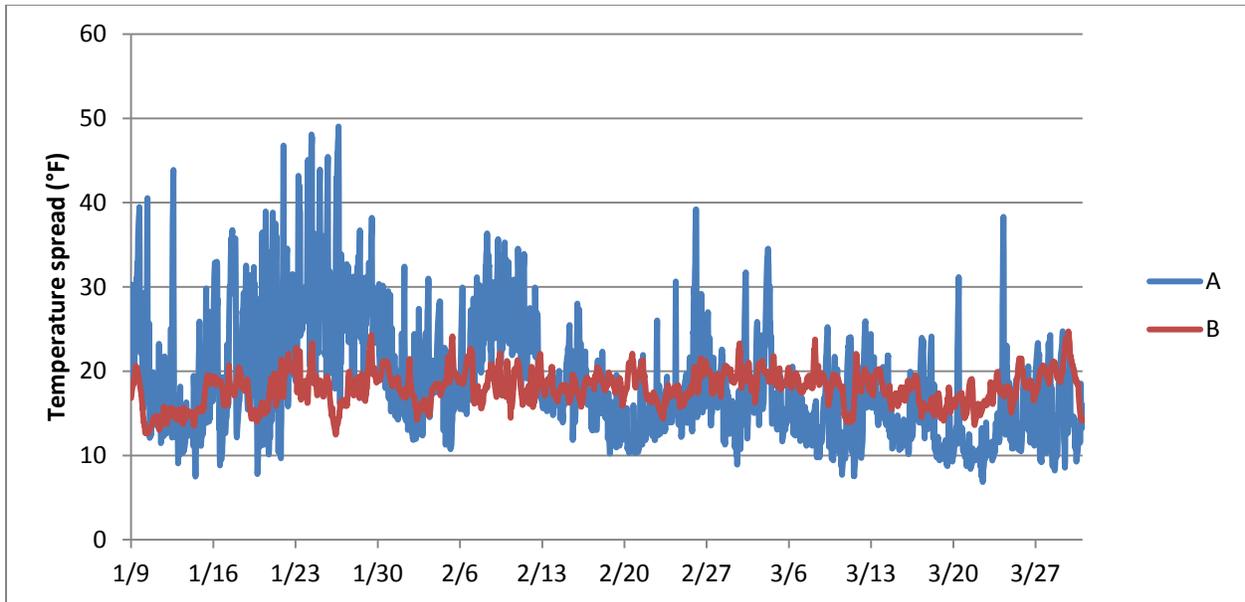
Figure 20. Temperature spreads at both buildings

Figure 20 compares the temperature spread at each building over the sample period. The temperature spread at Building B was clearly less volatile than that at Building A, indicating a more evenly heated building where intermittent supplemental heating in the units occurred less frequently. However, spread was not always lower than at Building A, reflecting the unit-specific zoning in Building B, which allowed tenants to change their unit temperatures to some extent.
