Field Testing of Compartmentalization Methods for Multifamily Construction

K. Ueno and J.W. Lstiburek
Building Science Corporation

March 2015

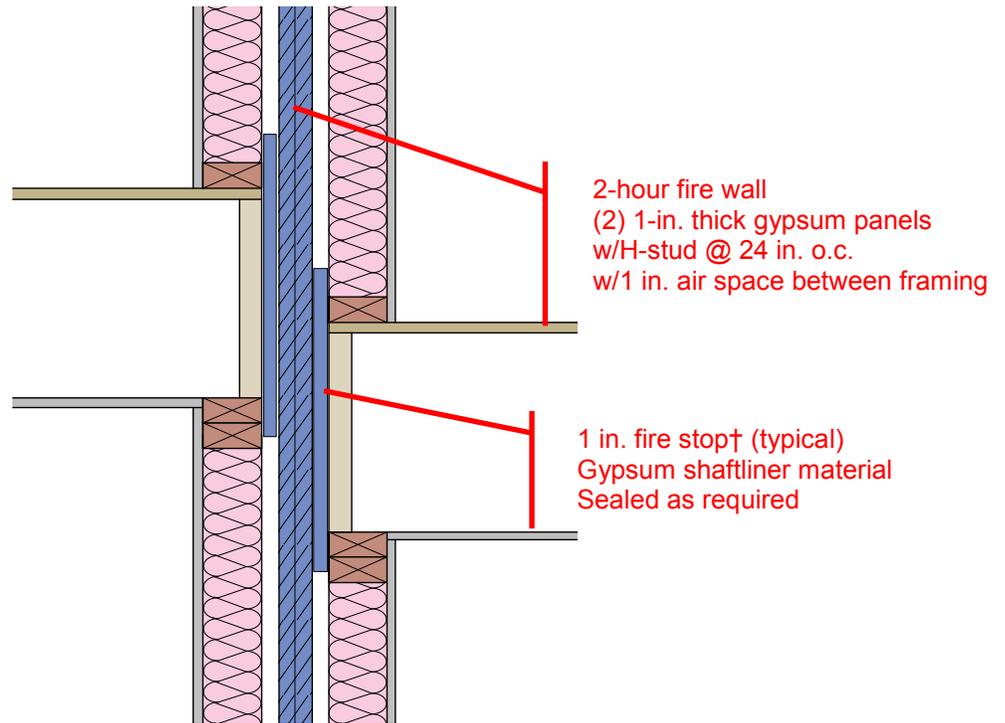
Figure 5. Area separation wall (fire-resistance rated wall assembly) at floor framing

The air gap is nominally compartmentalized by 1-in. thick gypsum “fire stop” in the cavity at floor levels (Figure 4 and Figure 5), exterior walls (Figure 6), and the attic floor. This “fire stop” is highlighted (†) in Figure 4 and Figure 5: it is called out in the manufacturer’s illustrations, but is not part of the U347 assembly. This “fire stop” callout overlaps in concept with the fire-blocking requirements of the IRC (§R302.11). The “fire stop” air seal is reliant on a tight fit in the opening, which may or may not occur, given framing construction tolerances. Also, interunit leakage may occur at the H-stud and C-channel joints of the double 1-in. gypsum board wall.

[BSC]). The lack of correct air sealing at this detail is one of the fundamental sources of the air leakage issues seen at these assemblies.

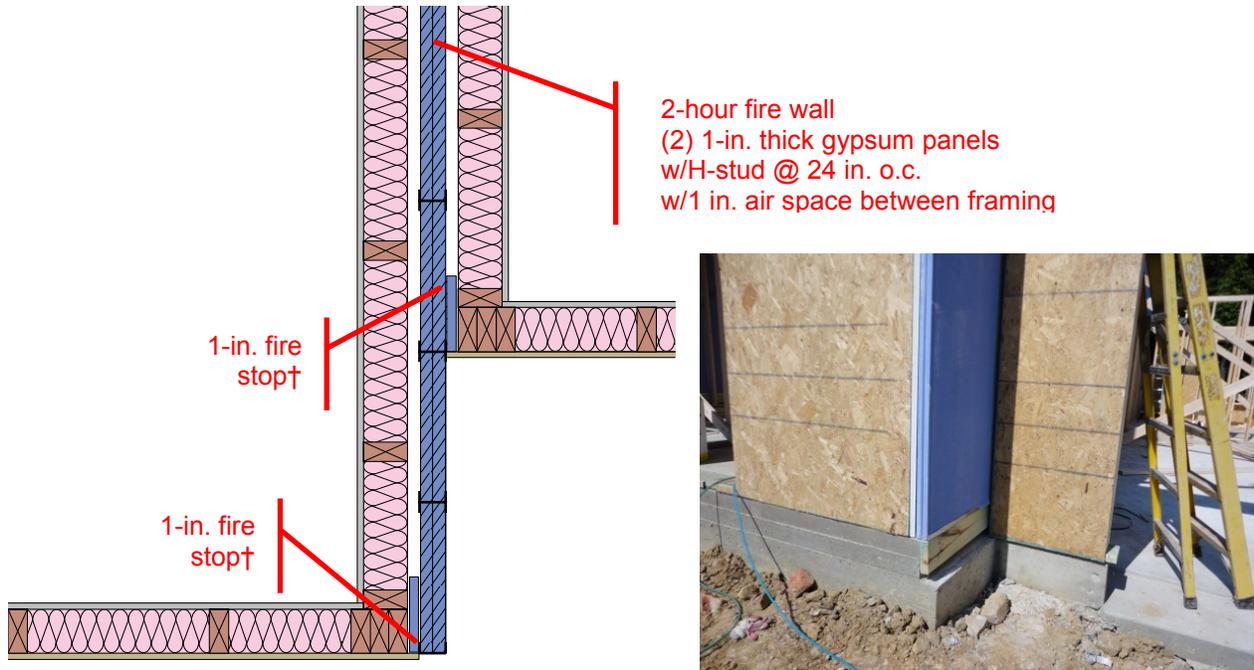
Figure 6. Area separation wall (fire-resistance rated wall assembly) detail at offset units

Another problem geometry is shown in Figure 6: the fire separation wall penetrates to the exterior (because of a wall offset), leaving the edges of multiple layers exposed to the exterior.

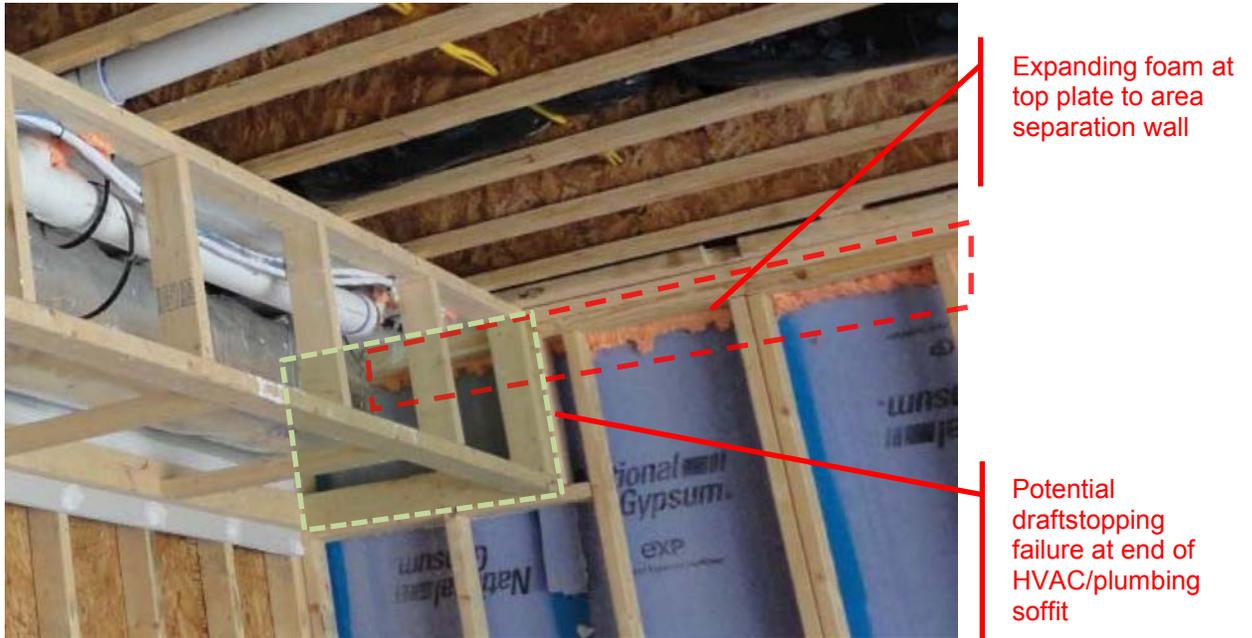
Figure 12. Expanding foam at garage, top plate to area separation wall

At the garage (unconditioned space), the area separation wall's top plate was sealed with expanding foam, per Figure 12. The uncapped soffit is a potential draftstopping failure, connecting the HVAC/plumbing soffit to the area separation wall cavity.

The 1-in. cavity between the interior wall 2 × 4 framing and the double 1-in. shaft liner board should have been sealed with expanding foam (Figure 12); however, this detail was apparently omitted or improperly done. A similar situation was seen at the building in frame: this location should be filled with 1-in. gypsum fireblocking, but it was missing at one unit (Figure 55).

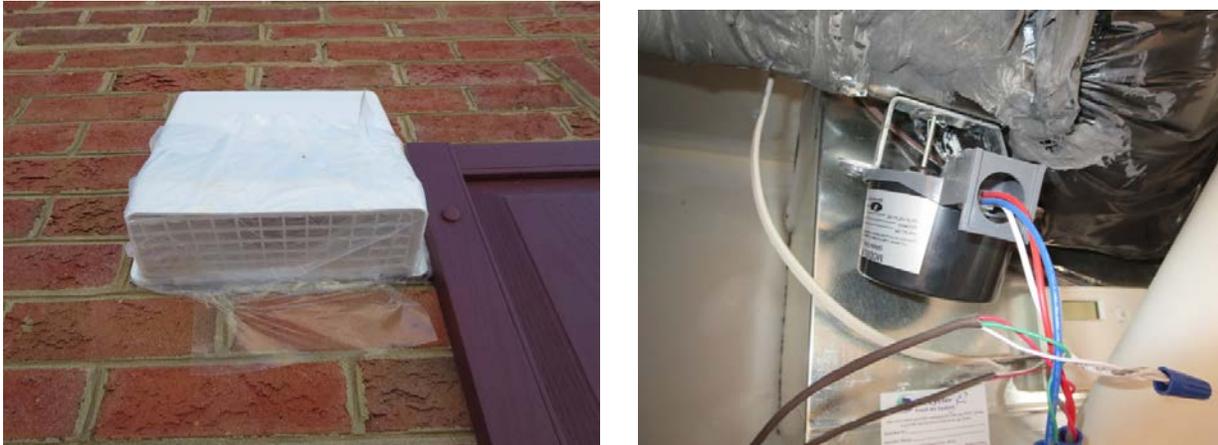
Figure 21. Outside ventilation air intake; motorized damper at air handler

During the Day 2 tests, all outside ventilation air intakes were taped off at the exterior hood (Figure 21). This was done because Day 1 testing revealed noticeable air leakage coming from some ductwork systems (especially at the returns). The likely explanation was a malfunctioning motorized damper on the outside air duct (Figure 21); however, the damper would have had to be disassembled to ascertain its position. Given that the focus of this research is enclosure leakage, the ventilation ducts were removed from the experiment with this sealing.

Various mechanical systems were also a source of air leakage. Air leakage was evident at the air handler returns, which was linked with incorrectly operating motorized dampers in the outside air supply ventilation duct (see Figure 21).

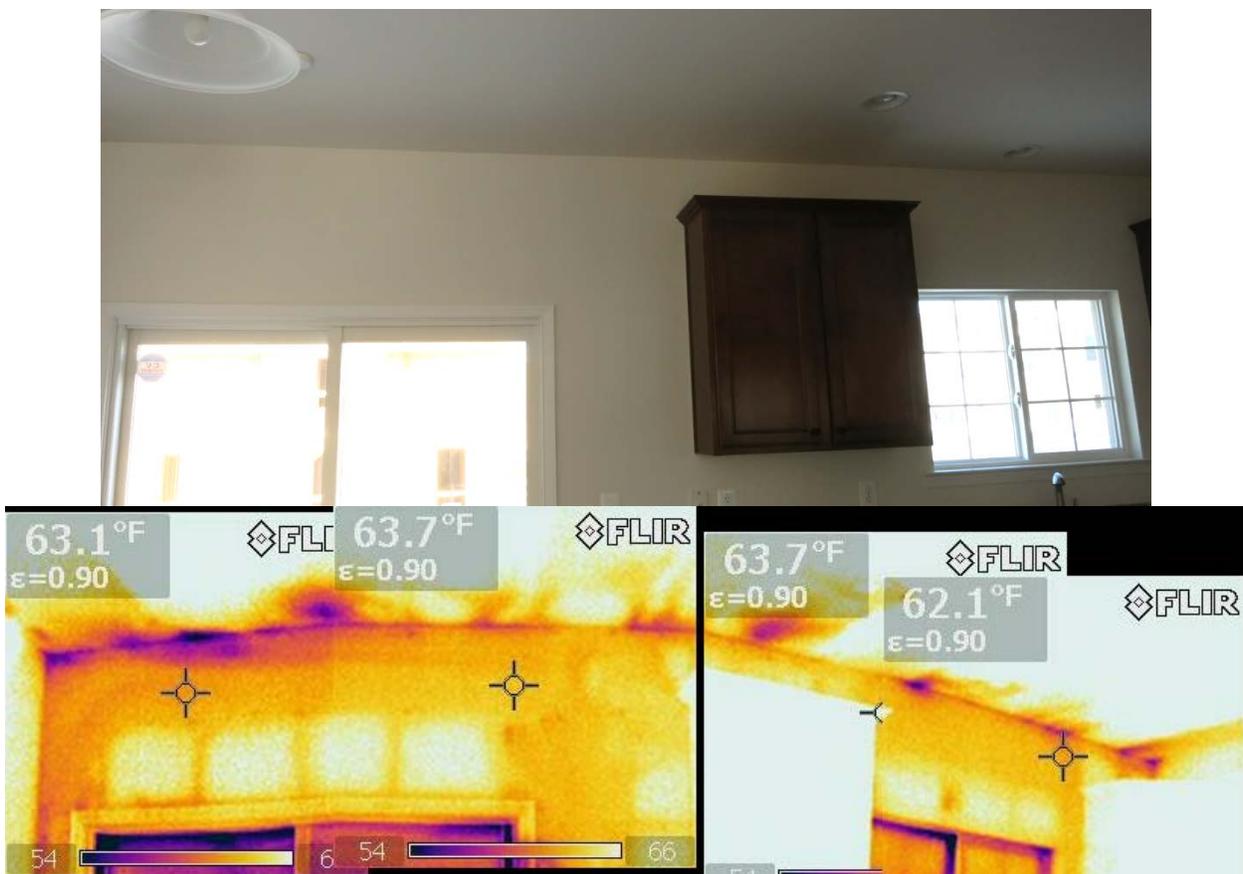
Figure 25. Rear second-floor kitchen/dining area, Unit 6704 (middle)

One consistent issue arose at the second- to third-floor ceiling/floor assembly (across several units); this is shown at a rear second-floor kitchen in Unit 6704 (conventional construction) in Figure 24 and Figure 25 (keyed to “A” in Figure 23). Air is entering the floor framing cavity from the exterior at the third-floor overhang detail.

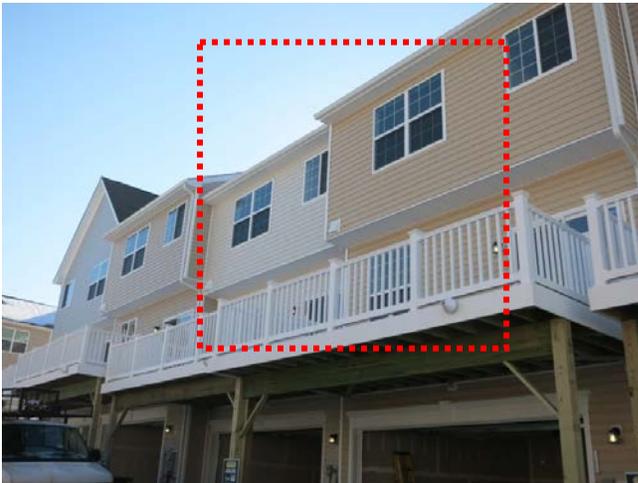
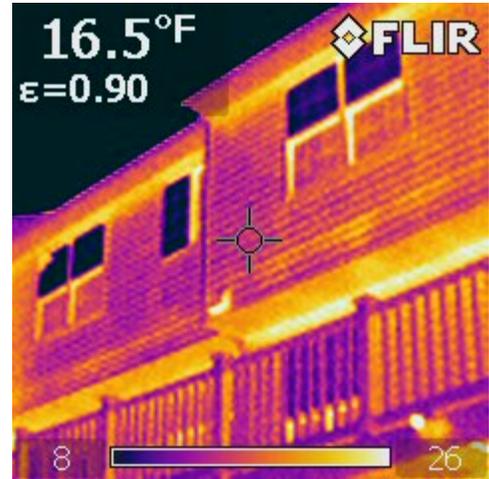
Figure 28. Rear overhang infrared image, units 6702 and 6704 (taped and conventional)

An exterior infrared image of the overhang (Figure 28) shows warmer surface temperatures (outdoor temperature 30°F and rising). This might be due to air leakage, but the overhang surface is shielded from night sky radiation, which might increase its temperature.

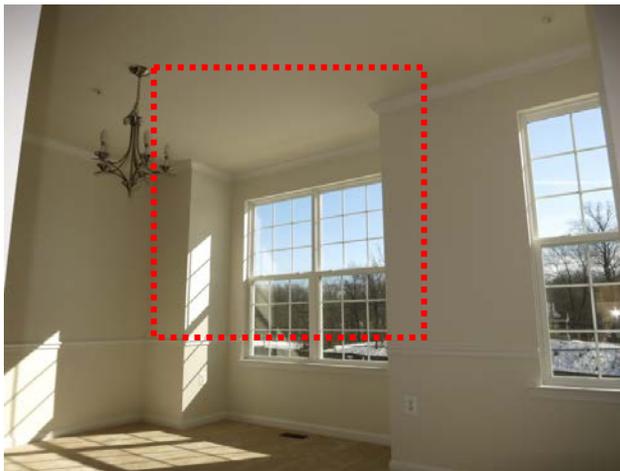
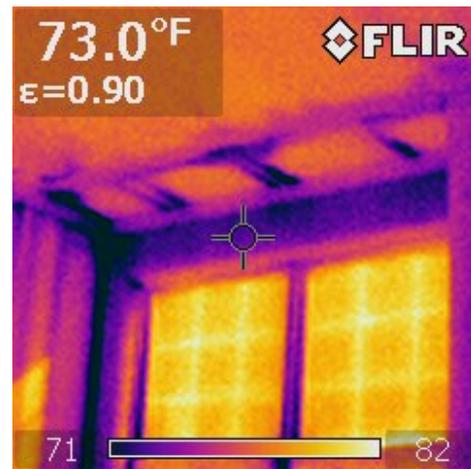
Figure 29. Front bump out bay detail at unit 6702

The projecting bay at the front of Unit 6702 (middle, improved, and taped) had significant air leakage at the ceiling, visible at the framing (Figure 29; keyed to “B” in Figure 23). An exterior view of the bay is seen in Figure 30. The metal roof of the bay does not appear to be vented; no further investigation or disassembly was done.

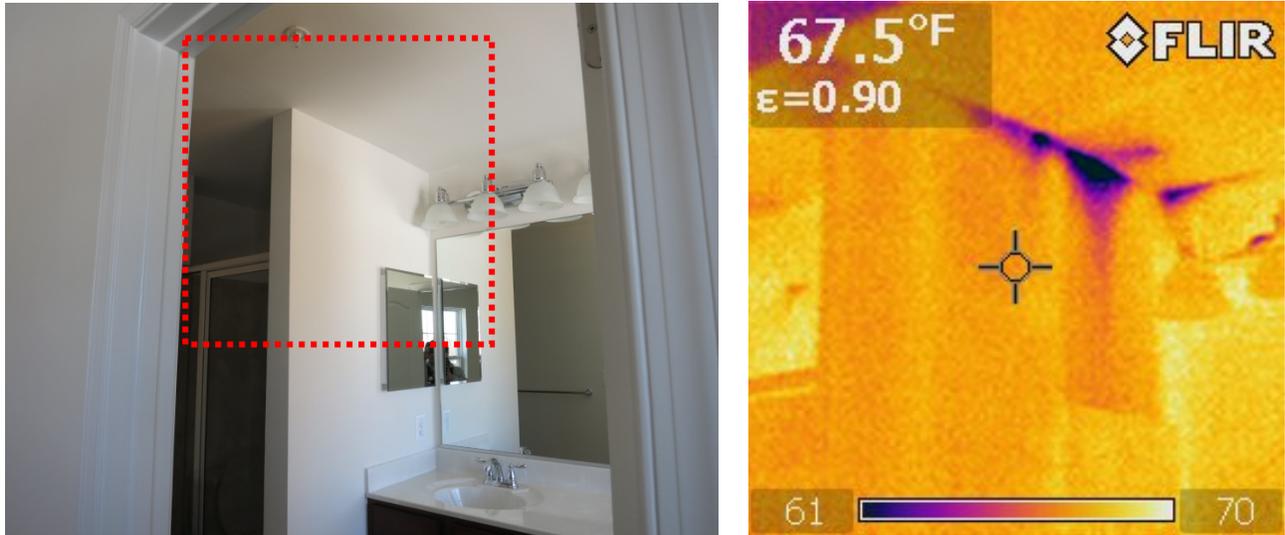
Figure 35. Interior wall under attic (third floor), Unit 6702

At several interior walls under the vented/unconditioned attic, noticeable air leakage was visible at the top plate (Figure 34 and Figure 35, keyed to “D” in Figure 23). Unfortunately, this indicates that the interior top plate detail (Figure 8) was not executed correctly or consistently.

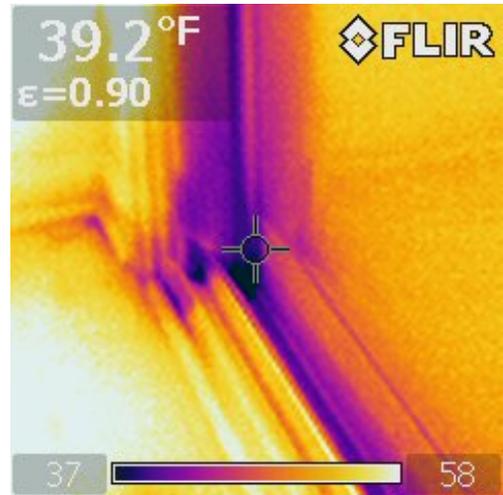
Figure 39. Sliding glass door air leakage at weep hole (door unit)

Windows and doors were noticeable sources of air leakage. Air leakage occurred in the window units at the sash to frame interface (often worst at the corners), as shown in Figure 38. At a sliding glass door, an interior weep hole at the sill track was a distinct air leakage point (Figure 39 and Figure 40), which is a flaw in the design of the unit.

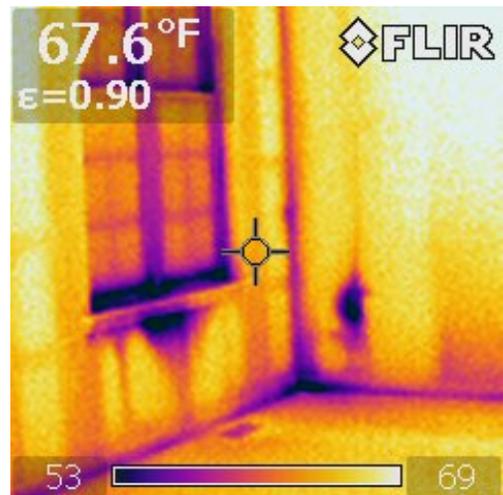
Figure 41. Window air leakage (window-to-wall connection at sill), Unit 6706

The window-to-wall connection was also a source of air leakage in some cases, as evidenced by the leakage plume coming from the stool casing below the window sill (Figure 41).

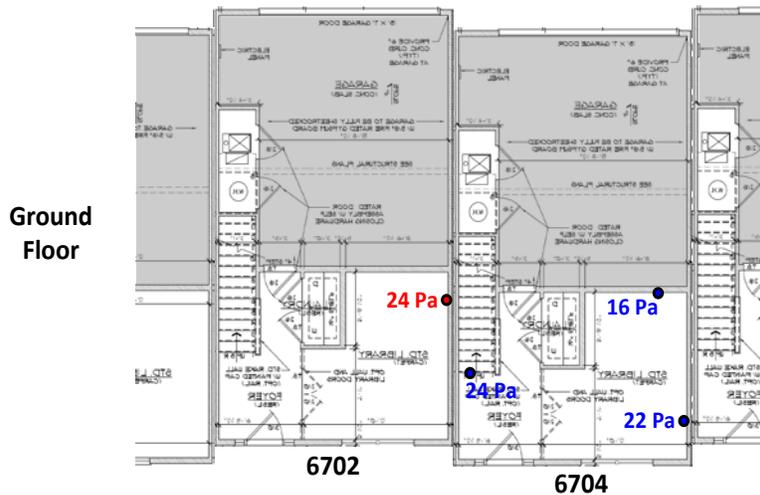
Figure 63. Pressure difference measurements, first floor (6702–6704)

- The area under the stairs in Unit 6704 is still roughly half inside/half outside (24 Pa), despite the nulled test. This suggests that the leakage at the stairs is due to a connection to the mechanical room in the garage (rather than at the area separation wall alone).

- The area separation wall cavity near the garage in Unit 6702 has a large pressure drop (24 Pa), despite the wall being “nulled” by the two fans. This suggests substantial leakage to the garage from this cavity (per Figure 51).

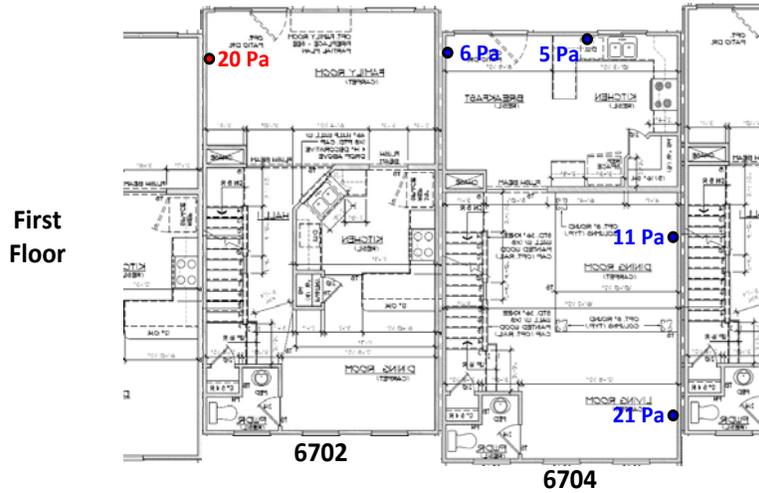
Figure 64. Pressure difference measurements, second floor (6702–6704)

- Pressure differences to the nulled area separation wall were as low as 4–6 Pa in some cases, suggesting that the depressurization field has reached those cavities. However, this is not a “perfect” result (i.e., 0 Pa difference), which shows that the nulling test is not a complete elimination of air leakage between units. Interstitial cavities between the two nulled units result in a gradient of pressures through the various air spaces.

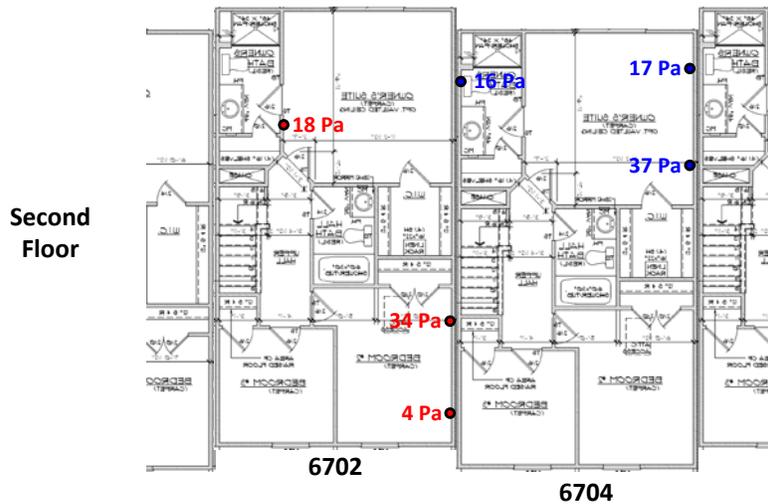
Figure 65. Pressure difference measurements, third floor (6702–6704)

- Other pressure differences into the nulled area separation wall were higher: the third floor bedroom was 34 Pa, suggesting substantial leakage to the attic from the area separation wall cavity.
- Pressure differences to the nonnulled area separation walls ranged from 10–37 Pa, with 20 Pa measurements typical. This suggests that—as discussed elsewhere—there is substantial leakage from the area separation wall cavity to exterior or other units.

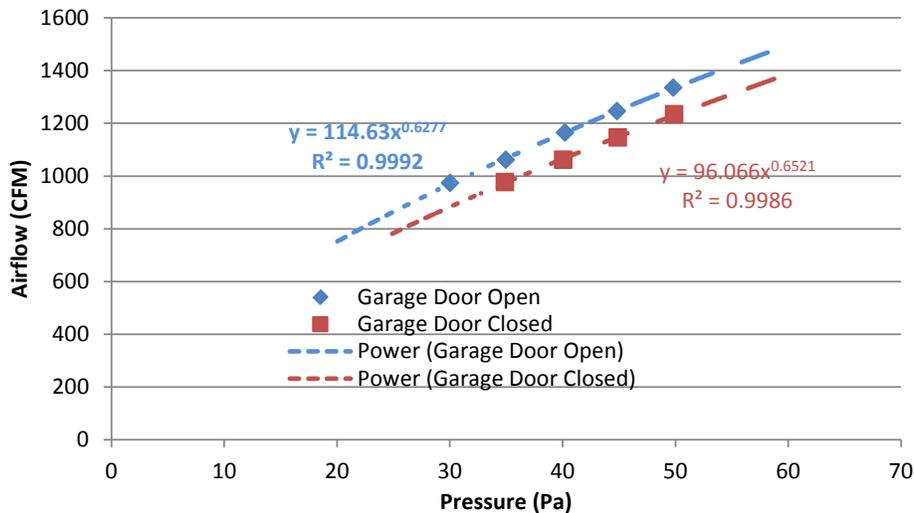
Previous measurements and observations suggest substantial air leakage to the garage. Multipoint blower door tests were run with the garage door open and closed in Unit 6706 (middle, “improved” details, no sheathing tape), as shown in Figure 66. The difference between the garage door open/door closed tests was 8% of the result (1336 versus 1232 CFM50).

Figure 66. Air leakage results with garage door open and closed, Unit 6706

During the “door closed” test, the pressure difference from the unit to the garage was measured: the garage was consistently connected 50% to the unit. This implies that leakage from the garage to the exterior (i.e., around a leaky garage rollup door) is equal to the leakage from the unit to the garage. This has negative consequences for energy and indoor air quality (contamination from garage pollutants).

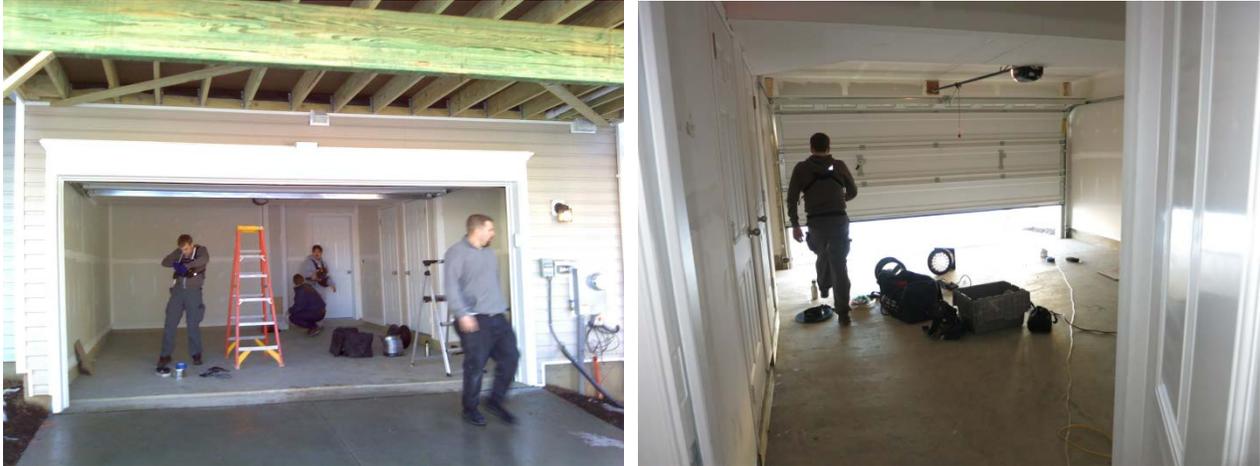
Figure 67. Unit 6706 garage overview

For instance, the overhead bulkheads required for ductwork running across floor framing (Figure 67) connect floor framing cavities across the width of the garage that are well-connected in turn to the interior. If draftstopping is omitted at the end of the bulkheads, they will be well connected to the area separation wall cavities (Figure 12).

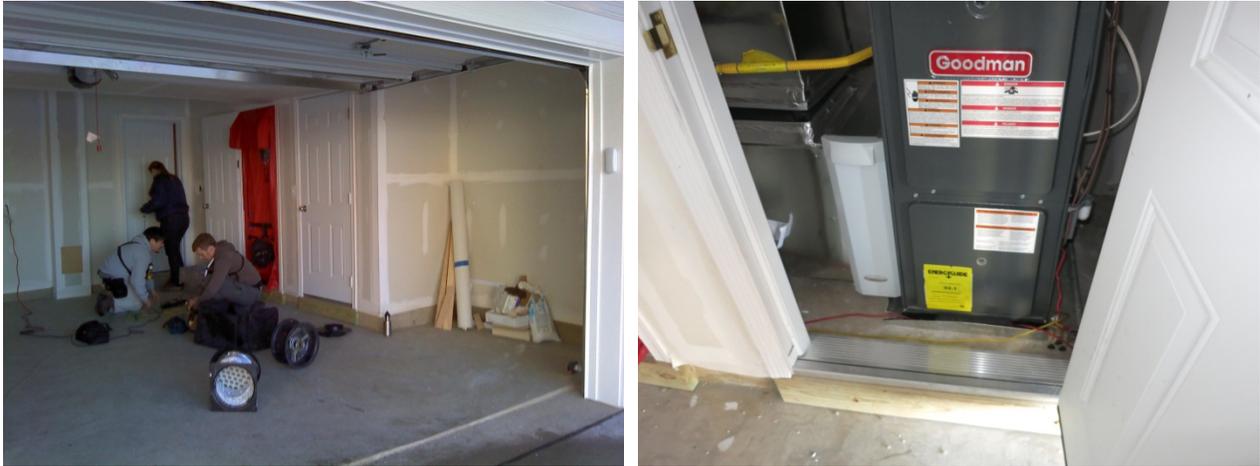
Previous testing indicated that the mechanical room is another source of leakage. Leakage locations likely include the swinging doors (despite weather stripping), and connections from garage gypsum board imperfections (e.g., gypsum board-to-foundation stem wall connection) into the framing cavities.

A nulled test was performed using a TEC Minneapolis Duct Blaster installed in the mechanical room door (Figure 68), with the unit and mechanical room simultaneously depressurized. Hult and Sherman (2014) note that a two-fan “pressure balancing” test has lower uncertainty than most single-fan methods. However, the authors also noted that the two-fan Herrlin and Modera method has even lower uncertainty than pressure balancing; this method will be considered in future work.

Figure 68. Mechanical room located in rear garage (Unit 6706)

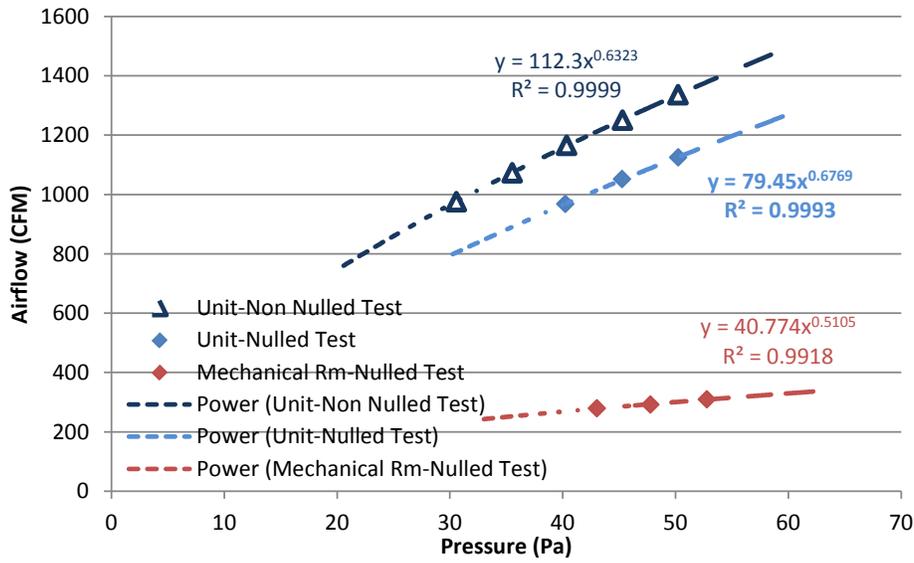
Figure 70. Garage mechanical room nulled and nonnulled tests, Unit 6706

Results are summarized in Table 6, with the CFM50 (from the multipoint test), and calculated EqLA (in square inches). The sum of the two nulled tests (1122 + 300 = 1423 CFM50) is not equal to the nonnulled test (1332 CFM50), even though both tests nominally measure leakage of unit and mechanical room to the exterior. The explanation is that during the nonnulled test, the pressure field does not extend completely to the mechanical room (21 Pa in the mechanical room, when the unit was at 50 Pa test pressure), resulting in a lower measured flow. But the results indicate that roughly 20% of the unit’s total leakage originates at the mechanical room. These results also allow calculation of the connection of the mechanical room to the unit’s interior space (210 CFM50/22 in.² EqLA). EqLA is considered a reasonable representation of actual changes in air leakage open areas (TEC 2014).

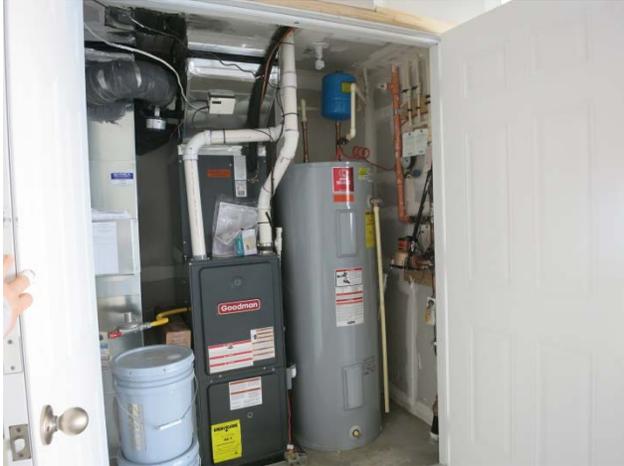
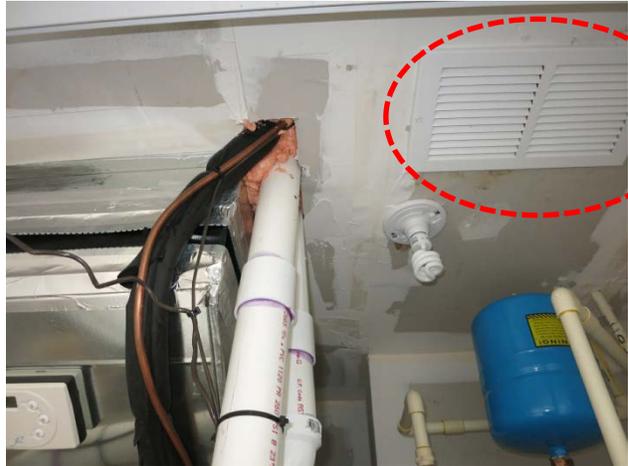
The mechanical room is well connected to the interior, as it is intentionally heated (see supply register in Figure 71 right). There are also many connections from the mechanical room to interstitial spaces (wall stud and floor joist cavities) from the variety of mechanical penetrations, including furnace supply/exhaust pipes (Figure 71, right), air conditioner refrigerant lines (Figure 72), supply and return duct penetrations, pipe penetrations (Figure 72), and other substantial openings (Figure 73 is a clear opening into the floor joist cavity). If the floor joist cavity is connected to the exterior or the garage, it is in turn connected to the interior. These penetrations are difficult to access and seal, given the congestion in the small mechanical room.

Figure 71. Furnace and water heater at mechanical room (Unit 6700); supply register

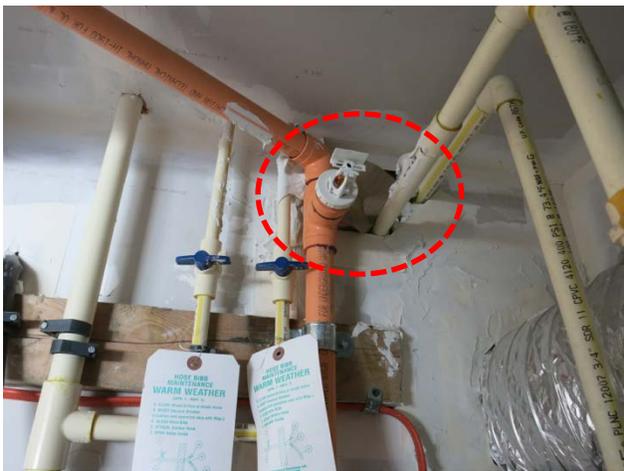
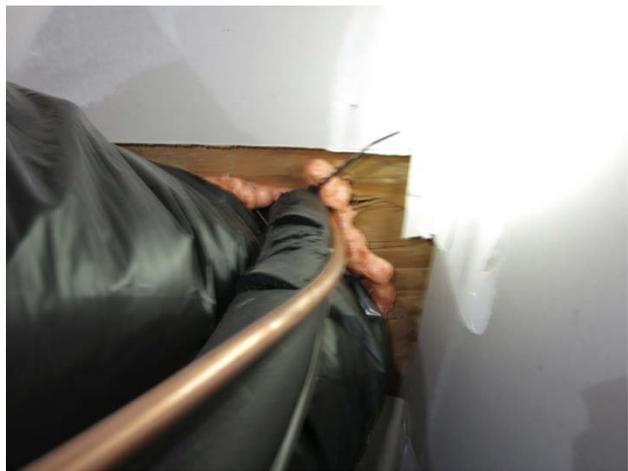
Figure 72. Ceiling and wall penetrations at mechanical room (Unit 6702)

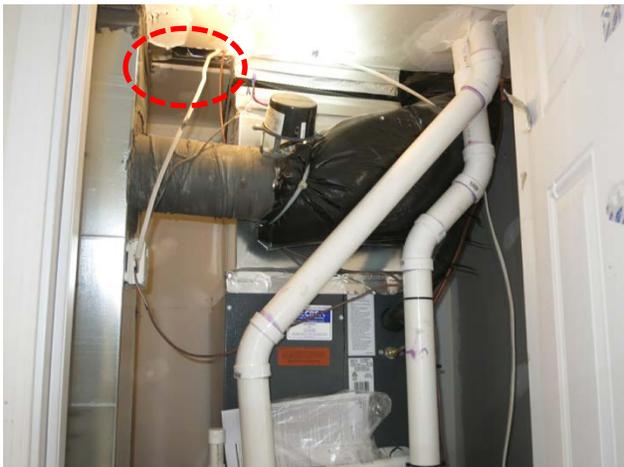
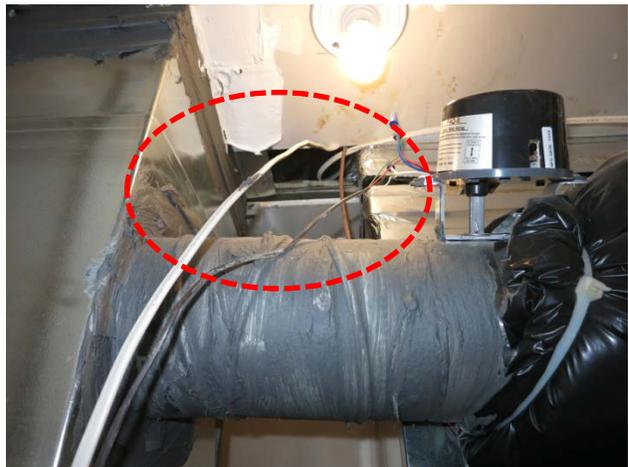
Figure 73. Ceiling penetrations at mechanical room (Unit 6702)

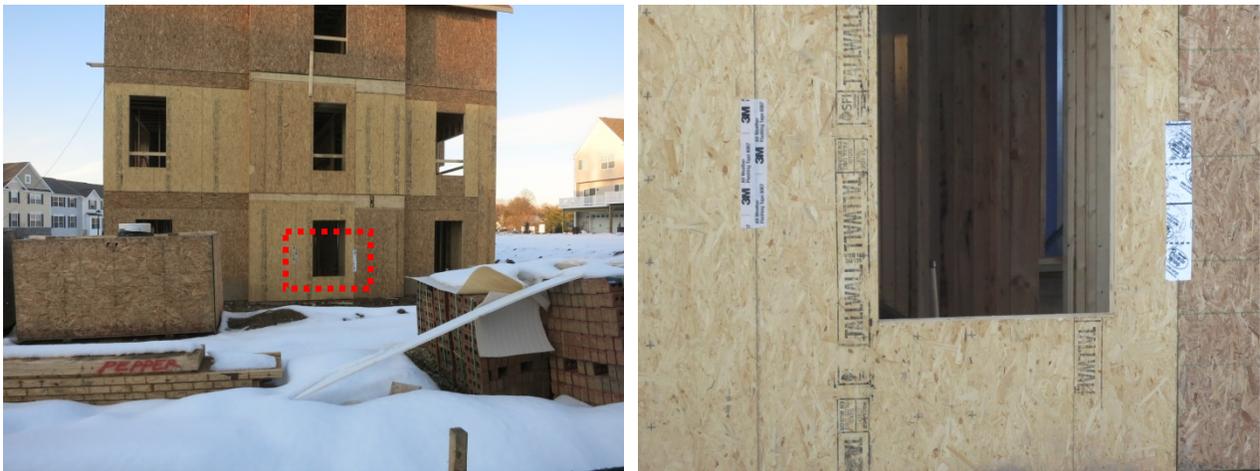
At the conclusion of Day 1 testing, samples of sheathing tape were adhered to seams at the building in frame. Geometries included flat OSB seams (Figure 74) and an OSB-to-gypsum outside corner (Figure 75). One tape was 3M All Weather Flashing Tape 8067 (high tack acrylic adhesive tape with a 10 mil proprietary backing), which Holladay (2013a, 2013b) found to be a good performer on OSB. The other was Protecto Wrap “Super Stick Building Tape” (polyester metalized foil acrylic adhesive tape), which is intended for sealing of exterior sheathing (among other uses). Both tapes had excellent initial adhesion, even at the cold temperature during application (30°F). The wall-to-foundation joint was not taped in this work.

The intent was to leave the tapes in place and have the builder document the performance over time, after temperature cycling and exposure. However, house wrap was applied to the entire building the next day, so no results were obtained. This experiment could be repeated at other jobsites or at a controlled exposure site.

Figure 74. Test application of two types of adhesive sheathing tape

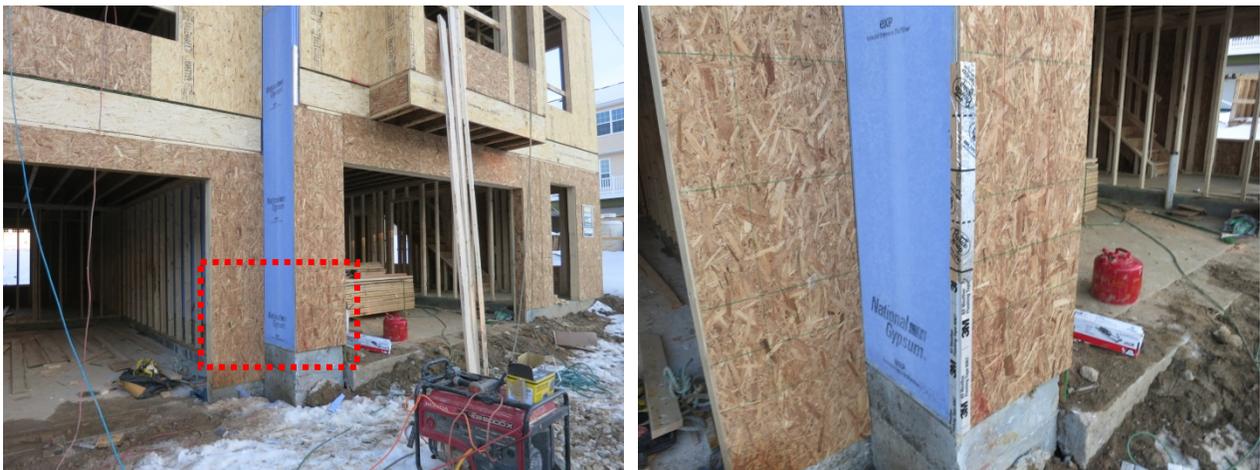
Figure 75. Test application of two types of adhesive sheathing tape

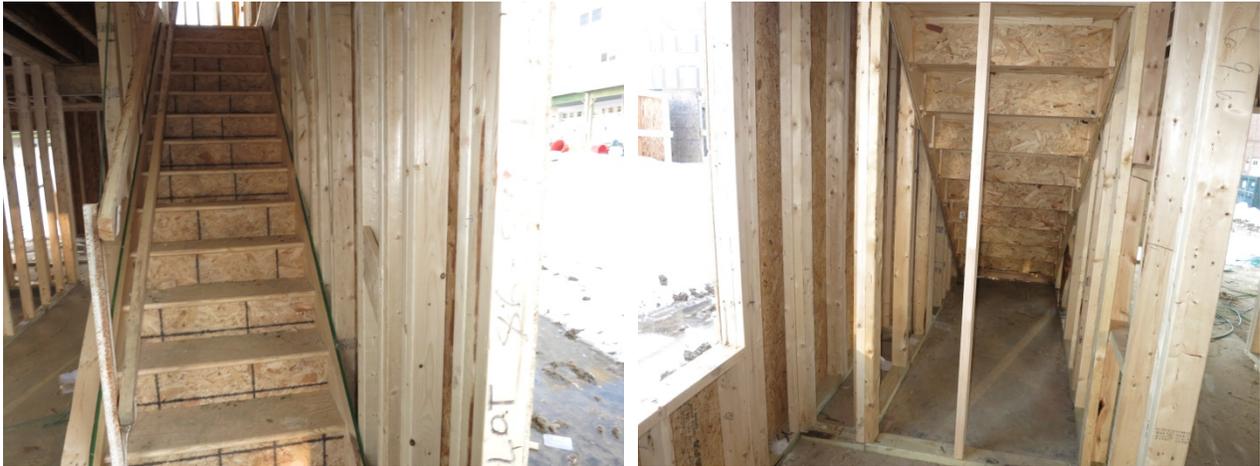
The interior staircase effectively functions as a component of the air barrier, based on the air leakage patterns and interstitial pressure measurements (Figure 48 through Figure 50). Ideally, the triangular volume under the stairs would be contained entirely within conditioned space, and a vertical air seal detail per Figure 76 would be installed at the end wall of this space. The rough frame condition of a stairwell (albeit on an exterior wall) is shown in Figure 77.

Figure 77. Stairwell on exterior wall
