# Energy Retrofit Field Study and Best Practices in a Hot-Humid Climate

J. McIlvaine, K. Sutherland, and E. Martin  
*Building America Partnership for Improved  
Residential Construction*

March 2013

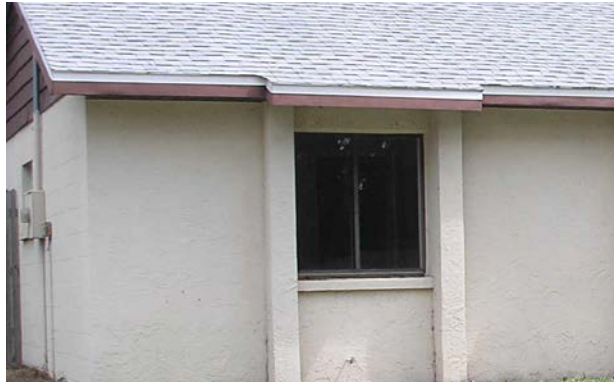
Painted stucco over wood frame or concrete block describes the exterior wall finish of nearly every study home, a style typical of the Florida housing stock (Figure 8). A few older study homes were painted concrete block with no stucco, and a few had vinyl siding. Forty-one homes (59%) were constructed entirely with concrete block walls and 22 (31%) were all frame. The remaining seven (10%) were a combination of block and frame (Table 3).

**Figure 8. Typical wall construction of light color paint on stucco finish over concrete block**

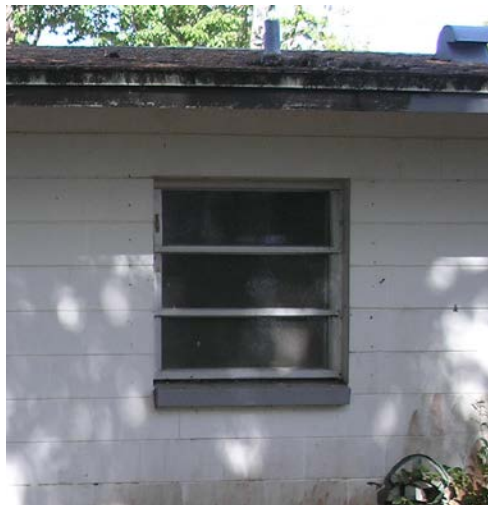
**Figure 9. Typical awning-style window type**

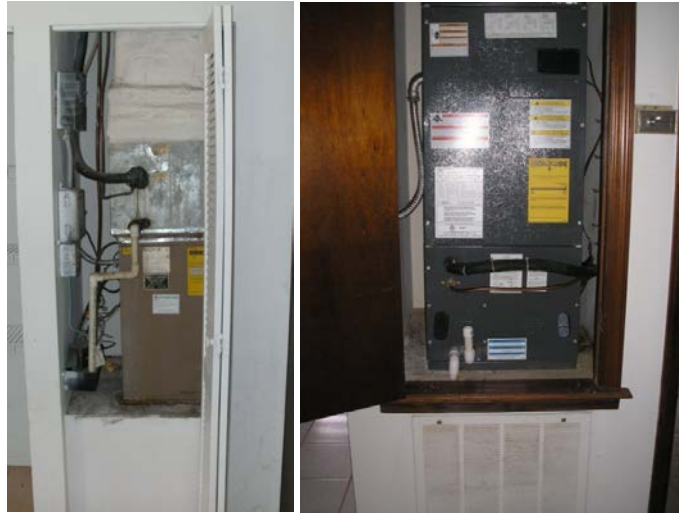
- **Forty homes.** Upflow AHU in conditioned space, usually in a dedicated closet (Figure 24), mounted on either:
  - A framed AHU platform with a wall-mounted filter-back return grille (Figure 24) and a central return plenum formed by a cavity under the platform. In many homes, the cavity was unfinished (Figure 25, left). Finished cavities were formed by sealed duct board (Figure 25, right) or drywall.

**Figure 24. Upflow AHUs in conditioned space in a dedicated closet. Interior AHU closets with returns formed by platforms had wall-mounted return grilles with a full door on an adjacent wall (left) or a partial door above (right).**

The best practices related to AHU replacement are modeled after the Florida Residential Mechanical Code requirements for new homes. These include finished and sealed return air plenum, mechanically fastened and sealed supply plenum connection to the AHU, finished closet walls and ceiling (when applicable), provision of 4-in. clearance around the AHU. Additional best practices not related to new construction code include ACCA Manual D return sizing, sealing the gap between the supply plenum and ceiling drywall, and sealing the gap between the return plenum and the AHU platform.

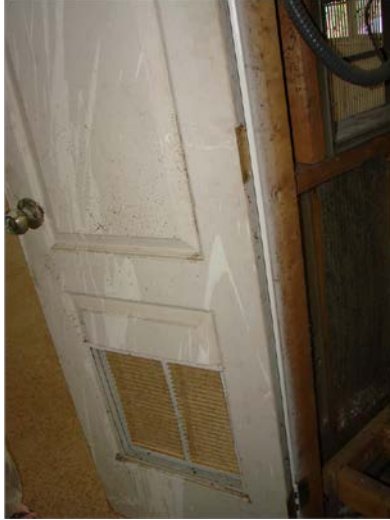
- A metal AHU stand or framed platform with the filter at the bottom of the AHU and the whole closet constituting the return plenum. The return air path was usually through a louvered door or a grille in the closet door (Figure 26).

Figure 26. Interior closets that served as return plenums had louvered doors or door-mounted return grilles.

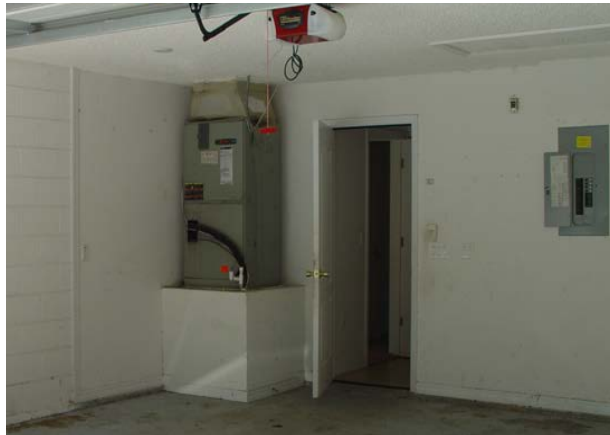
- **Nineteen homes.** Upflow AHU on a framed platform in the garage (Figure 27) with plywood or drywall exterior finish and duct board or open framing inside platform forming a return plenum underneath. This is the typical configuration for new Florida homes with garages (except the return plenum must have a sealed interior finish). The return air path is through:

Figure 27. Upflow AHUs on framed platforms in garage with a wall-mounted filter-back grille were ducted directly into the platform cavity.

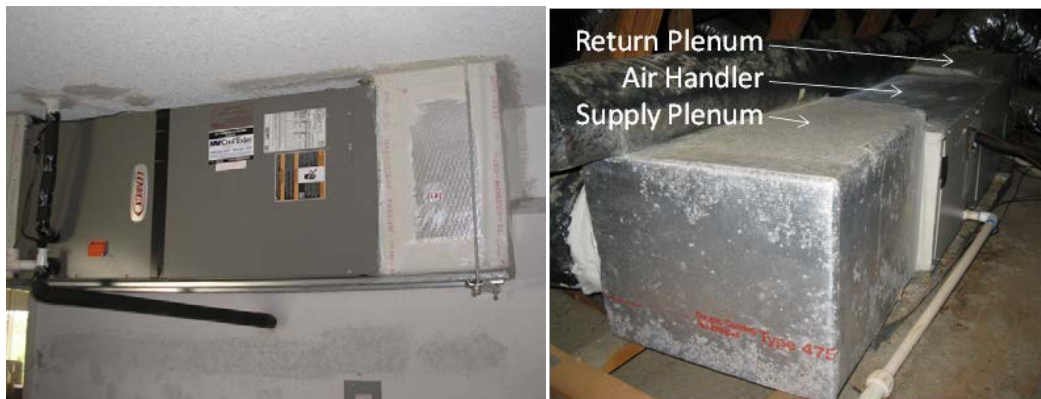
- **Two homes.** Horizontal flow AHU in the garage (Figure 28, left) with duct board supply and return plenums. The return air path is through a wall- or ceiling-mounted filter-back grille.

- **Six homes.** Attic-mounted horizontal flow AHU (Figure 28, right) with duct board supply and return plenums. The return air path is through a ceiling-mounted filter-back grille.
- **Three homes.** Package unit exterior to house with return air path through a wall-mounted filter-back grille. Two were units typical of manufactured housing (Figure 29, left) and one unit was typical of portable classrooms (Figure 29, right). In all three homes, systems were put together haphazardly with ill-fitting parts, which makes airtight assembly challenging.

Figure 28. Horizontal flow AHUs mounted at ceiling of garage (left) and in the attic (right)

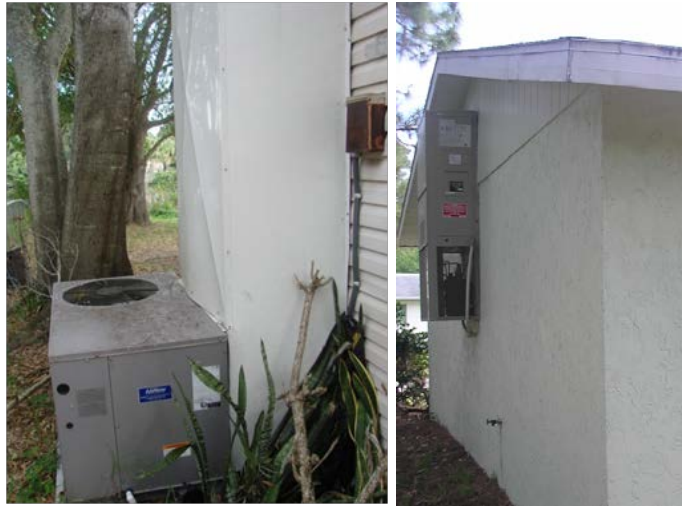
**Figure 29. Exterior package units with return air path through a wall-mounted filter-back grille. Ground mounted unit with metal shroud housing main return and supply ducts (left) and wall-hung unit with attic-mounted ducts (right).**
