Evaluation of Crawlspace Retrofits in Multifamily Buildings

Armin Rudd

Building Science Corporation

September 2014

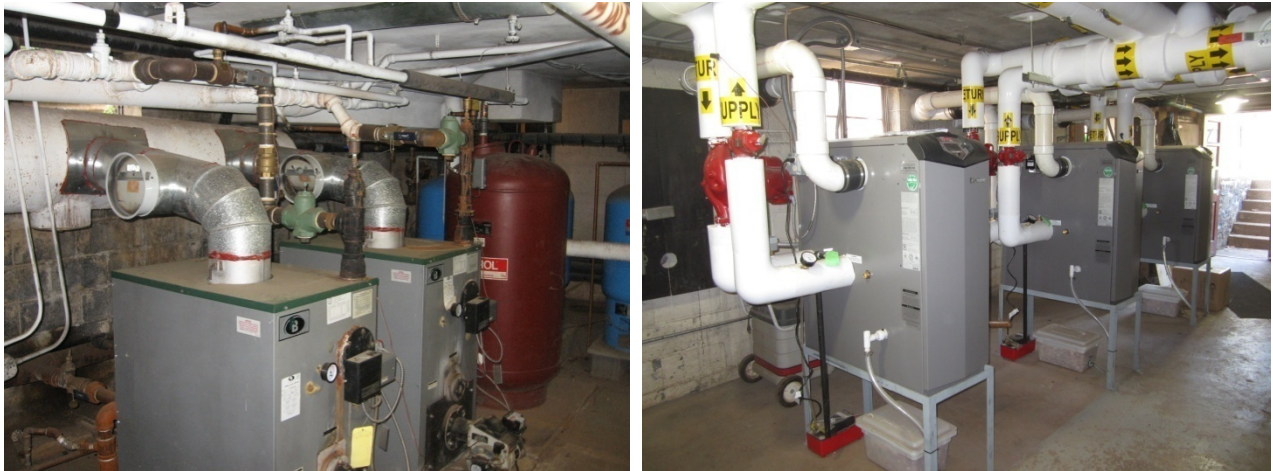
Figure 9. Atmospheric boilers (L) were replaced with condensing sealed-combustion boilers (R)

The central heating plant uses oil to heat water for space heating and domestic hot water (DHW). Figure 7 shows that oil consumption peaks at about 2,300 gal/month in winter, and is about 900 gal/month in summer. The central plant fuel was switched from oil to gas. Figure 9 shows the before and after boiler retrofit photos.

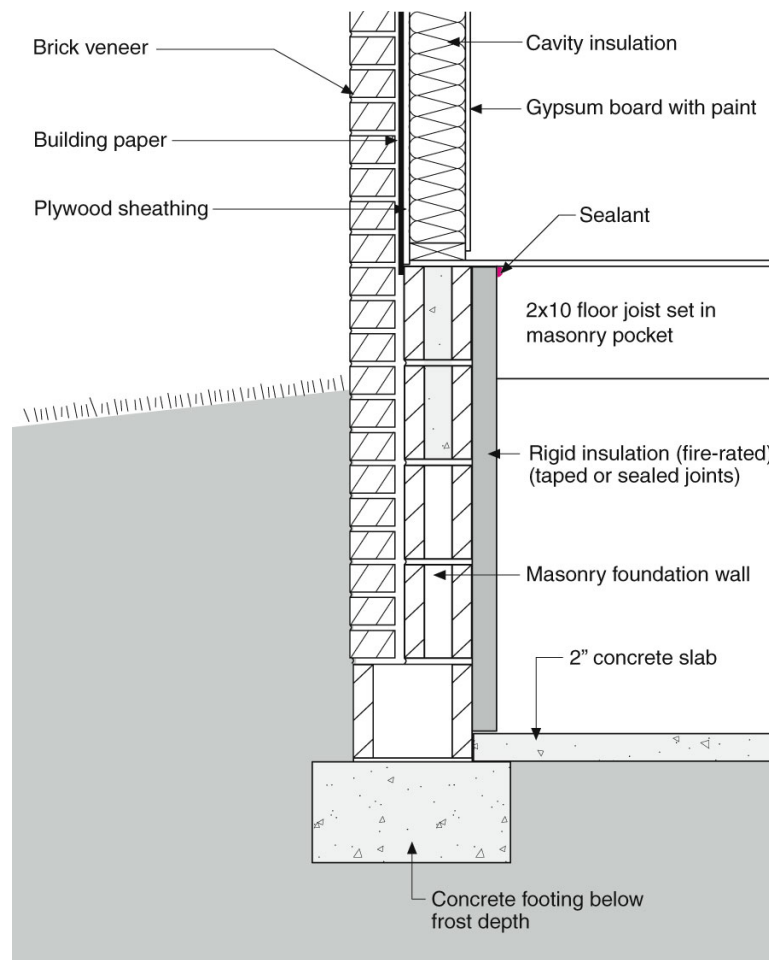
Figure 14 is a section drawing of the “as-built” crawlspace after the wall insulation retrofit; Figure 15 shows what would have been a recommended best practice design from the beginning.

Figure 14. Section drawing of the “as-built” crawlspace wall after the wall insulation retrofit

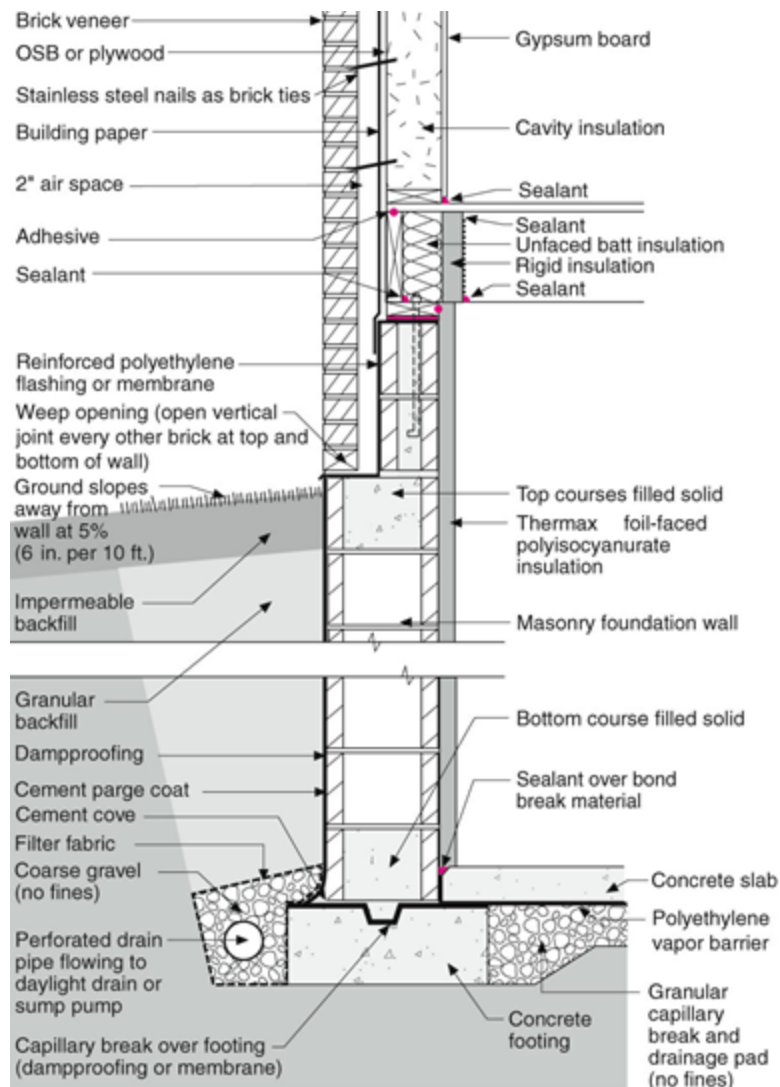
Figure 15. Section drawing of what would have been a recommended appropriate design from the beginning

Design professionals sometimes argue that the floor above the crawlspace, rather than the crawlspace walls, should be insulated. That may be true in many cases, but in this case it would have been a disaster for the durability of wood framing in the crawlspace. If the floor above the crawlspace were insulated instead of the walls, the crawlspace would have become colder than it had been for much of the year, raising the relative humidity (RH), and resulting in mold and rot in a short time. The wet crawlspaces at Oakwood Gardens survived as well as they did because they were kept warm with heat from the dwelling units above. Keeping the crawlspaces even warmer with heat from above, by insulating the walls to reduce heat loss, is clearly the right way to go.

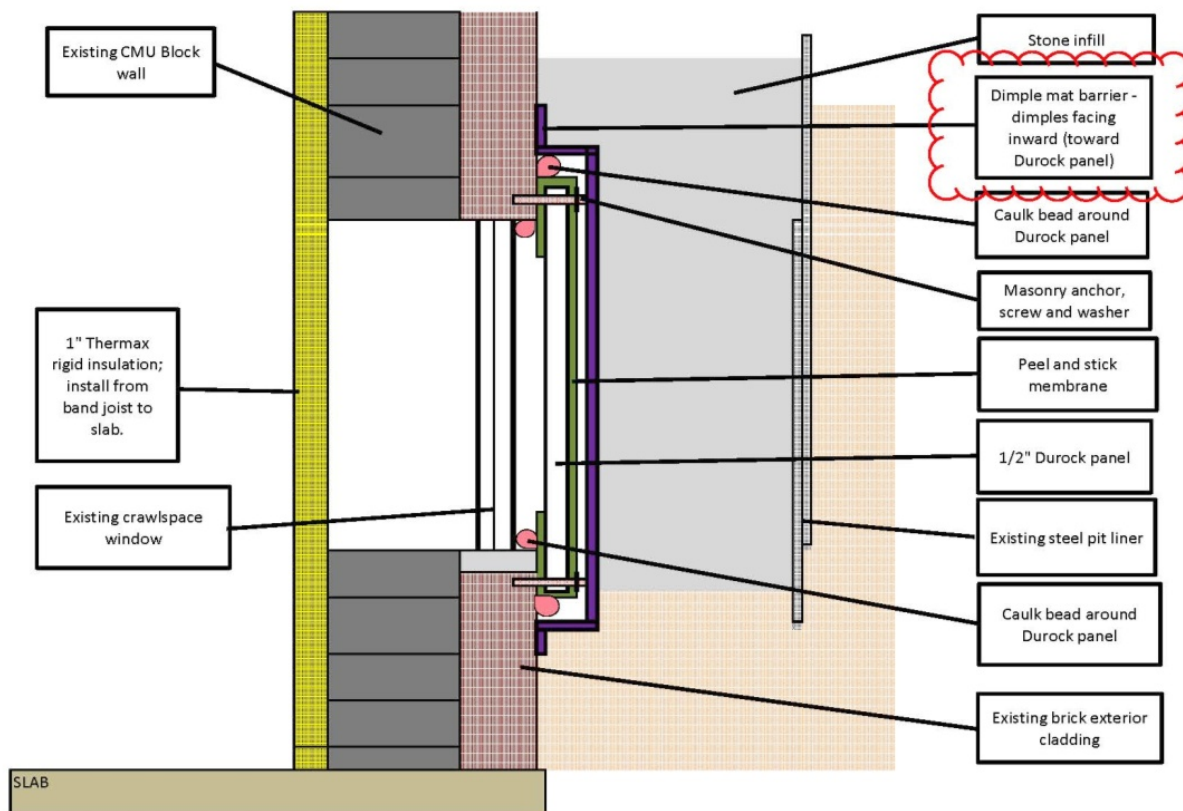
Figure 17. Window well retrofit detail that went out with the Innova bid request, for sealing the crawspace windows against water intrusion and air leakage

After the initial site visit, BSC recommended that blocking off and sealing the crawlspace windows against air infiltration and bulk water intrusion would be necessary to make the unvented crawlspace retrofit effective. Innova then sent out new bid request language and details (Figure 17) relative to the crawlspace insulation and air sealing improvement measure, on June 17, 2011, as follows:

- a. Insulate the interior face of the basement and crawlspace walls from the sill plate down to floor slab with 1" (one inch) Thermax rigid insulation.
- b. Block below-exterior grade crawlspace windows with ½" Durock panel. Wrap panel in peel-and-stick impermeable membrane. Affix to surrounding masonry with masonry anchors, screws and washers. Apply caulk seal at interior where panel meets window opening and at exterior where panel meets brick cladding. Backfill window pits with loose stone fill.

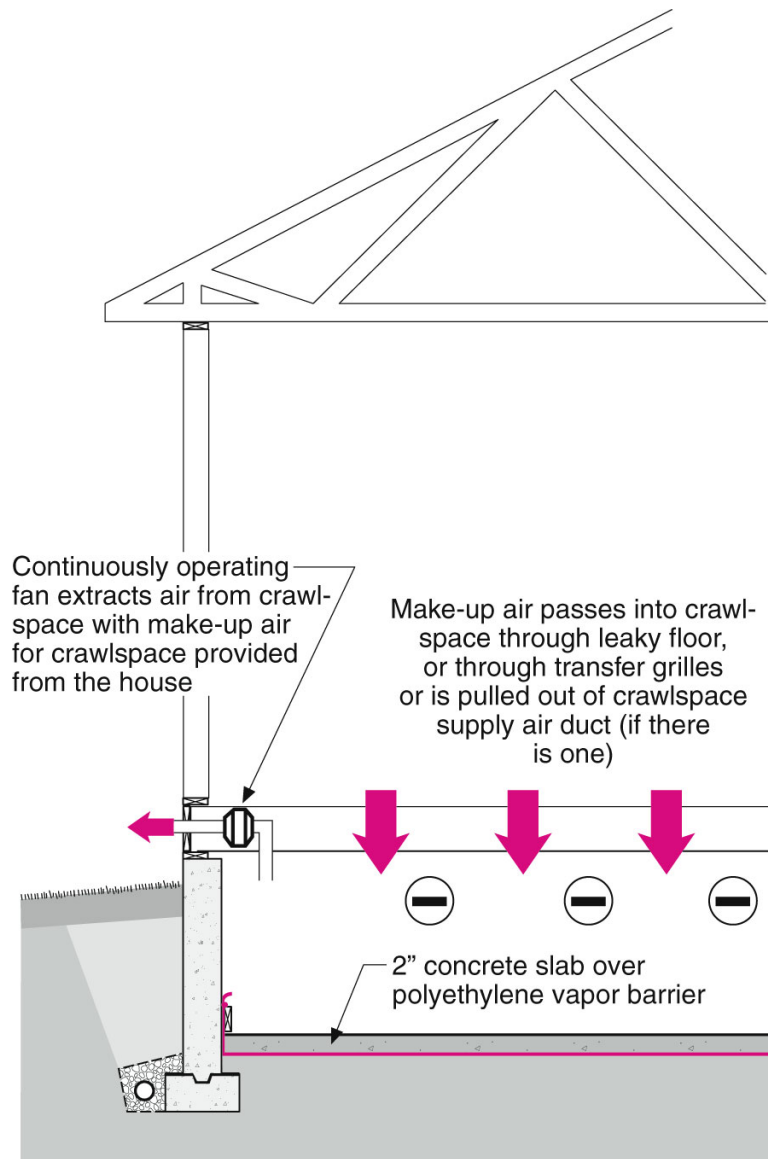
Figure 18. Unvented crawlspace exhaust ventilation schematic

After the exterior crawspace windows were blocked and sealed off (all of which were air leaky and some of which were allowing bulk water intrusion to the crawlspaces), and after the interior wall insulation part of the unvented crawspace retrofit was completed, controlled mechanical exhaust ventilation of the crawspace was installed. This system is shown schematically in Figure 18. The under-slab polyethylene vapor barrier shown in Figure 18 is best practice but not part of the existing condition. A drawing of the installed exhaust ventilation system is shown in Figure 21. The floor interface between the crawspace and the dwelling units above was leaky compared to the insulated and sealed foundation walls (Figure 19); thus, exhaust ventilation of the crawspace would preferentially draw air from the dwelling units above, helping to further dry the crawlspaces and improve air quality in the dwellings.

With relatively airtight crawspace walls, air from the dwelling units will be drawn through leakage in the floor. That will reduce the crawspace humidity, potentially reduce radon gas concentration in the crawspace, and potentially improve air quality in the dwelling units. The reasons are both because of slightly increased dwelling air exchange with outdoors and because of keeping contaminated air from the crawspace from moving upward into the dwelling units. The existing dwellings did not have designed whole-building mechanical ventilation. The rated power draw of the inline exhaust fan used for each crawspace was 21.2 W, for a total annual

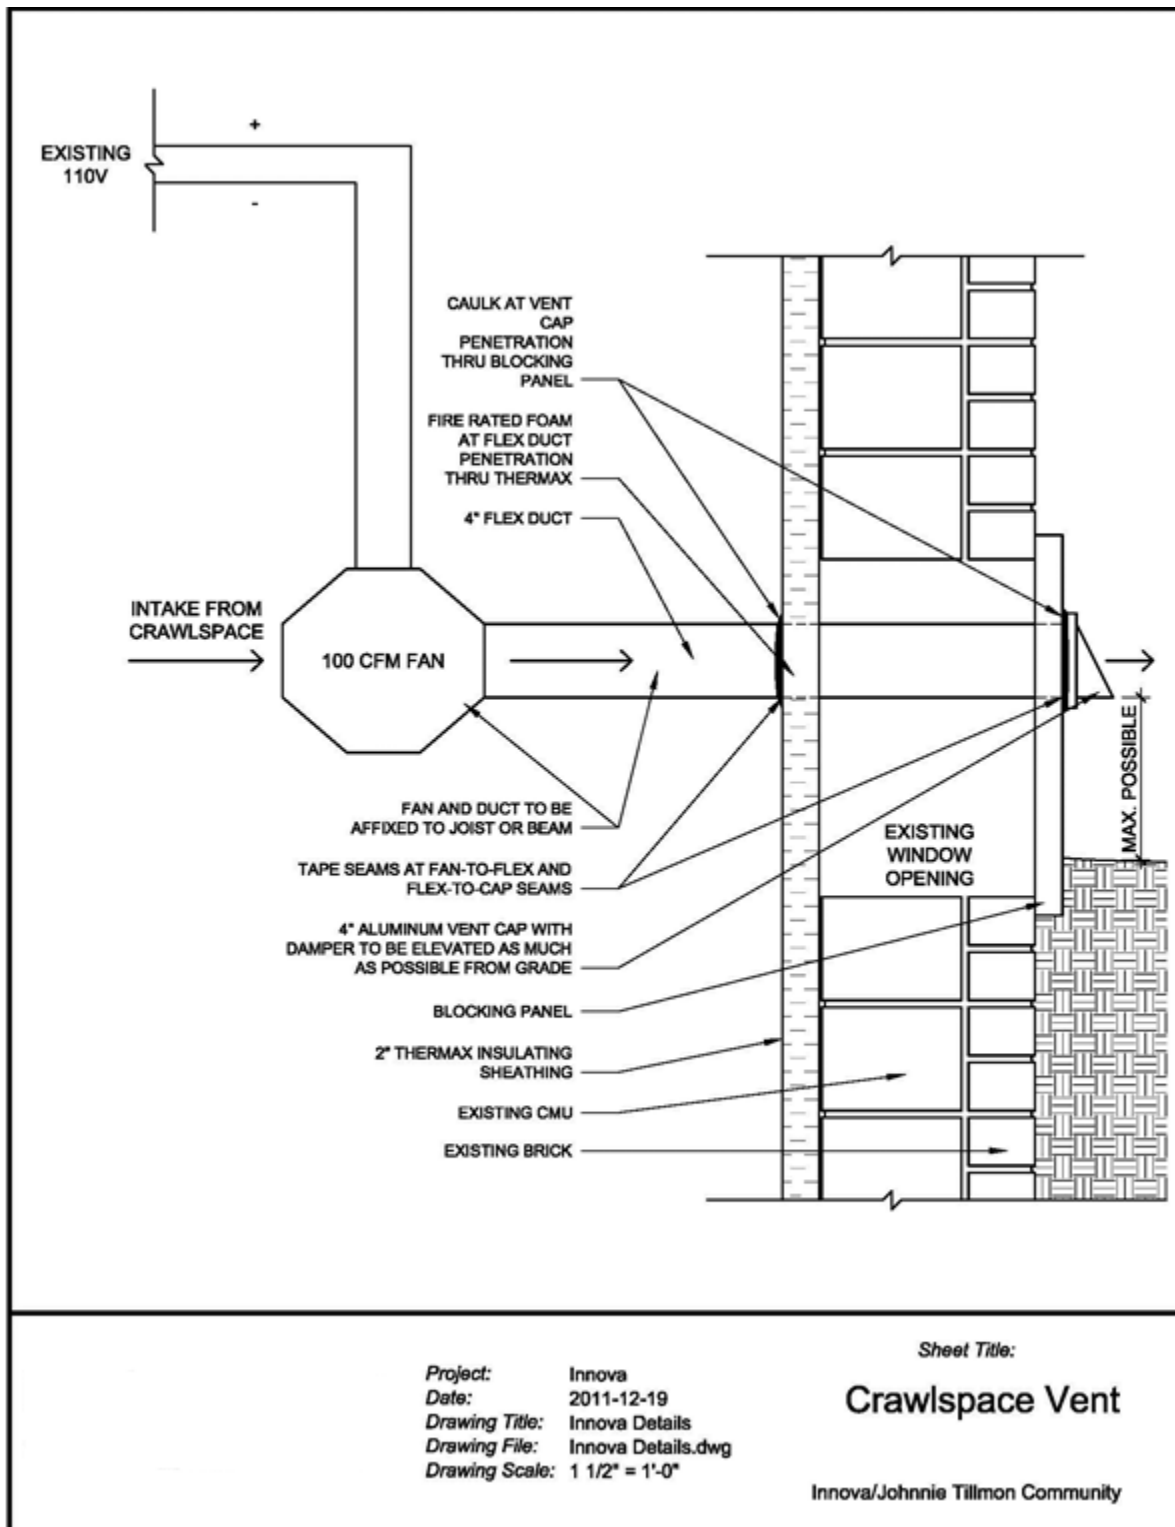
Figure 21. Drawing of the unvented crawlspace exhaust ventilation system design

Installing crawlspace exhaust ventilation is a low-energy strategy that significantly reduces the risk of contaminated air moving from the crawlspaces into the units. It also stands a good chance of returning the crawlspace humidity level to no more than it was before the crawlspace retrofit, or better. However, in some crawlspaces, exhaust ventilation may still not be adequate to remove enough moisture evaporating in the crawlspace because bulk water rises from below the slab. In this case adding dehumidification would likely not be sufficient either, and the operating cost would be high. Rather, a sump pump should be installed in the crawlspaces that are chronically wet. The 2-ft to 3-ft deep plastic sump pits are to be perforated with drilled holes in the bottom so that as the water table rises the water will be removed before it reaches the bottom of the slab. This was done in four of the nine crawlspaces, in Buildings B and E.

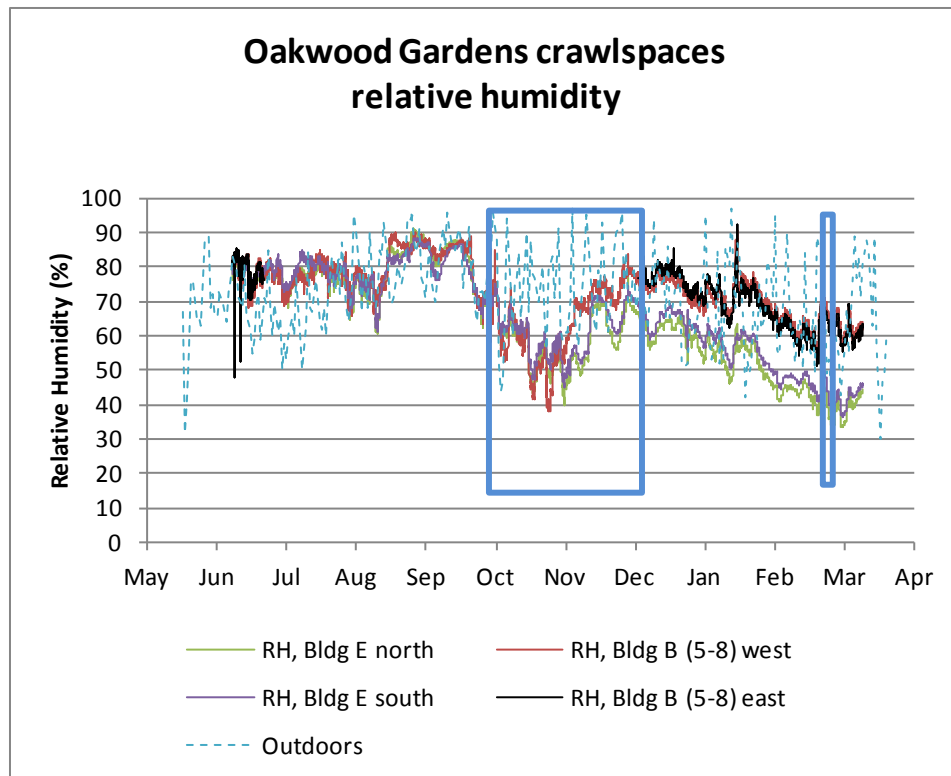
Figure 26 shows that the RH between the two crawlspaces tracked very closely at an elevated level, between 70% and 85%, from June to September before the crawlspace retrofit was started. The month between the middle of August and the middle of September was also a historically

rainy period. After that, the crawlspaces started drying out with the receding water table and drier ambient conditions. However, November was again wet, and the crawlspace insulation and window blocking retrofit closed that moisture in. As winter progressed, the crawlspaces were drying out again, and stabilized around the time of the exhaust ventilation system and sump pump installations in late February to early March. The Building B crawlspace was always the wettest and most flooded at times, which is evident in that the Building B crawlspace stabilized at about 60% RH, or about 20% RH higher than the Building E crawlspace.

Figure 26. Pre-retrofit and post-retrofit monitoring of crawlspace air RH

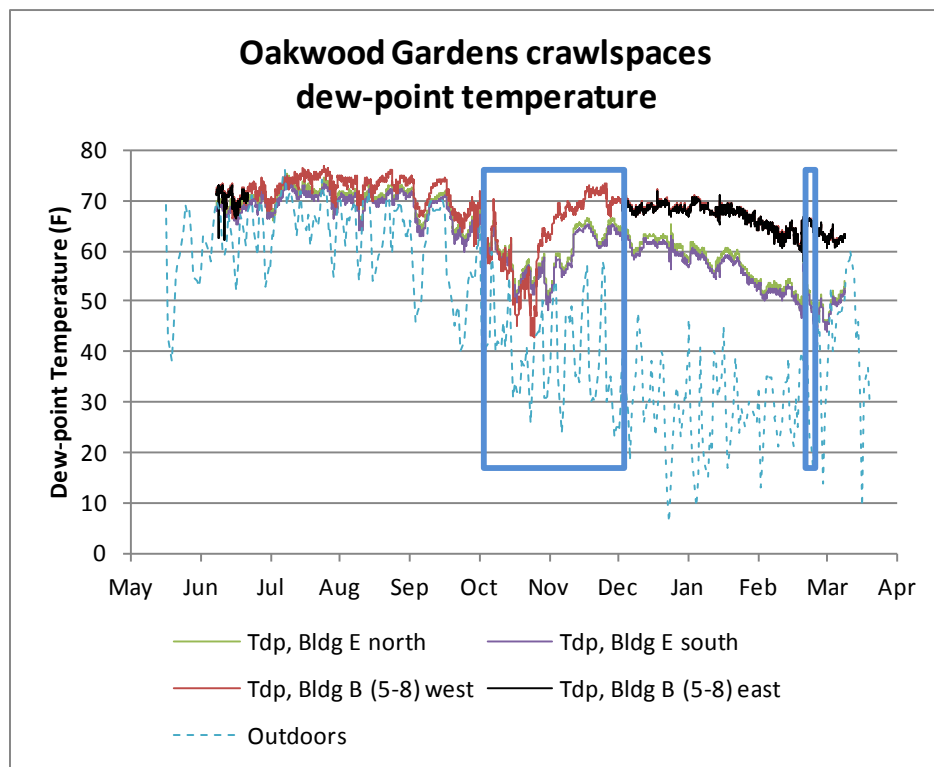
Although RH is dry bulb temperature dependent, dew point temperature indicates air moisture level independent of dry bulb temperature. As shown in Figure 27, the crawlspace dew point temperature of 75°F remained elevated above the summer outdoor dew point temperature for most of the period before the crawlspace retrofit. That was due to bulk water intrusion, wet slabs, and frequent standing water in the crawlspaces. Only when the unvented crawlspace retrofit was complete—with blocked windows, insulated walls, exhaust ventilation, and sump pumps in the wettest locations—did the crawlspace dew point temperatures stabilize at acceptable levels. The Building E crawlspace dew point temperature of about 50°F is quite acceptable, but we hope that the Building B crawlspace continues to trend downward to avoid condensation on the steel I-beams and cool slab edges.

Figure 27. Pre-retrofit and post-retrofit monitoring of crawlspace air dew point temperature

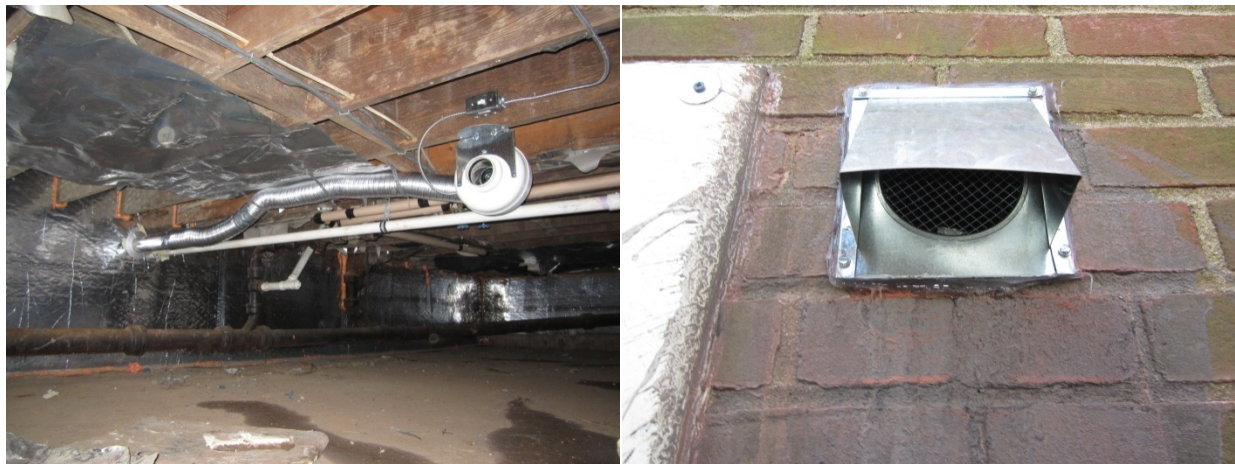
Figure 33. Unvented crawlspace exhaust ventilation fan and ducting to outside wall cap
