# Retrofitting a 1960s Split-Level, Cold-Climate Home

Srikanth Puttagunta

*Consortium for Advanced Residential Buildings*

July 2015

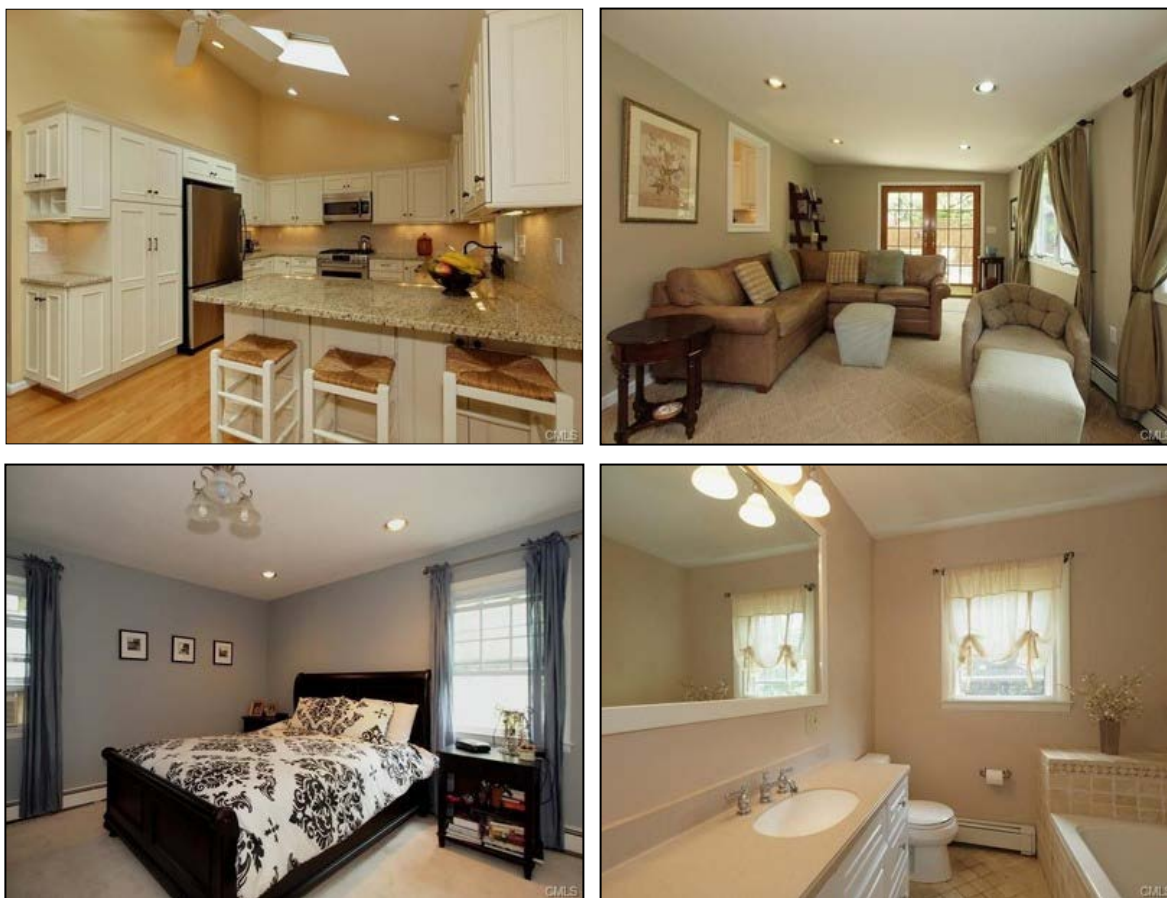
The 1960s split-level home in Figure 1 may appear to be move-in ready, because it is clean and the kitchen and bathrooms have been updated. Yet this home's heat is supplied by an oil boiler through hydronic baseboards, and its cooling is supplied by a combination of a poorly fitted through-wall air conditioner in the kitchen and three window air conditioners. Overall insulation condition was marginal, with severely deteriorated fiberglass batts in the wall cavities and ceiling. Blower door testing revealed a building infiltration rate that was slightly higher than 7 ACH50. The end result, based on information from the previous homeowners, was an annual utility cost of slightly more than \$5,700 for this 2,000-ft<sup>2</sup> home, which is double that of a comparable home built to the 2009 International Energy Conservation Code requirements. According to 2009 estimates by the Joint Center for Housing Studies, nearly 40% of residential energy consumption is attributable to homes built before 1970 (JCHS 2009).

**Figure 1. Interior of existing home**

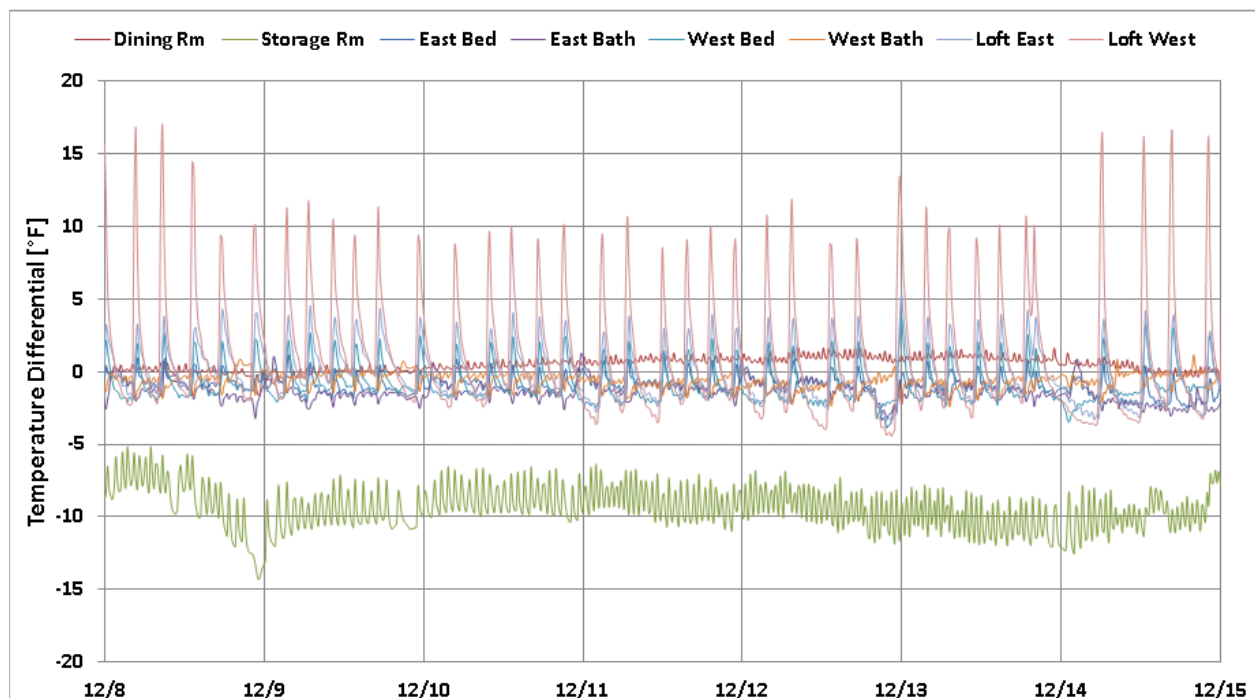
A key goal of the homeowners was to provide better zonal temperature control. In their previous townhome, two systems conditioned the space (one for the lower two floors and one for the upper two floors). The homeowners constantly had to deal with under- and overheating in spaces that did not have control thermostats. Figure 4 shows the temperature differential between the control thermostats on the second and third floors and the other rooms being serviced by those systems. Bedrooms tended to be 2°–5°F warmer during heating periods and up to 3°F cooler between heating cycles. The fourth-floor loft could be 10°F warmer than the control thermostat on the third floor. The bottom floor was typically 10°F cooler than the control thermostat on the second floor. Some efforts to balance the system were made, but resulted in loud ductwork from overdampened supply registers.

**Figure 4. Temperature differential between control thermostats and other rooms being served by each heating, ventilating, and air-conditioning system**

The improvements in air leakage rates, insulation levels, modulating boiler, and multiport heat pump should allow for more uniform temperature control from room to room. Still, this requires more controls than a typical heating, ventilating, and air-conditioning system that might have only one or two zone controls.

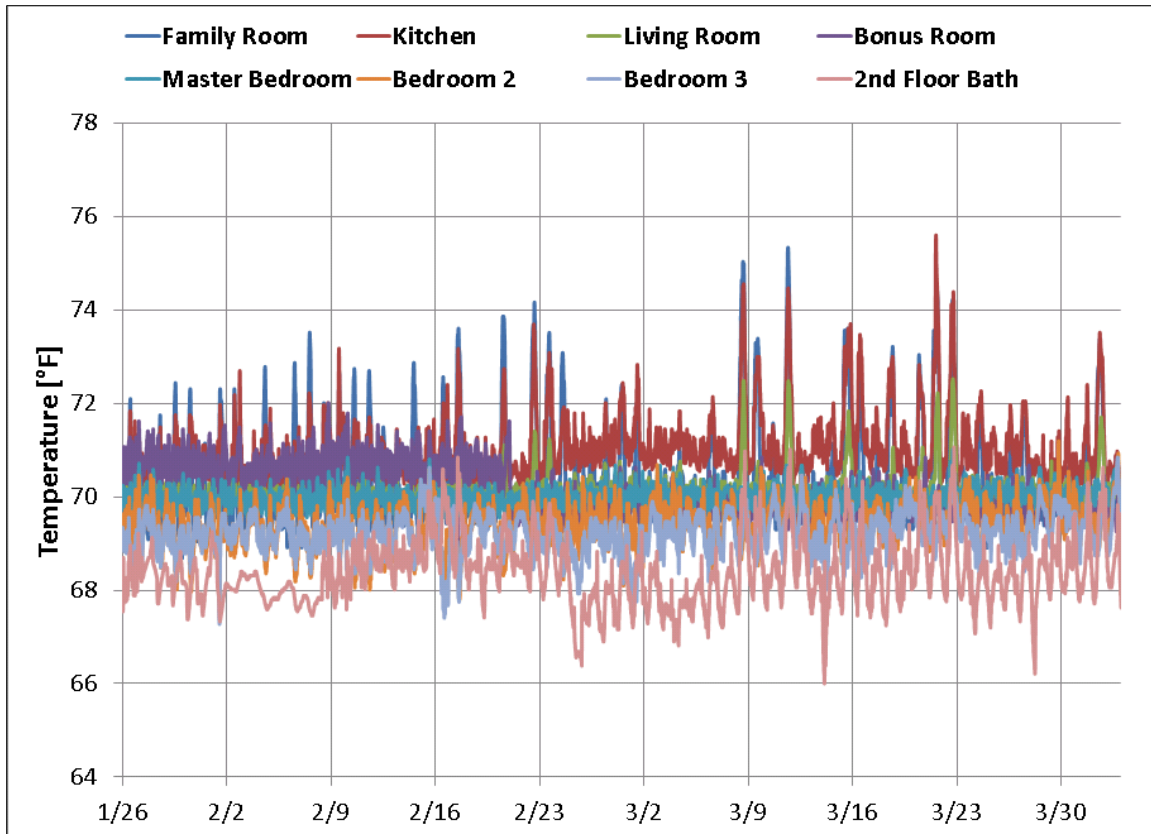
To quantify comfort, the temperature and RH of all rooms were monitored per the Building America Indoor Temperature and Humidity Measurement Protocol (Metzger and Norton 2014). According to ACCA’s Manual RS (Rutkowski 1997), the temperature differential should not exceed a maximum of  $\pm 4^{\circ}\text{F}$  and should average to no more than  $\pm 2^{\circ}\text{F}$  between rooms and floor-to-floor. Figure 15 shows that the temperature maintained a  $\pm 2^{\circ}\text{F}$  between rooms (70°F set point throughout the home). Over the winter monitoring period, the home met these comfort guidelines. The only instances in which the temperature exceeded this range were a result of cooking that increased temperatures in the kitchen and adjoining family room. Also, the second-floor bathroom likely was not maintaining a similar temperature to the master bedroom, where the controlling thermostat is located, due to undersized baseboard heating (configuration of bathroom left a minimal length of hydronic baseboard heater on the bathroom’s exterior wall).

**Figure 15. Temperature conditions in each room over the winter 2014**

All the measurements referenced in Figure 15 are based on interior wall measurements (in line with typical guidance for placing thermostats). CARB was interested to see the variation in each room's temperature profile between the interior and exterior walls. The exterior temperature measurement was taken at the same height as the interior wall measurement and was carefully planned to avoid potential impacts from direct solar gain through the windows. Figure 16 shows that temperature variation within rooms was between  $+2^{\circ}\text{F}$  and  $-5^{\circ}\text{F}$ . The family room and master bedroom had the least variation in temperature between the inner and outer measurements. These rooms also had thermostats for the hydronic baseboard system. Bedrooms 2 and 3 are on the same zone as the master bedroom and were within  $\pm 2^{\circ}\text{F}$ . The two spaces that had the largest temperature variation were the living room and bonus room. The bonus room is a longer room, so it had the greatest distance between the inner and outer measurements of any of the rooms. The living room has the fireplace and large bay window, which is older than all the other windows in the home. So while the bay window has double pane glass, its larger size and potential lower performance U-value, along with the uninsulated masonry fireplace, are likely resulting in the outer portion of the room being  $2\text{--}4^{\circ}\text{F}$  cooler than the inner portion. These two spaces are the least used by the homeowners, so it has not been an issue. If these rooms are used more in the future and the temperature variation is uncomfortable, the controls could be adjusted. Each of these spaces has a thermostat for the hydronic heating system, so the set point temperature could be raised  $2^{\circ}\text{F}$  to have the average center of room temperature be  $70^{\circ}\text{F}$ .

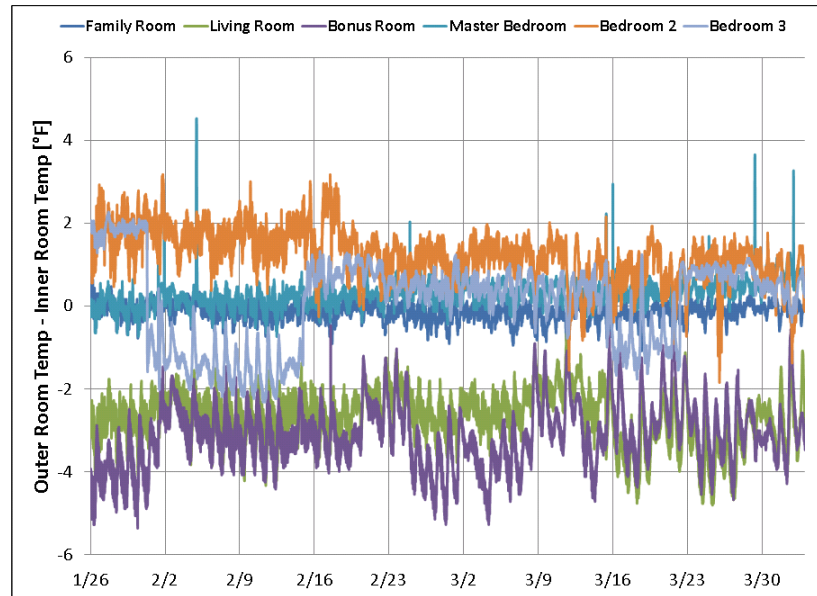
**Figure 16. Temperature variation within each room**

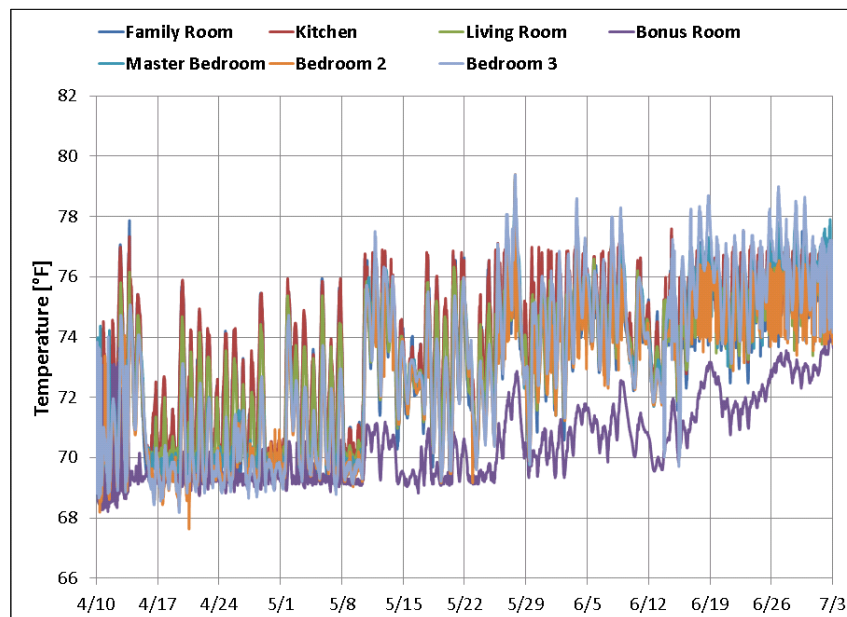
The home now has a multiport heat pump for cooling, so each room has its own cooling system and can be maintained at the desired temperature. Minimal space conditioning was used during the April and May swing season. Air conditioning was used more starting in late May. Figure 17 shows that the temperature fluctuated within  $\pm 3^{\circ}\text{F}$  of the  $75^{\circ}\text{F}$  set point. This makes sense with the thermostat dead band configured at  $2^{\circ}\text{F}$ .

**Figure 17. Temperature conditions in each room over spring and summer 2014**

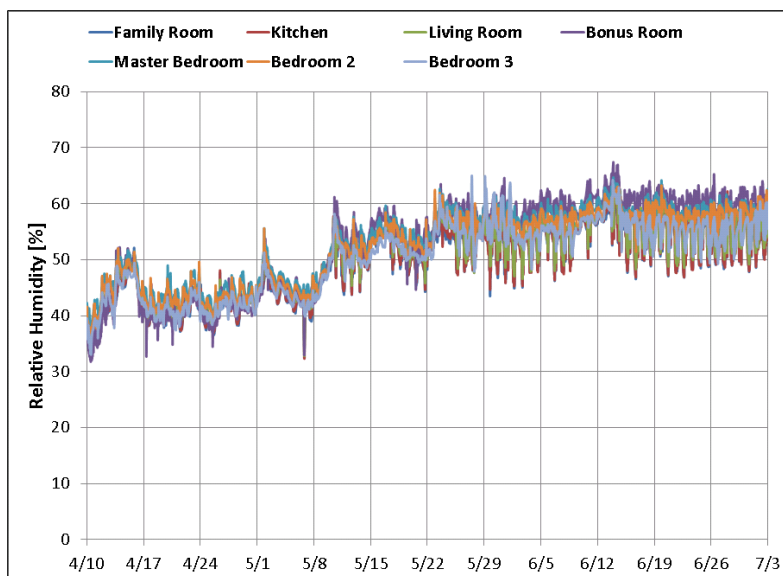
More important than the summer sensible cooling (temperature) control is the latent cooling (humidity) control. Over the initial summer months, RH was controlled at 48%–62%, well within the desired RH range (Figure 18).

**Figure 18. RH conditions in each room over the spring/summer 2014**

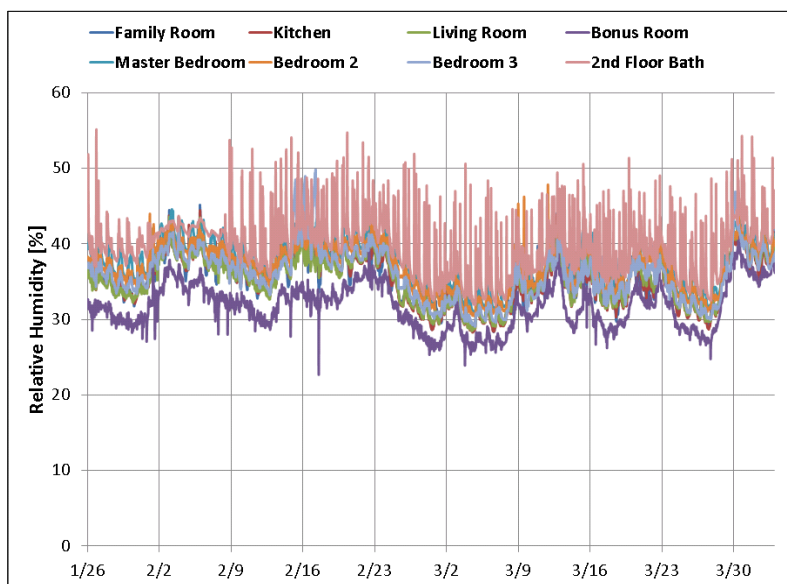
Figure 19 shows that RH naturally remained at 25%–45% for most of the rooms in this retrofit home. The second-floor bathroom saw spikes in RH up to 55% during shower events, but this was quickly exhausted to outdoors and the RH returned to normal levels.

**Figure 19. RH conditions in each room over the winter 2014**

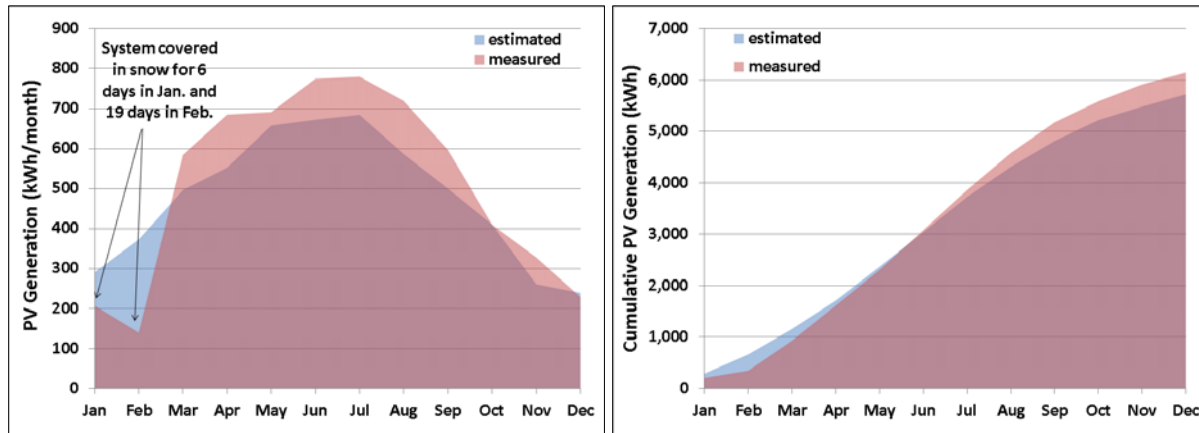
The local utility incentive requires the PV system is required be monitored. Therefore, daily monitoring of actual production of the system was possible through an online portal. The actual generation of the PV system (6,243 kWh) versus estimates by the National Renewable Energy Laboratory's PVWatts (5,721 kWh) was evaluated. Overall generation was actually higher than projected and would have been even higher (estimated to be an additional 2% of output generation) except for the 25 days during the winter when the PV system was covered by snow. The additional output of the system means that the estimated SPB would actually be 11 years versus the original 12 year estimate, assuming similar annual output year to year.

**Figure 20. Actual PV electricity generation compared to projected estimates**
