# **Performance Evaluation and Opportunity Assessment for St. Bernard Project**

**Bruce Dickson** IBACOS. Inc.

June 2011

# Technical Report: Performance Evaluation and Opportunity Assessment for St. Bernard Project

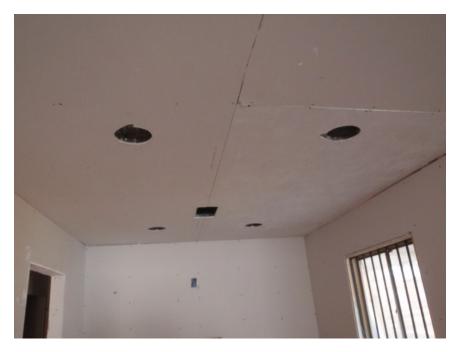
Figure 16. Photo of Recessed Light Fixtures

Many homes are equipped with recessed light fixtures. All of the units are air tight and insulation contact rated. Installing these fixtures with the gasketed or caulked in trim ring is critical in achieving the air tightness of the fixture.

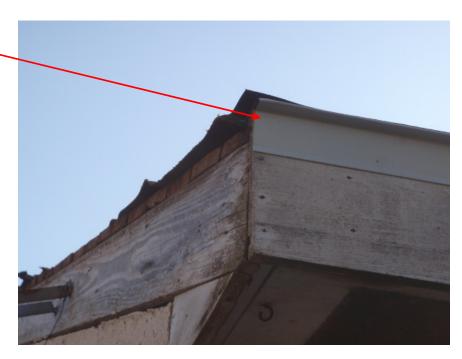
Figure 50. Photo of Properly Installed Drip Edge

In this instance, the drip edge was installed correctly with the drip edge installed first at the eave and the underlayment over the edge followed by drip edge at the rakes.

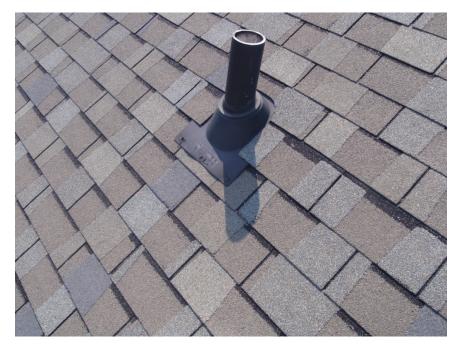
Figure 52. Photo of Proper Roof Boot Installation

Example of a proper installation. The lower part of the flange overlaps the lower shingles and the side and upper shingles overlap the flange.

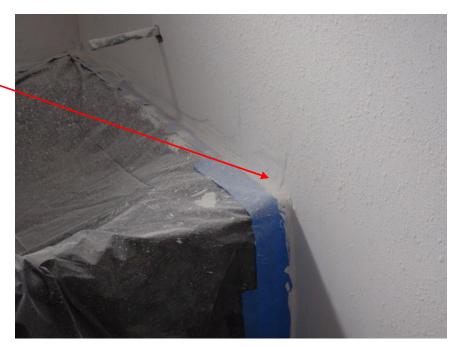
Figure 62. Photo of Improper Backer Board Installation

No comprehensive flashing strategy was observed at the nailing fin of tub and shower units. In most cases the wall board was installed directly upon the unit. This detail will eventually deteriorate due to the wicking ability of the gypsum based backer board.

**Tub Surround Details** Another instance where the backer board was installed tightly to the tub.

Install 4" butyl flashing over the nailing fin of the tub unit and stick to the installed blocking. Installing a 4" butyl tape over the tub/shower nailing fin to the surrounding framing can prevent water from getting into the wall cavity.

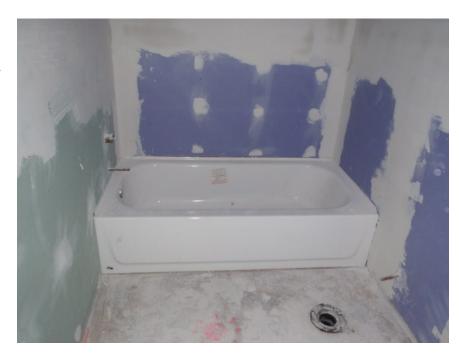
Figure 63. Photo of Proper Back Board Installation

In this instance the backer board was held up and installed on the top edge of the fin. This practice is acceptable as long as the previously described flashing detail is carried out.
