Field Testing Unvented Roofs with Asphalt Shingles in Cold and Hot-Humid Climates

Kohta Ueno and Joseph W. Lstiburek Building Science Corporation

September 2015

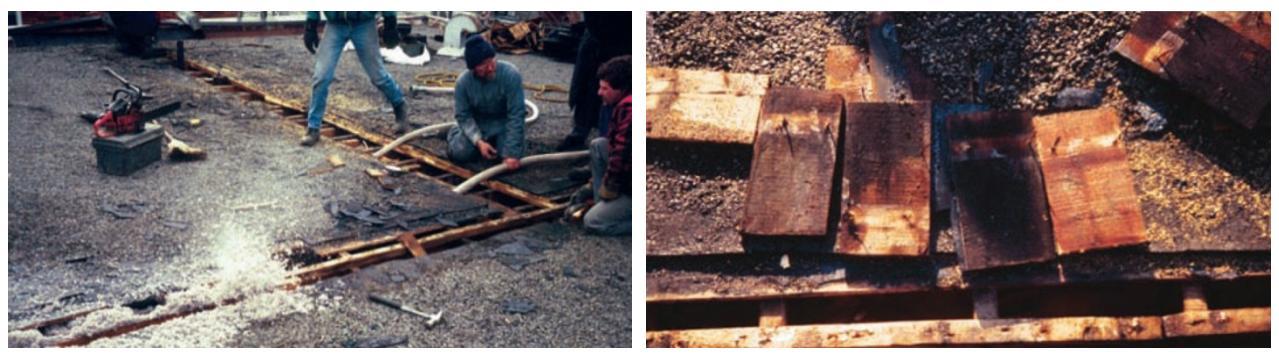
Figure 1. Dense-pack insulation of roof (left); resulting moisture issues (right)

However, a dense-packed compact roof assembly has high moisture and durability risks due to wintertime interior-sourced condensation (Lstiburek 2010b); Schumacher and LePage 2012) (Figure 1).

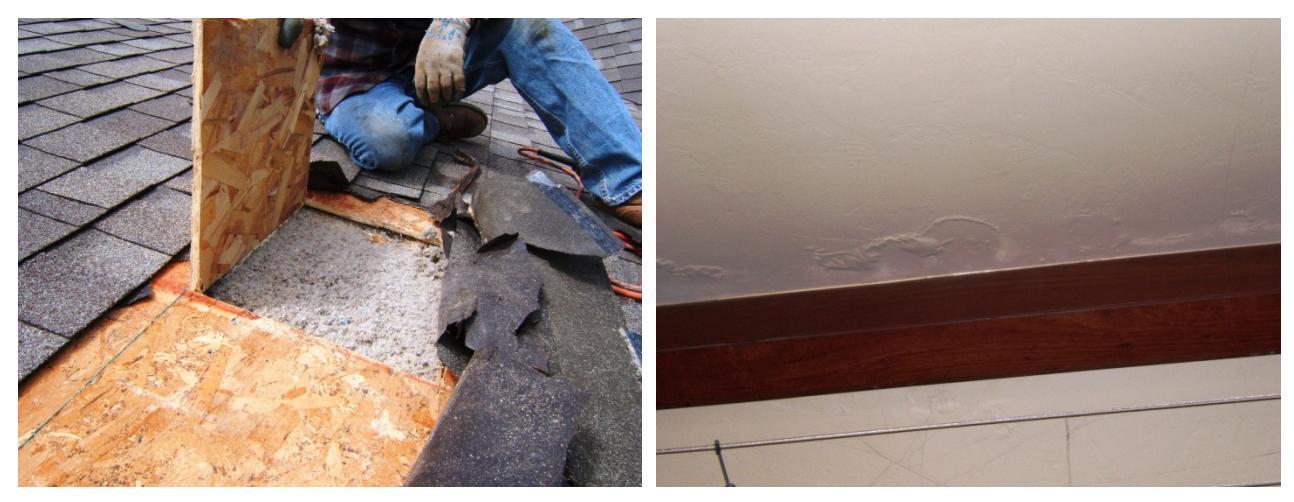
Figure 10. Dry sheathing lower at roof (left); interior ridge conditions (right)

Moisture issues in unvented roof assemblies often manifest in the form of damage to the sheathing at the ridge of a sloped roof, colloquially known as *ridge rot*. An example is shown in Figure 9, which was a dense-pack cellulose roof in a northern California location (CZ 3C).

These issues arose soon after construction (during the first winter); the problems were manifested as paint blistering at the interior gypsum wallboard (GWB) near the roof (Figure 10, right), due to dripping of accumulated condensation. The issue was definitely localized at the ridge of the roof; disassembly at a lower section of the roof showed dry sheathing conditions (Figure 10, left). Air barrier imperfections at the interior GWB (especially at the ridge board interruption) were contributing factors.

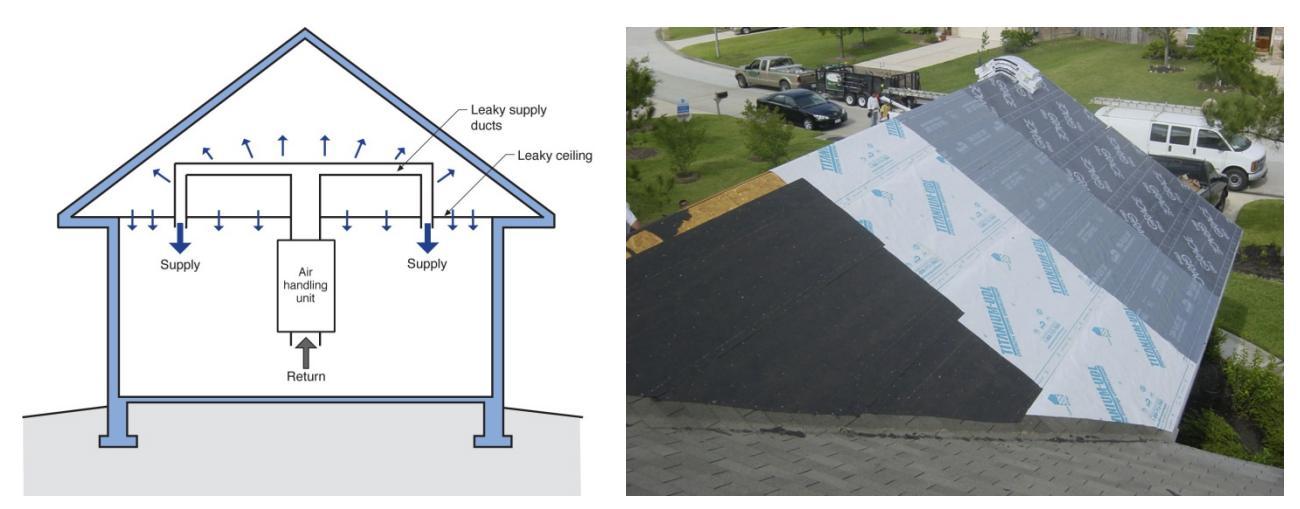
Figure 11. Air leakage communication from unvented attic to main space (left); Houston-area roof underlayment study (right)

The author cites Houston-area field research about the effect of vapor-permeable and vaporimpermeable shingle underlayments on inward vapor drives (Figure 11, right); the study found no measurable differences between these roof test bays. Therefore, he notes that shingle inward drive issues are not a significant moisture source.

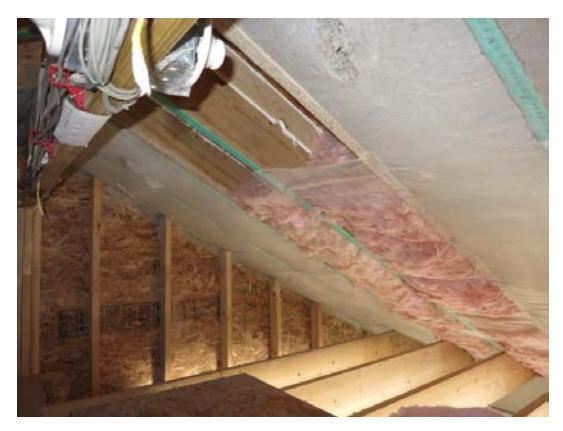
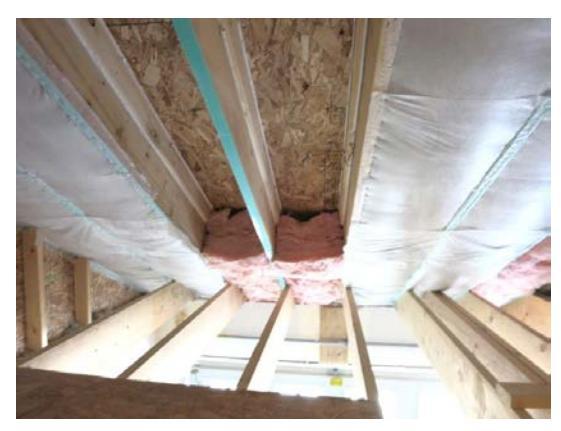
Figure 21. Top vent fiberglass roofs (Roofs 4 and 5)

This assembly is identical to Roof 2 (top vent cathedral-cellulose/GWB), but fiberglass batt replaces the dense-pack cellulose. Installation of the R-38 batt in these roofs is shown in Figure 21; even with careful installation the batts buckle away from the roof sheathing (not Grade I installation).

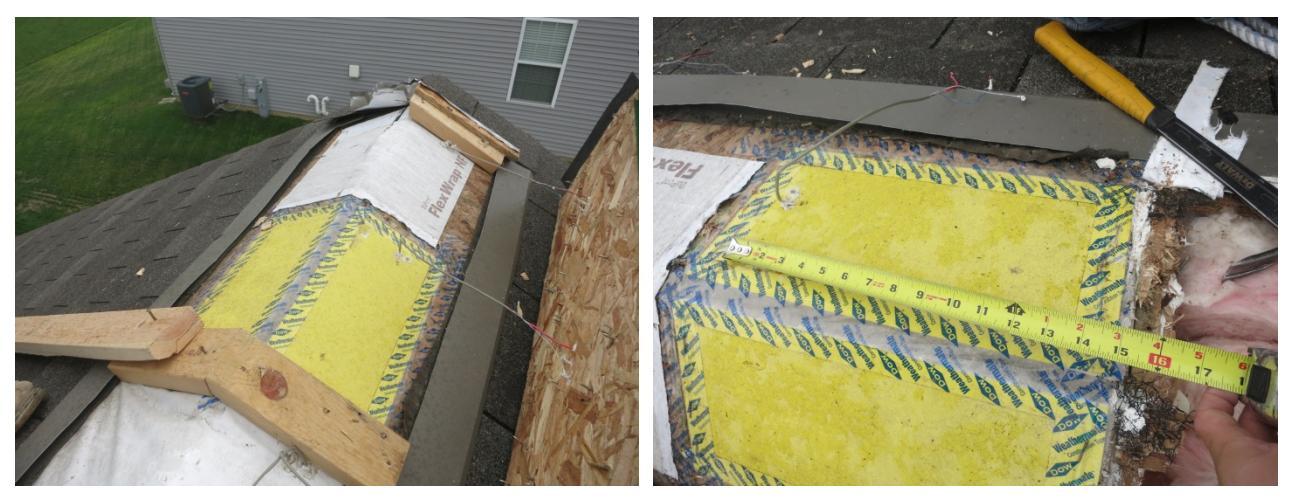
Figure 24. Diffusion vent (6) (left); unvented (7) ridge conditions (right)

This assembly is the unvented dense-pack cellulose roof that failed in previous work. This bay was intended as a control and to provide a comparison between previous known failures and the experimental assemblies.

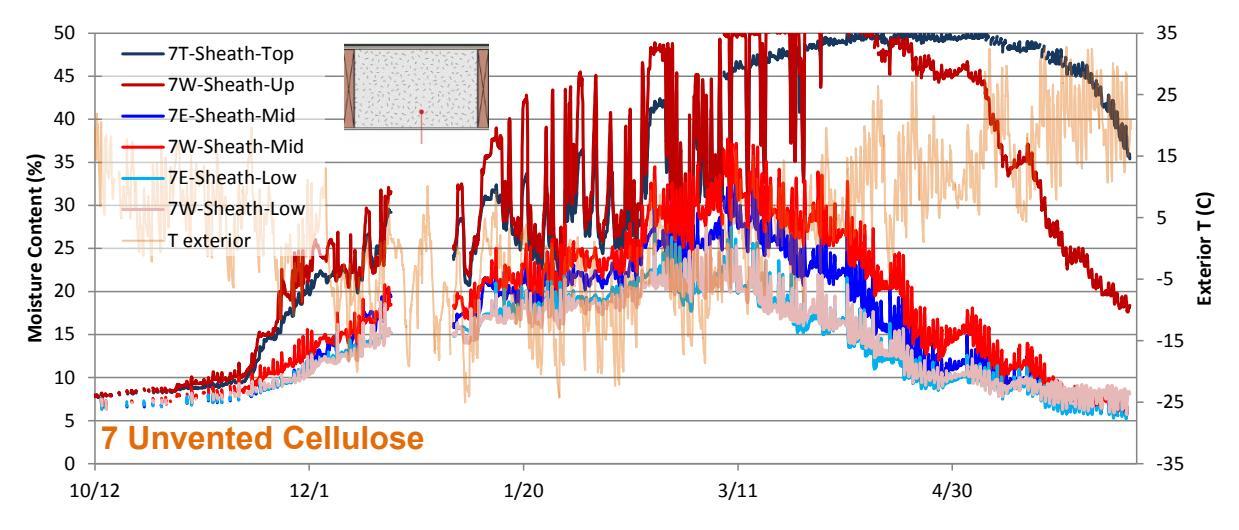
Figure 45. Roof 7 (unvented cellulose) sheathing MCs (unfiltered data)

The results for unvented cellulose (Roof 7) and diffusion vent cellulose (Roof 6) are shown in Figure 45 and Figure 46, respectively. MCs were much higher; during much of the winter they exceeded 20%. Both roofs also showed the expected spatial pattern: moisture levels were higher at the higher section of the roof; roof ridge MCs exceeded 40%, which has risks rot and decay.

The upper MC measurements are difficult to read because they shifted suddenly high levels. These MC anomalies coincided with freezing temperatures; freezing of water in the sheathing likely resulted in inconsistent electrical resistance and thus measured MC. The MC trends during nonfreezing temperatures are more representative of actual conditions. Therefore, the previous data were filtered (only MC measurements higher than 0°C [32°F] are plotted) to make the graphs more readable; all remaining graphs are shown with filtered data. The filtered data for unvented cellulose (Roof 7) and diffusion vent cellulose (Roof 6) are shown in Figure 47 and Figure 48.

One marked difference between these two roofs is their dry-down period in the spring, highlighted in dashed gray rectangles. The MC in the diffusion vent (Roof 6) roof falls much faster, and to a lower level (12% MC) than the unvented roof (Roof 7) (17% and 35% MC). This probably indicates the greater drying available by diffusion in Roof 6.

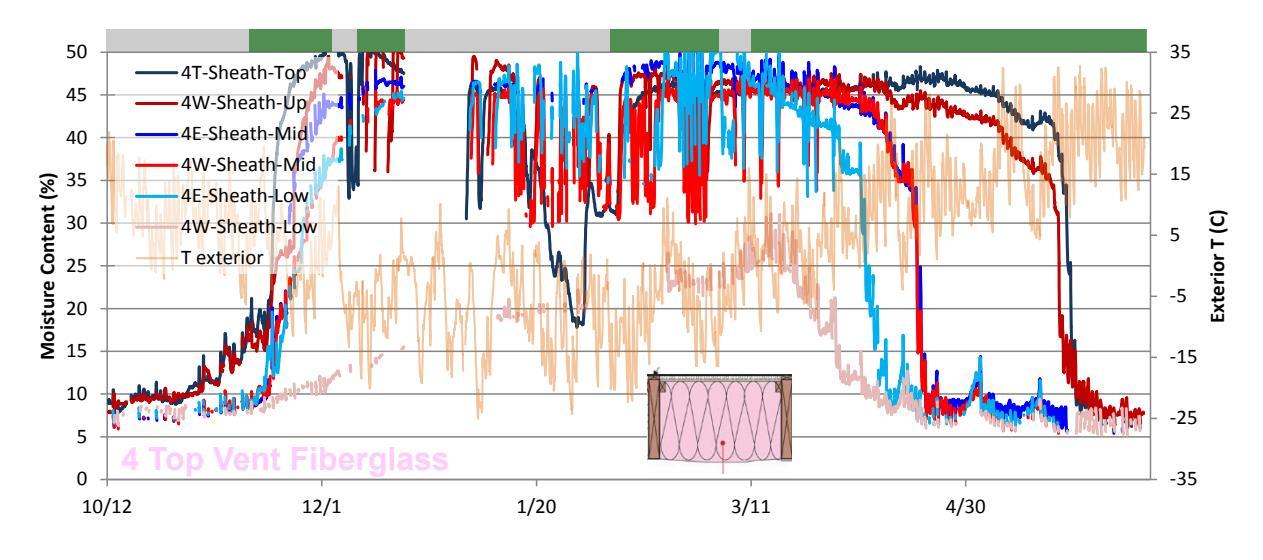
Figure 52. Roof 4 (top vent fiberglass, no GWB) sheathing MCs

The results for the fiberglass top vent roofs (breather mesh netting under shingles) are shown in Figure 51 (top vent fiberglass with GWB) and Figure 52 (top vent fiberglass, no GWB). These measurements showed much greater variation in moisture levels during the winter; MC showed sudden drops. Therefore, these graphs were plotted with the constant dew point graphic; periods of sudden drying and periods when humidification was not running show some correlation.

The two assemblies show different responses: the GWB assembly (Roof 5) has some degree of stratification (higher MCs at the upper parts of the roof); the no GWB assembly (Roof 4) showed high MCs at almost all locations.

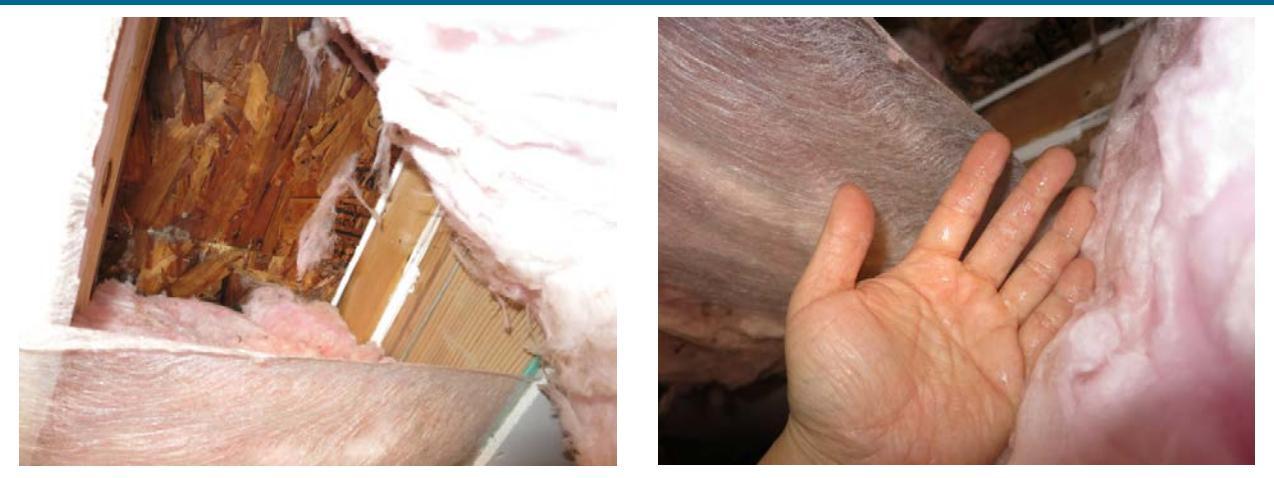
Figure 54. Top vent fiberglass, no GWB (4) wet sheathing (left); wet batt (right)

A mid-December site visit enabled researchers to verify that the monitored data reasonably reflected reality. The top vent fiberglass assembly without GWB (Roof 4) was examined from the interior. A brown stain that indicated water leakage was found (Figure 53, left); when the batt was removed, very wet and saturated roof sheathing and fiberglass were observed (Figure 53, right).

The sheathing was saturated with liquid water/condensation (Figure 54, left); the fiberglass was also saturated with condensation at the exterior surface (Figure 54, right).

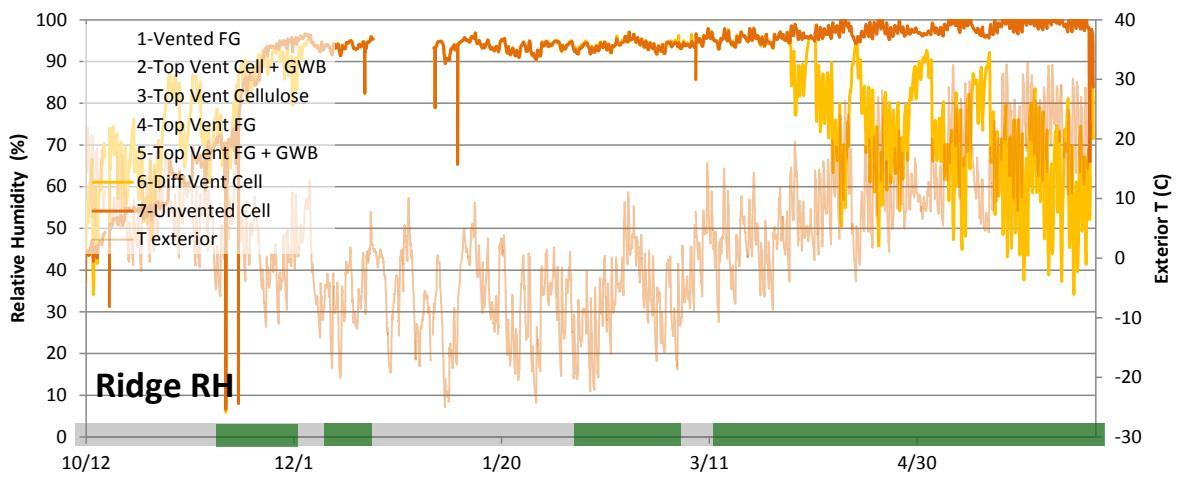
Figure 57. Roof ridge peak RH, diffusion vent (6) and unvented (7)

The unvented and diffusion vent roofs both spike in RH after the installation of humidification, and remain at high RH (90%–100%) through most of the winter. In the spring, the diffusion vent roof dries to safer levels; the unvented assembly remains at high RH levels.

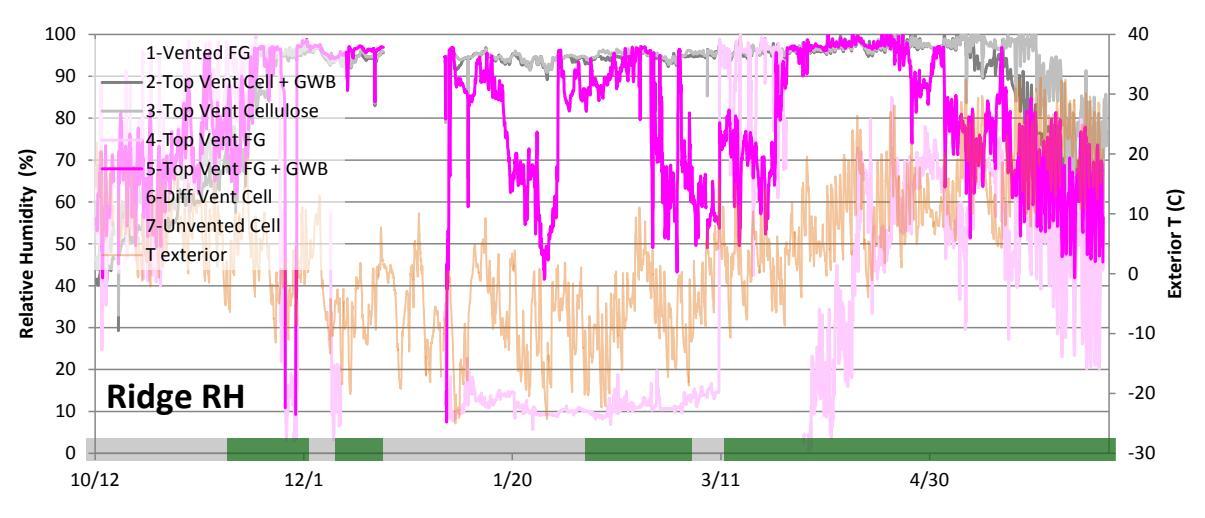
Figure 58. Roof ridge peak RH, top vent cellulose (2, 3) and fiberglass (4, 5)

The top vent cellulose roofs (2 and 3) showed similar behavior; the RH remained at 90%–100% through most of the winter and dried in the spring. The top vent fiberglass roofs (4 and 5) showed more variations, and Roof 4 (no WGB) showed extreme variations in RH (from 15% to 95%). These extreme variations were first interpreted as sensor failure: polymer capacitance-based RH sensors are known to have issues with high RHs and condensing conditions that were consistent with the measurements taken at the roof ridge.

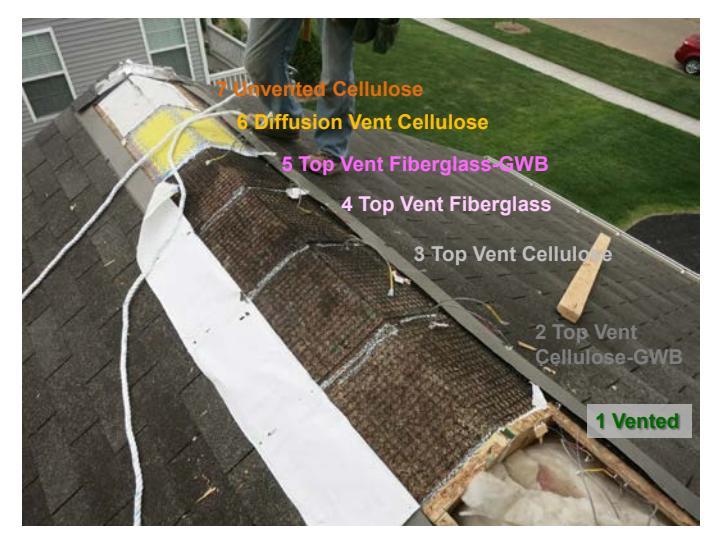
Figure 65. Ridge conditions before the breather mesh was removed

Given the concentration of moisture at the roof ridge, the exterior disassembly proceeded from the ridge downward. Figure 65 shows the conditions before the doghouse sheathing, 2×4 standoffs, and house wrap ridge wrap were removed.

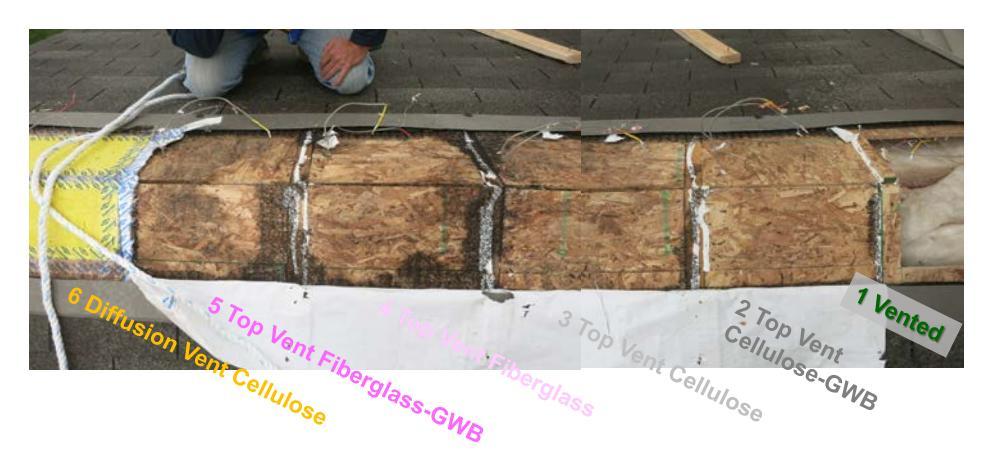
Figure 66. Ridge conditions after the breather mesh was removed

Figure 66 and Figure 67 show the conditions after the breather mesh was removed. The breather mesh was run continuously across all four top vent assemblies, so unintentional cross flow could occur here. The roof sheathing is not continuous across the four bays due to the dropped sheathing detail.

The exterior sheathing was apparently moisture damaged (stained, likely mold growth); the greatest damage was concentrated at the fiberglass bays.

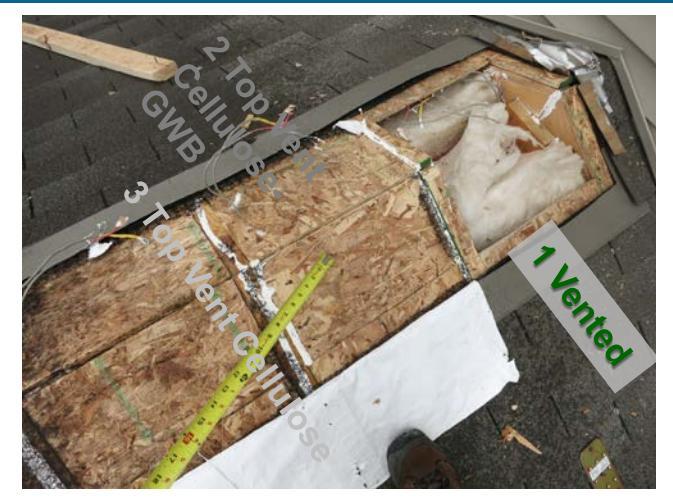
Figure 69. Ridge sheathing conditions, Roofs 1, 2, and 3

The sheathing at the top vent cellulose roof (3) is damaged (see Figure 68). However, based on the damage pattern (adjacent to bay 4, top vent fiberglass) and the complete lack of top surface damage in the adjacent cellulose bay (top vent cellulose with GWB; Figure 69), the staining on Roof 3 is likely due to cross-airflow leakage coming from the adjacent fiberglass assembly.

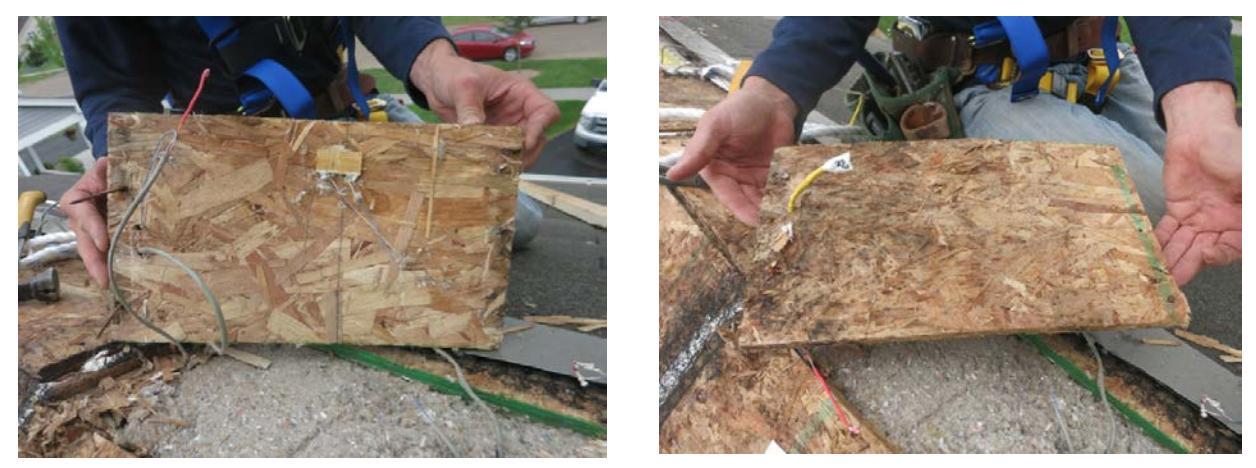
Figure 70. Ridge sheathing bottom (left); top (right) conditions, Roof 3

The top and bottom of the sheathing in Roof 3 (top vent cellulose with GWB) is shown in Figure 70. The interior surface showed rusted fasteners, some discoloration, and grain raise/thickness swelling of the OSB, but no visual indication of mold growth. The top side, in contrast, showed the mold growth that is suspected to have originated from an air leak in the adjacent fiberglass bay.

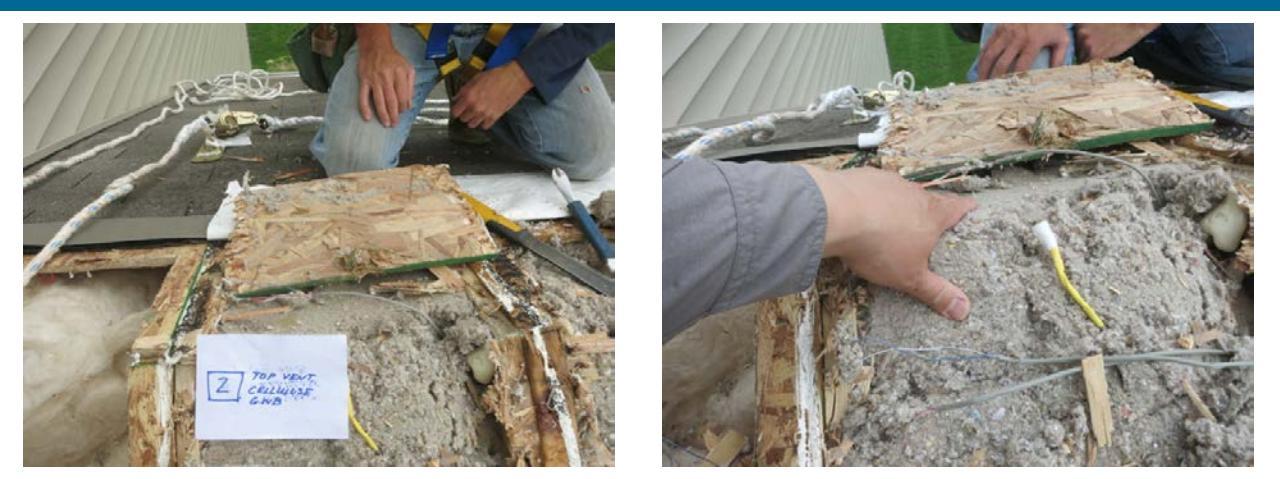
Figure 71. Ridge sheathing top conditions, Roof 2 (left); cellulose conditions (right)

Conditions at Roof 2 (top vent cellulose, no GWB) are shown in Figure 71; interior sheathing had similar conditions to Roof 3 (no visible mold growth, rusted fasteners, grain raise of OSB).

The cellulose insulation had not settled over the course of a winter and was not visibly damaged. There was some caking of the cellulose (adhesions to the roof sheathing), which is regarded as an indication of dried moisture accumulation (Rose and McCaa 1998; Derome 2005).

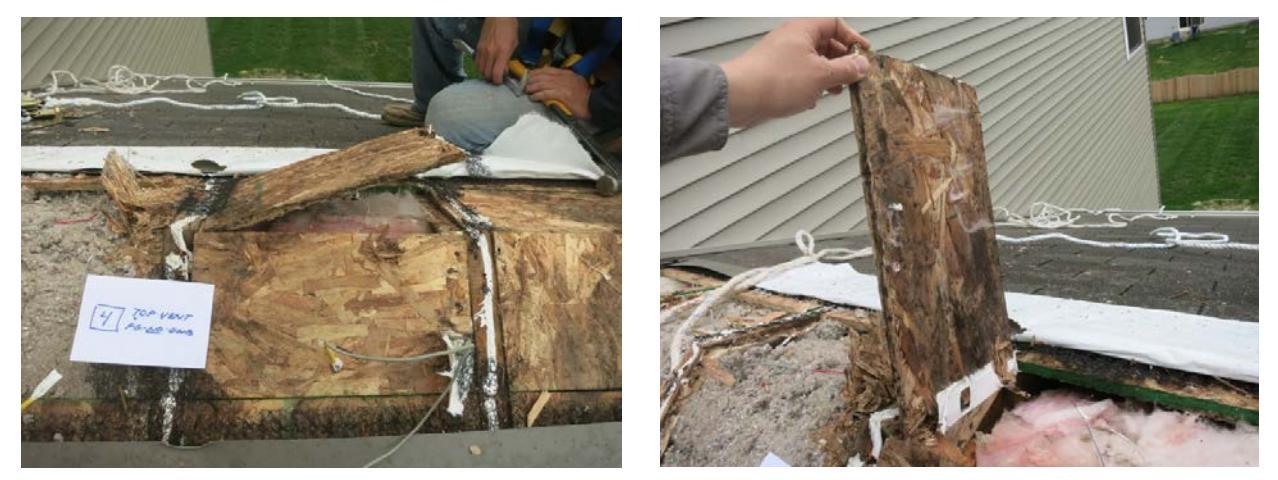
Figure 72. Ridge sheathing top (left); bottom (right) conditions, Roof 4

In contrast, the top vent fiberglass roofs showed extensive damage. Sheathing conditions at Roof 4 (top vent fiberglass, no GWB) are shown in Figure 72; the exterior side is stained with suspected mold (near the assumed air leak), and the interior side has extensive staining and growth; insulation has adhered to the sheathing (Figure 72, left). Figure 72 (left) shows the east (rear) facing roof sheathing.

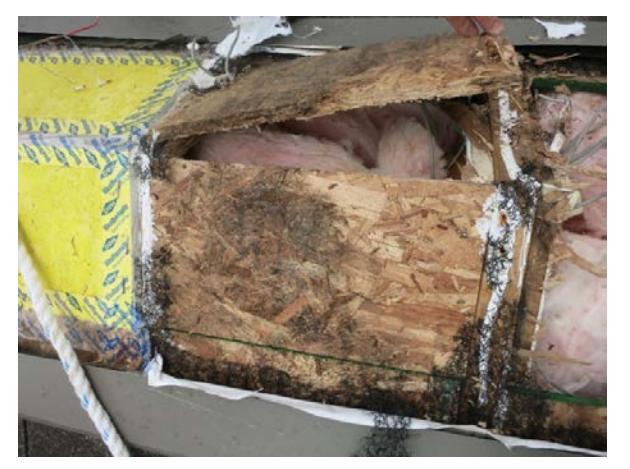
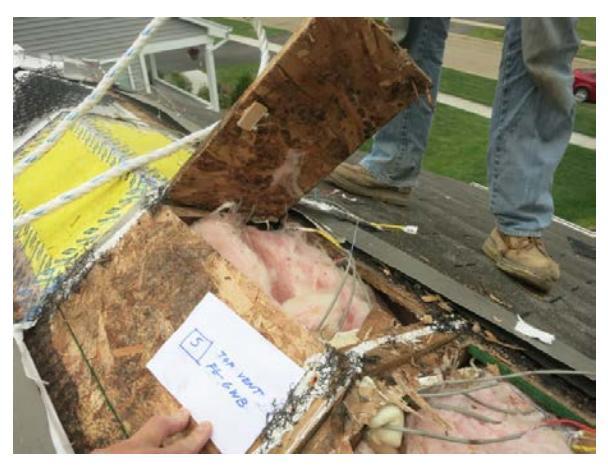
Figure 74. Ridge sheathing conditions, Roof 5

Similar images are shown for Roof 5 in Figure 74 (top vent fiberglass with GWB); both exterior and interior sides showed extensive damage and staining (wetter on the inside).

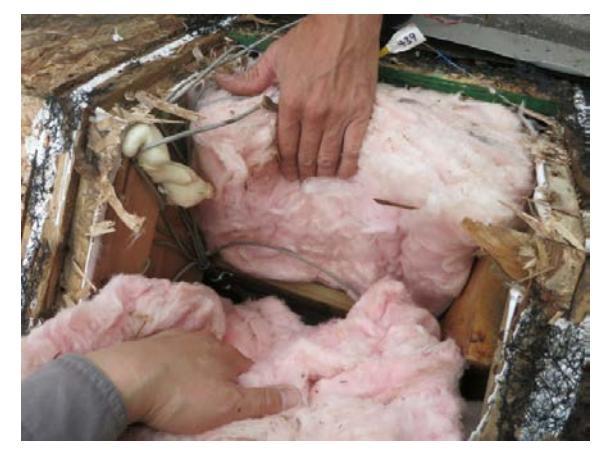
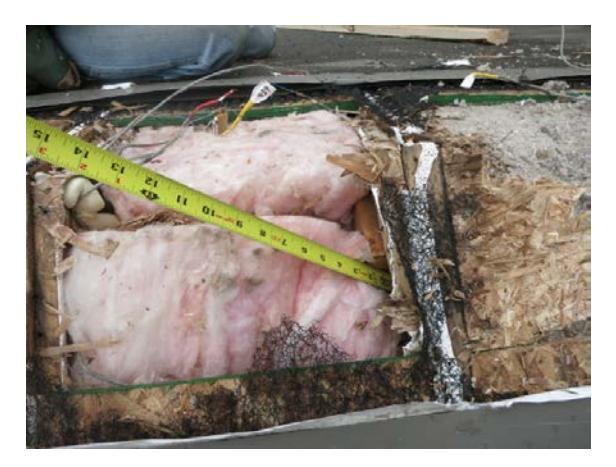
Figure 75. Fiberglass batt conditions at ridge, Roof 4

The rafter bays apparently had mold growth on the framing that was concentrated at the exterior (colder in winter) side (Figure 75 and Figure 76). Although the fiberglass batts were installed meticulously from the underside, gaps between the batts and framing were evident from the top side, which would have left possible openings for airflow bypass.

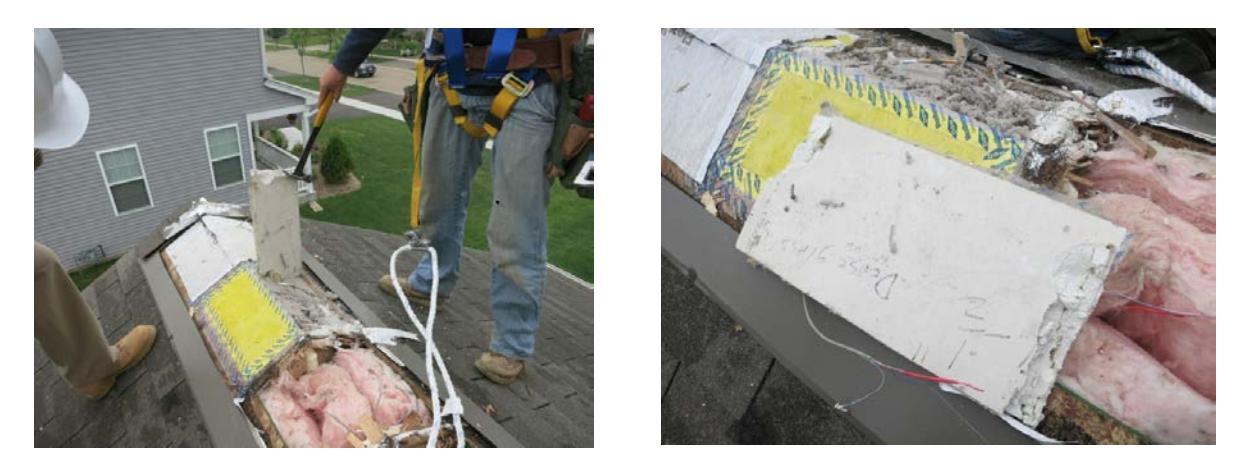
Figure 77. Ridge sheathing top and bottom conditions, Roof 6

The GWB sheathing at the diffusion vent roof (6) had no evidence of damage from the exterior. When disassembled, the GWB sheathing appeared to be basically intact and showed no evidence of staining or mold growth (Figure 77).

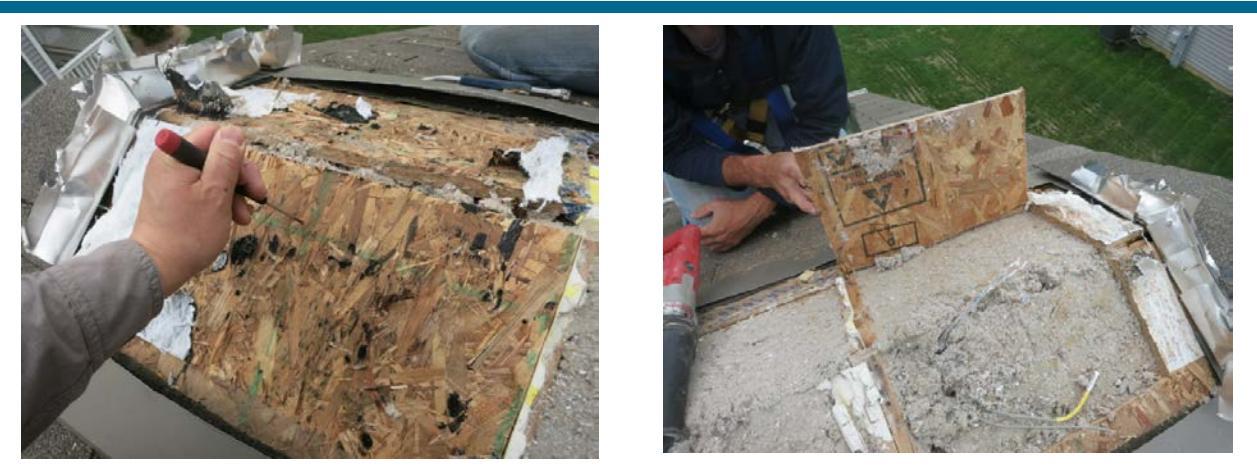
Figure 78. Ridge sheathing top and bottom; cellulose conditions, Roof 7

The unvented cellulose assembly (7) showed no damage from the exterior after the self-adhered membrane was removed (remnants are visible in Figure 78, left). When the sheathing was removed, only minor evidence of moisture issues (OSB grain raise, rusted staples, and cellulose caking) were seen; no mold growth was visible. The cellulose insulation did not settle during the winter; it still filled the cavity to the ridge.

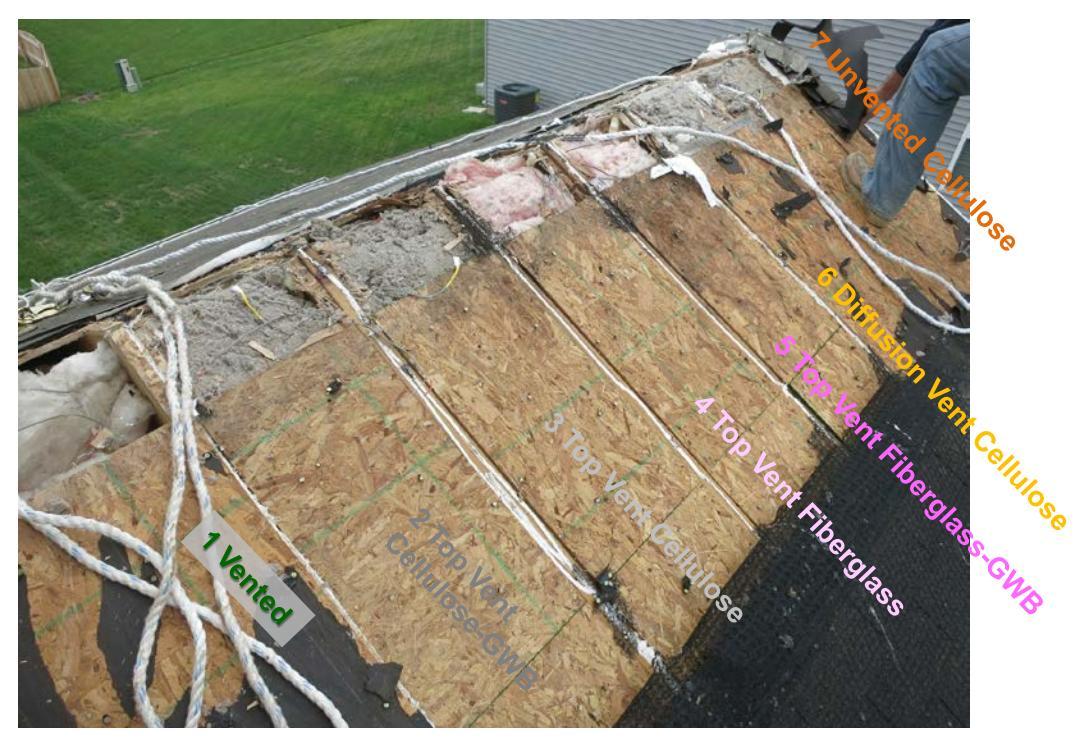
Figure 79. Sheathing away from ridge, west (front) face of roof

After the ridge was disassembled, the roof cladding materials were stripped near the ridge; the front (west) face is shown in Figure 79. All the top vent roofs show some exterior staining, but it is more severe at the fiberglass batt roofs.

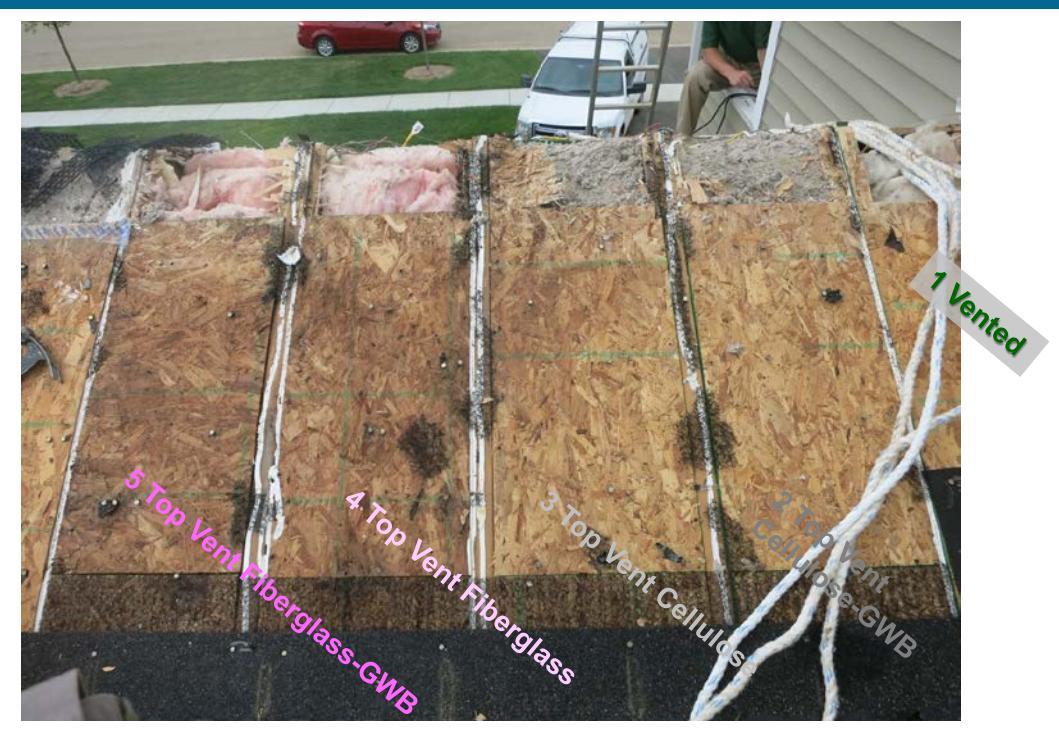
Figure 80. Sheathing away from ridge, east (rear) face of the roof

The same condition on the east (rear)-facing roof is shown in Figure 80, which showed similar patterns (worse conditions at fiberglass batt roofs).

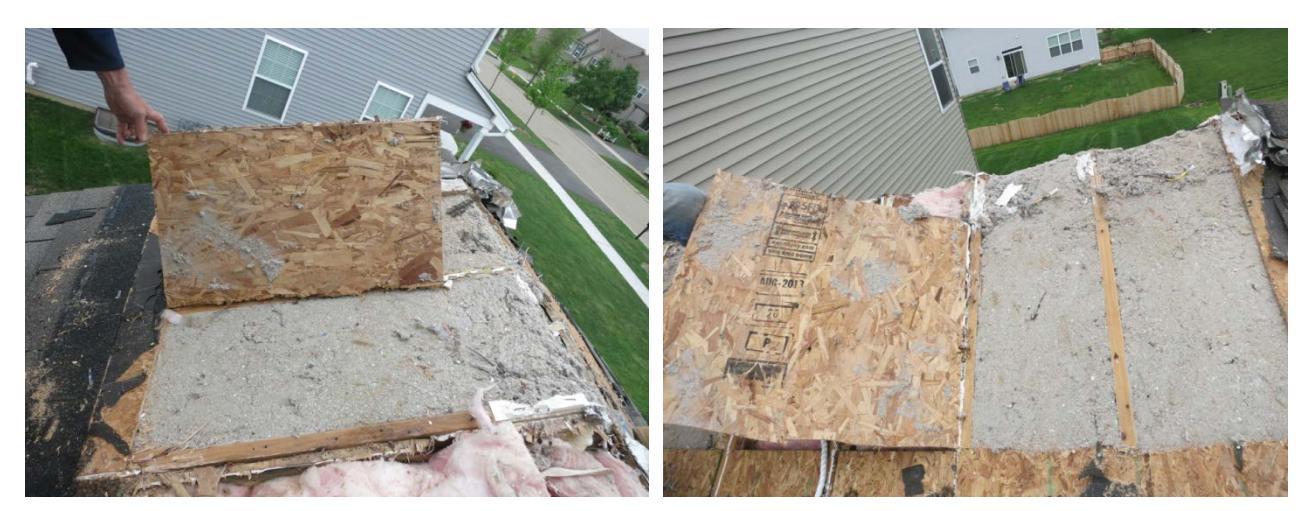
Figure 81. Sheathing away from ridge, Roofs 4 and 5 (left); Roofs 6 and 7 (right)

At the top vent cellulose roofs (4 and 5) and dense-pack cellulose roofs (6 and 7), the sheathing was largely intact. Minor damage was seen of grain raise, caking, and fastener corrosion (Figure 81).

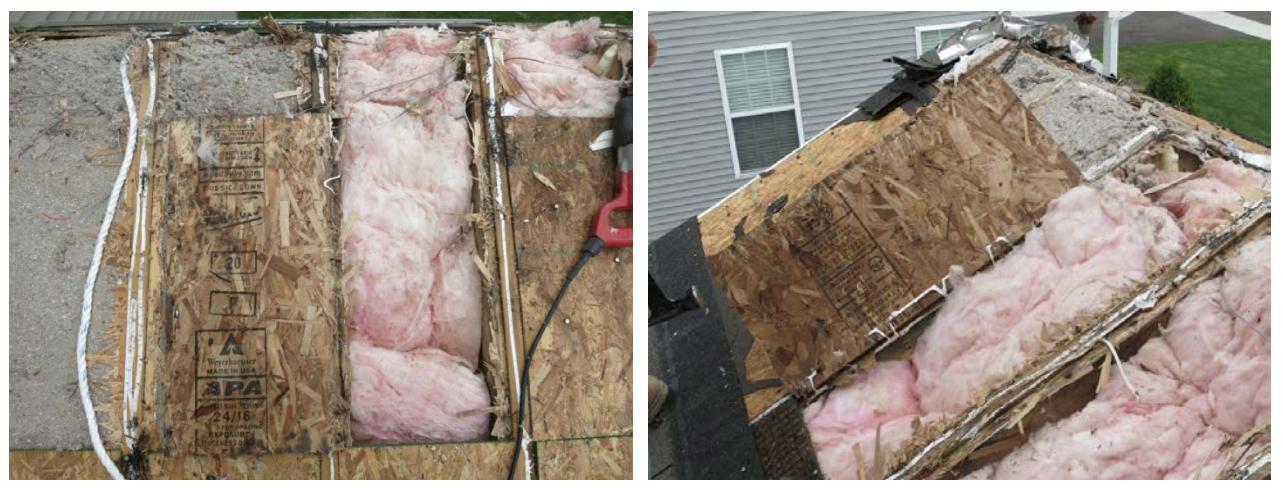
Figure 82. Sheathing away from ridge, Roof 4 (left); Roof 5 (right)

Similar to the ridge, the fiberglass batt roofs showed worse conditions than the cellulose bays away from the ridge (Figure 82). The sheathing condition at Roof 4 (top vent fiberglass, no GWB) was worse than Roof 5 (top vent fiberglass with GWB).

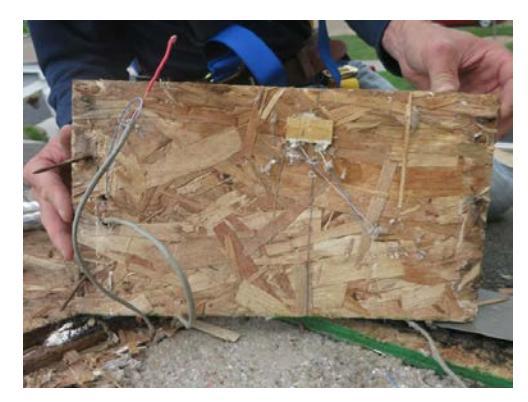
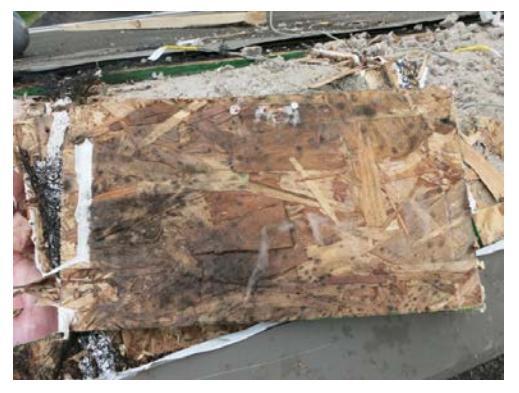
Figure 87. Top vent roofs, no interior GWB, east/front face; cellulose (left); fiberglass (right)

The top vent roofs gave a comparison of cavity insulations: dense-pack cellulose versus fiberglass batt. An ideal comparison would have compared dense-pack cellulose with blown-in fiberglass to eliminate the installation variable. The batt installation was imperfect; air leakage paths and voids allowed air to bypass the insulation and cause more serious damage.

In general, the moisture measurements were comparable, or in some cases the instrumentation in the fiberglass bays showed lower moisture levels. However, disassembly revealed that the roof sheathing and framing in the fiberglass batt roofs suffered much more moisture-related damage, including staining, mold, and mold growth, relative to the cellulose roofs (Figure 87).

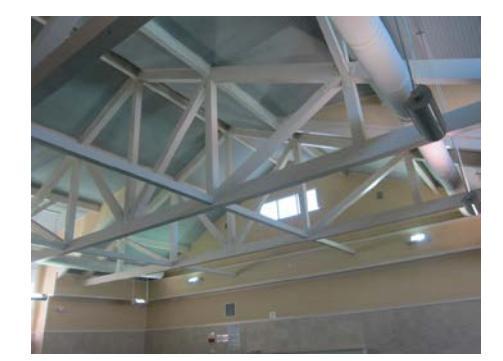
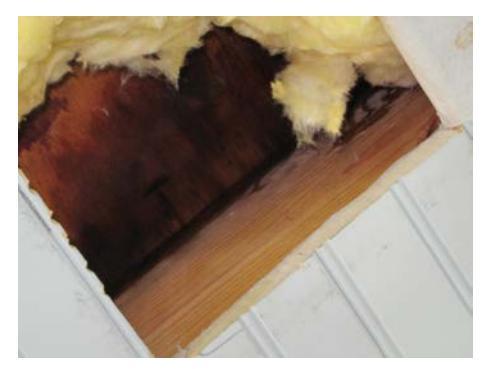
Figure 89. Ridge condensation issues; CZ 3A pool with interior polyethylene vapor barrier

This was demonstrated, for example, in a pool building investigated in CZ 3A (Wilmington, North Carolina; Figure 89). An interior polyethylene vapor barrier was installed, but connections were not made at the roof truss purlins. This roof failed because air leaked from the pool. This resulted in liquid water condensation at the ridge, which drained, ran out of the roof, and created visible interior staining.

Although vapor retarders can reduce sheathing wetting, vapor control alone is by no means a recommended approach for unvented roof assemblies in cold climates. Unless the vapor barrier is detailed perfectly as an air barrier, incidental leakage of interior air will cause wetting of the assembly. An interior vapor barrier such as polyethylene (Class I, 0.06 perm) would completely eliminate drying to the interior. This combination results in an assembly that performs well in theory (and in one-dimensional simulations) but is not at all robust in real-world conditions.

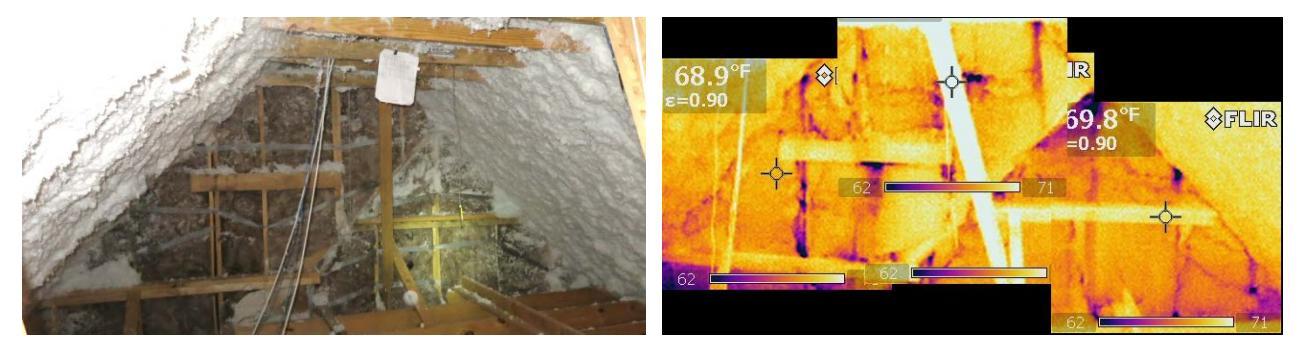
Figure 109. Air leakage at front attic gable end (location B)

roofs and walls, especially at complicated details with multiple intersecting planes. For instance, leakage was evident at dormer and gable end intersecting planes at the front of the house (Figure 108 and Figure 109), and roof-wall connections at the rear of the house (Figure 111). These and the following leaks are keyed to Figure 110.

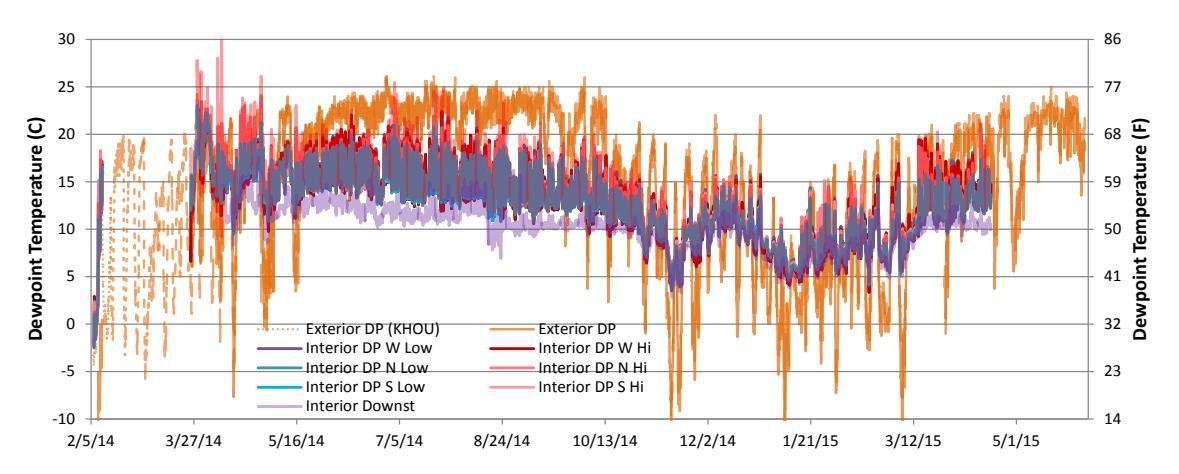
Figure 120. Houston exterior, attic, and main conditioned space dew point temperatures

Exterior and interior dew point (absolute air MC) conditions are shown in Figure 120; similar to temperatures, conditioned attic dew points operate between interior and exterior conditions in the summer. In the winter, interior dew points roughly track outdoor conditions (extremes are damped by house airtightness). No interior moisture is generated, because the house is an unoccupied model.

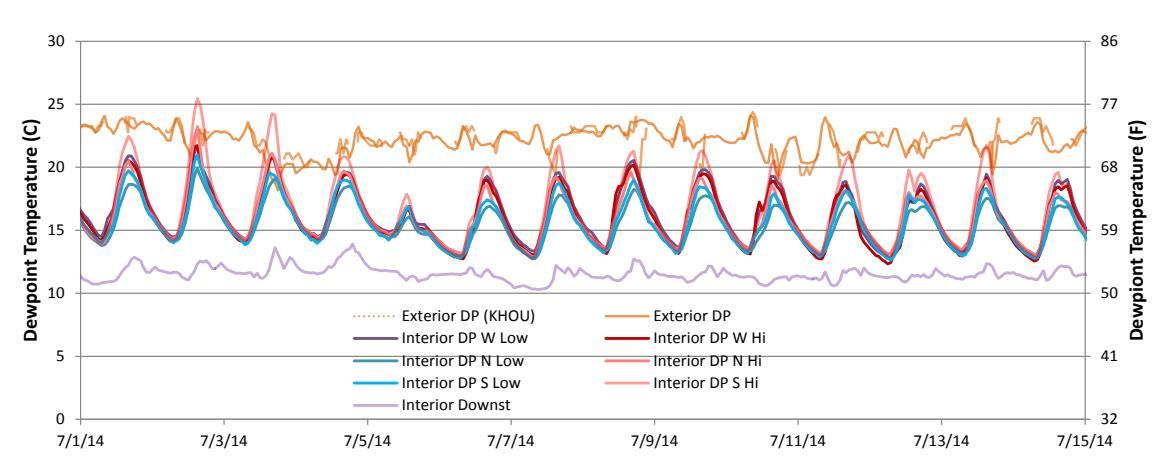
Figure 121. Houston dew point temperatures in the summertime (July 2014) detail

Attic and interior summertime dew point temperatures for 2 weeks in July 2014 are shown in Figure 121; interior main space dew points remained at a relatively stable level of $10^{\circ}-12^{\circ}C$ ($50^{\circ}-54^{\circ}F$) dew point.

Attic conditions were wetter than the interior. Again the space was not directly conditioned or dehumidified) and had a strong diurnal cycle. The peaks occurred between 3 and 6 p.m., which is consistent with moisture adsorbed in sheathing being driven out by solar gain and dry bulb temperature difference. After sunset, the sheathing tended to adsorb moisture from the air and pull down the dew point.

The data show stratification. The south high sensor shows the highest peaks, which is consistent with its location at the highest spot in the attic (Figure 118). North low and south low sensors showed the lowest peaks, which is also consistent with moisture stratification.

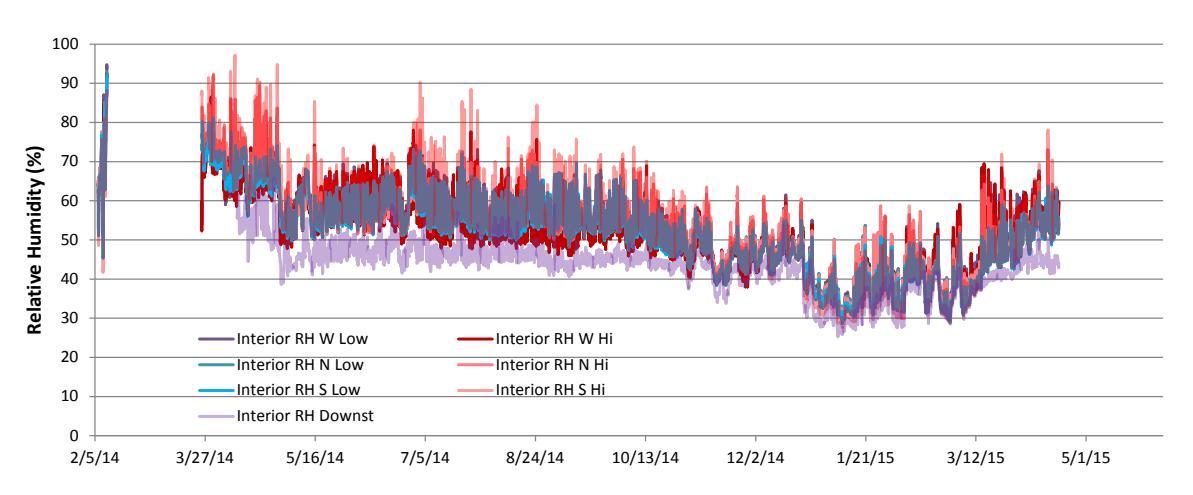
Figure 122. Houston attic and main conditioned space RH

Interior RH levels are shown in Figure 122; the initial data after the gap (semiconditioned construction period) has very high RHs (60%–90%), which is consistent with the moisture-generating construction activities (drywall mudding and interior painting) that occurred during that time.

The high RH outliers in the early (March 2014) data are south high and north high attic sensors, which are consistent with previous dew point measurements and moisture stratification.

Space conditioning was run from May 2014 onward; the interior main floor space ran 45%–55% RH in summer, and the attic typically cycled at 50%–70%. Wintertime interior RHs were typically 30%–50% because the exterior dew point was lower and the house was unoccupied.

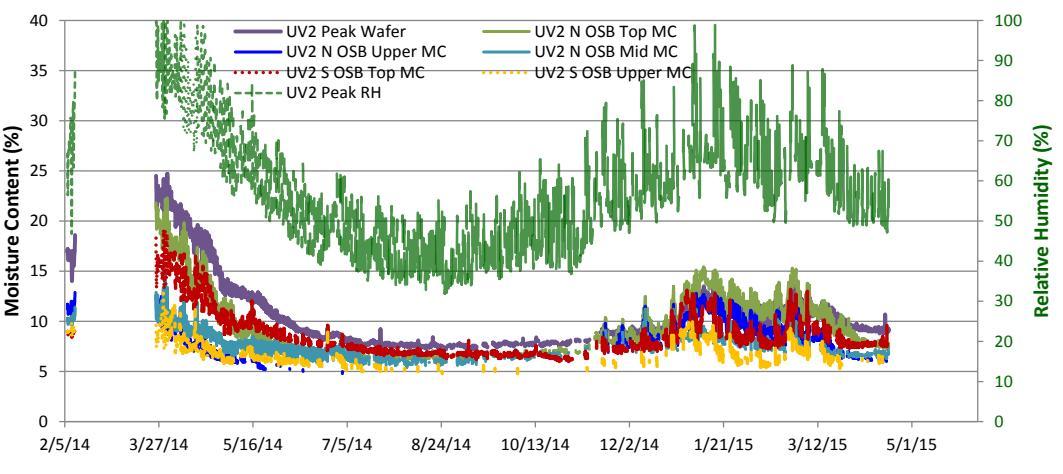
Figure 124. Unvented roof (UV2) roof MC and RH measurements

Unfortunately, the data logger failed in April 2014, so almost all the RH and MC channels were lost. The system will require a site visit for repair.
