Field Testing Unvented Roofs with Asphalt Shingles in Cold and Hot-Humid Climates

Kohta Ueno and Joseph W. Lstiburek Building Science Corporation

September 2015

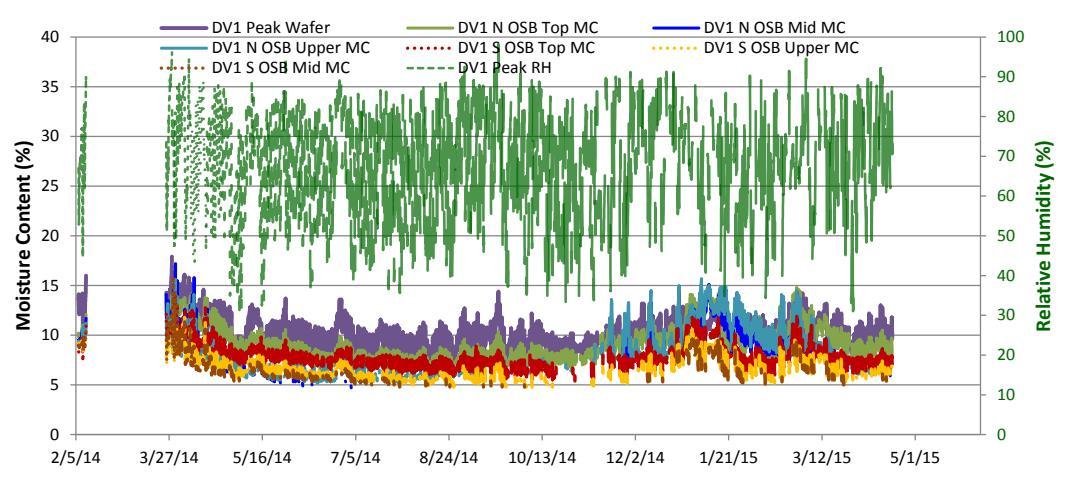
Figure 125. Diffusion vent (DV1) roof MC and RH measurements

In the diffusion vent roofs, initial winter MCs and RHs are much drier and safer than the unvented roofs. Peak MCs remain lower than 20%. However, summertime MCs are higher than in the unvented roofs. In winter 2014–2015, wood MC rose but were again well within the safe range (typically lower than 15%). The highest MCs were typically toward the peak of the roof. Roof peak RH measurements cycled on a diurnal basis; most readings are 50%–80%. The diurnal RH cycling in the diffusion vent roofs shows a greater range than that in the unvented roofs.

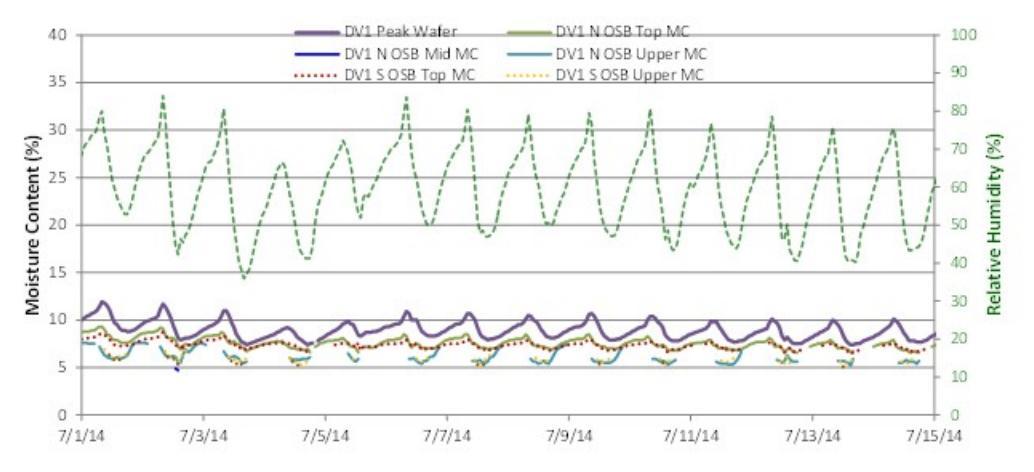
The summertime diurnal pattern is shown in more detail in Figure 129, which plots 2 weeks from July 2014. The roof peak RH shows a consistent sawtooth pattern with a slow rise and a sharp daily fall. The drop in RH consistently occurs at 7 a.m., which is consistent with morning solar warming. In the late afternoons (typically 4–5 p.m.) the RH started to rise again and continued to overnight until the morning.

Figure 129. Diffusion vent (DV1) roof MC and RH measurements, summer (July 2014) detail

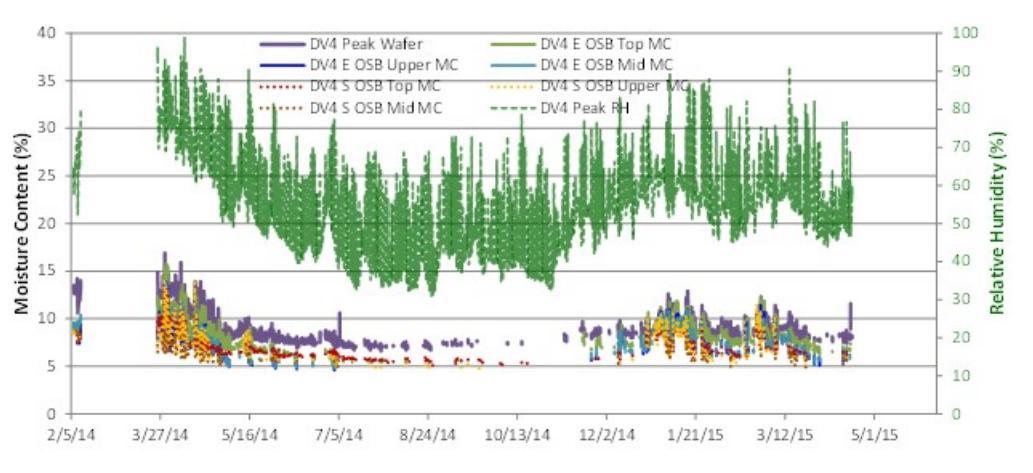
Figure 130. Diffusion vent at hip (DV4) roof MC and RH measurements

These roofs exhibit behavior partway between the unvented and diffusion vent roofs. The RH and MC have noticeable seasonal swings; the peaks occur during the winters. Similar to the unvented roofs, winter 2014–2015 peak RHs and MCs were much drier than the first winter.

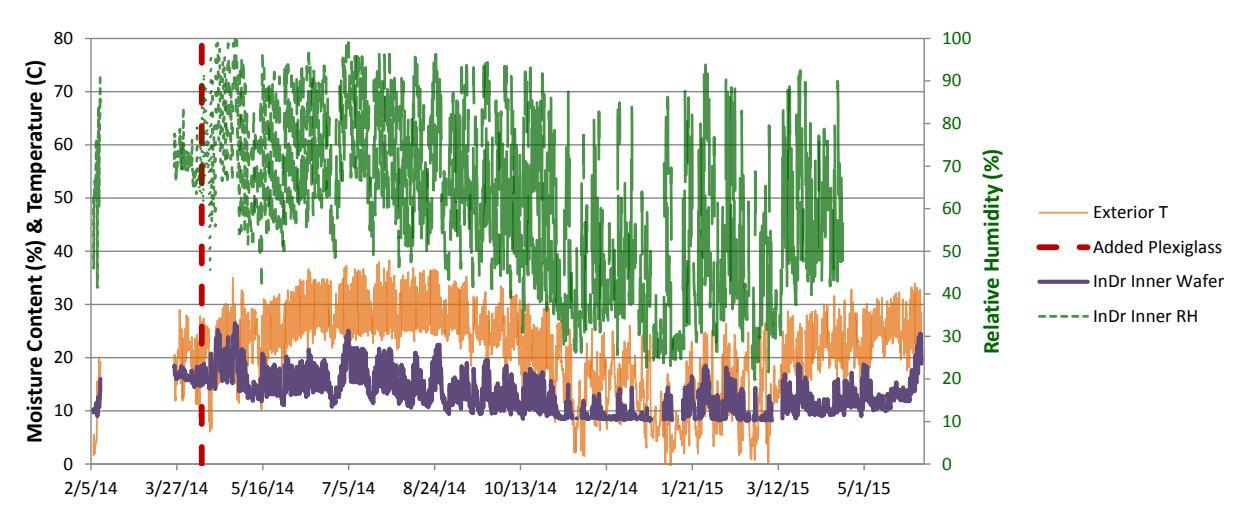
The interior-side RH and wafer MC for the inward drive experiment are shown in Figure 132; the exterior temperature is shown for reference. The experiment was put into operation in mid-April 2014, when the clear acrylic plastic cover was installed and air sealed (red dotted line). This caused moisture to accumulate. The RH and wafer MC increased after the clear plastic cover was installed. Interior-side RHs had peaks higher than 90% during the summer, but decreased during the early winter when outdoor temperatures dropped.

Figure 132. Inward drive interior-side RH and wafer sensor with outdoor temperature

The interior-side RH and wafer MC measurements moved in parallel, as expected. In a previous calibration (Ueno and Straube 2008), the wafer sensors came to equilibrium with 100% RH conditions (air in a closed container over water) at 28%–30% MC; immersing the sensors in liquid water increased MCs to 40%–45%. The wafer MCs remained lower than 28%–30%, which indicates no condensation or 100% RH conditions (consistent with RH results).

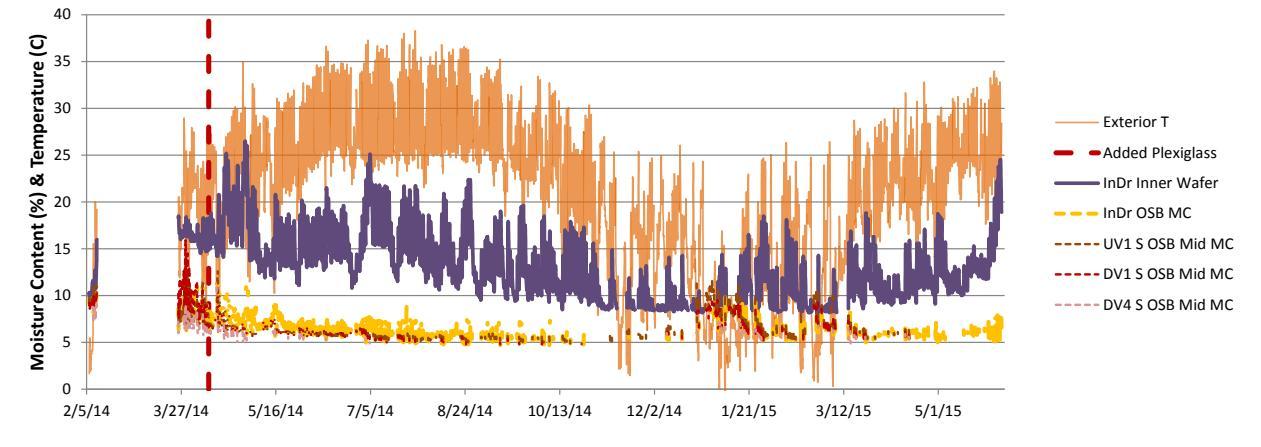
The inward drive roof sheathing MC is plotted with other lower sheathing MCs (same south orientation, both unvented and diffusion vent) in Figure 133. The wafer MC and outdoor temperature are also plotted for reference. The sheathing MC in the inward drive experiment is consistent with the other sheathing MCs, which points away from the accumulation of moisture within the sealed box.

Figure 133. Inward drive wafer sensor MC and sheathing MCs with outdoor temperature

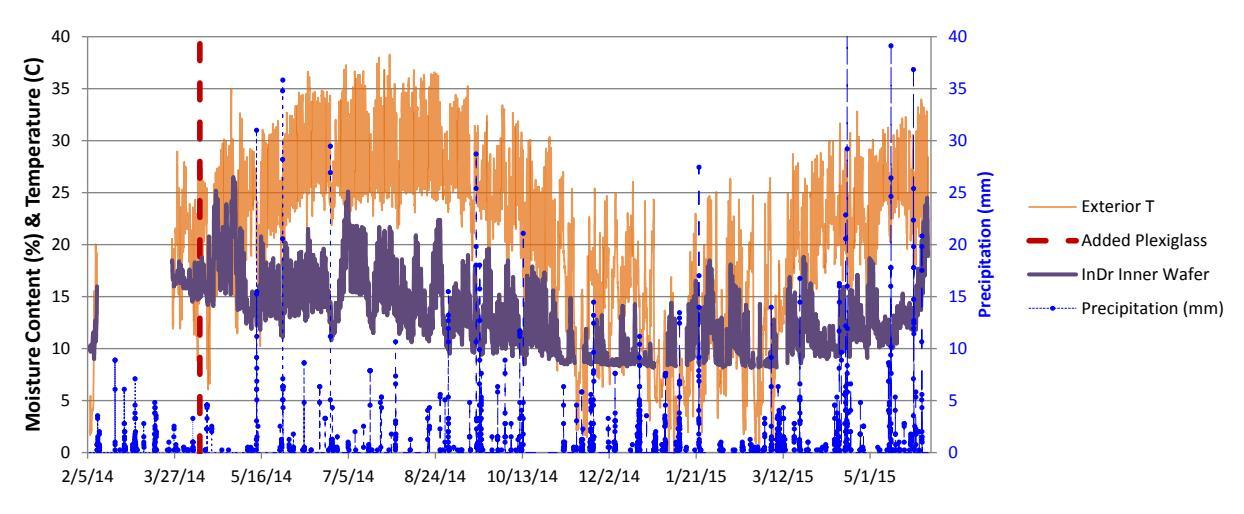
The wafer MC (and RH) data were examined to see if correlations could be found with exterior weather events. Comparisons with interior and exterior dew point showed minimal relationships. Precipitation was also plotted for correlation (Figure 134), given that wetted shingles are a suspected moisture source for inward drive. Although some wafer MC spikes correlated with precipitation, many other events were uncorrelated.

Figure 134. Inward drive wafer sensor MC and precipitation with outdoor temperature

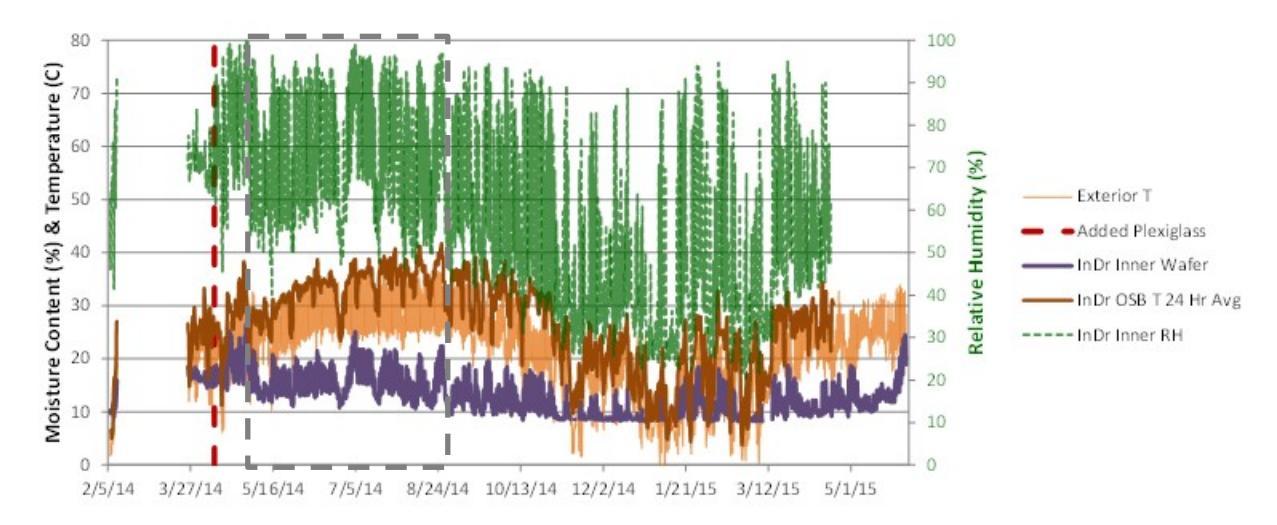
The most direct correlation to the wafer data was found by plotting the exterior sheathing temperature as a 24-hour rolling average (Figure 135); this is consistent with adsorbed moisture being driven from warm/hot sheathing to the cool interior side of the assembly or ping-pong water within the closed system. The correlation was very clear from May through August 2014 (Figure 136).

Figure 135. Inward drive interior-side RH, wafer MC, and sheathing temperature 24-hour average

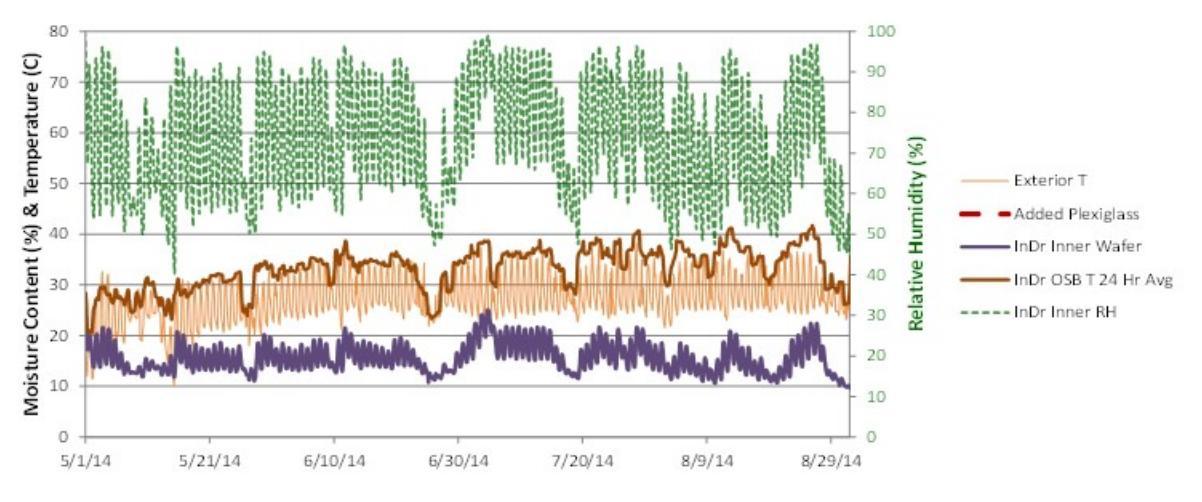
Figure 136. Inward drive interior-side RH, wafer MC, and sheathing temperature 24-hour average (summertime detail)

Overall MCs did not rise over time. This is an argument against moisture being driven through asphalt shingle layers (which would accumulate in the closed assembly) with a typical roof cladding and WRB (asphalt shingles with #15 felt).

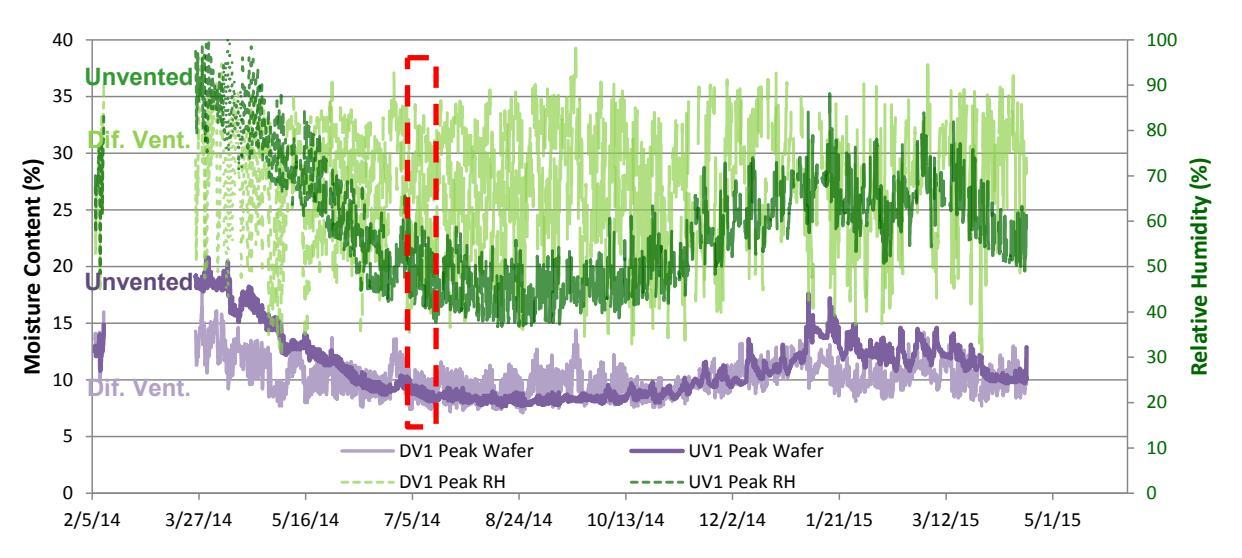
Figure 137. Diffusion vent (DV1) and unvented (UV1) comparison (ridge RH and wafer MC)

The unvented roof shows the seasonal rise and fall (wetter during the winter), and dry conditions during the summer. During the winter, interior moisture accumulates at the ridge under the vapor-impermeable membrane. During the summer, the thermal gradient drives moisture downward and out of the assembly; the vapor-impermeable membrane prevents exterior moisture from entering.

In comparison, the diffusion vent roof was drier during the winter, because the material is vapor permeable. During the summer RHs were higher than the unvented roof, possibly because it was connected to the exterior moisture conditions via the vapor-open ridge. This connection could also explain the diurnal cycling of RH levels.

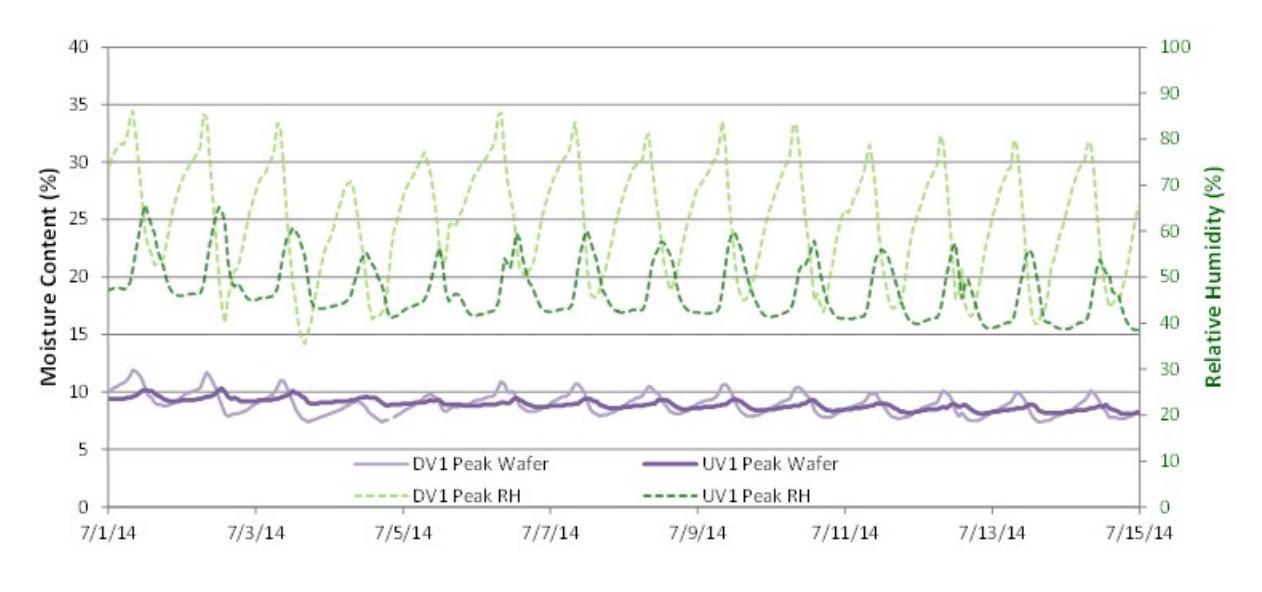
The diurnal cycling of RH levels was examined more closely for July 2014 (Figure 138), which zooms in on the area highlighted by the red box in Figure 137. As mentioned earlier, the diffusion vent ridge RH has a sawtooth pattern; a sharp drop in RH occurred in the mornings between 6 a.m. and 8 a.m. In contrast, the unvented roof's diurnal cycles were offset by several hours; the peak and drop off occurred between 10 a.m. and 12 noon. These two ridge locations were on the same roofline and should have seen identical solar exposure.

Figure 138. DV1 and UV1 comparison (ridge RH and wafer), summertime detail

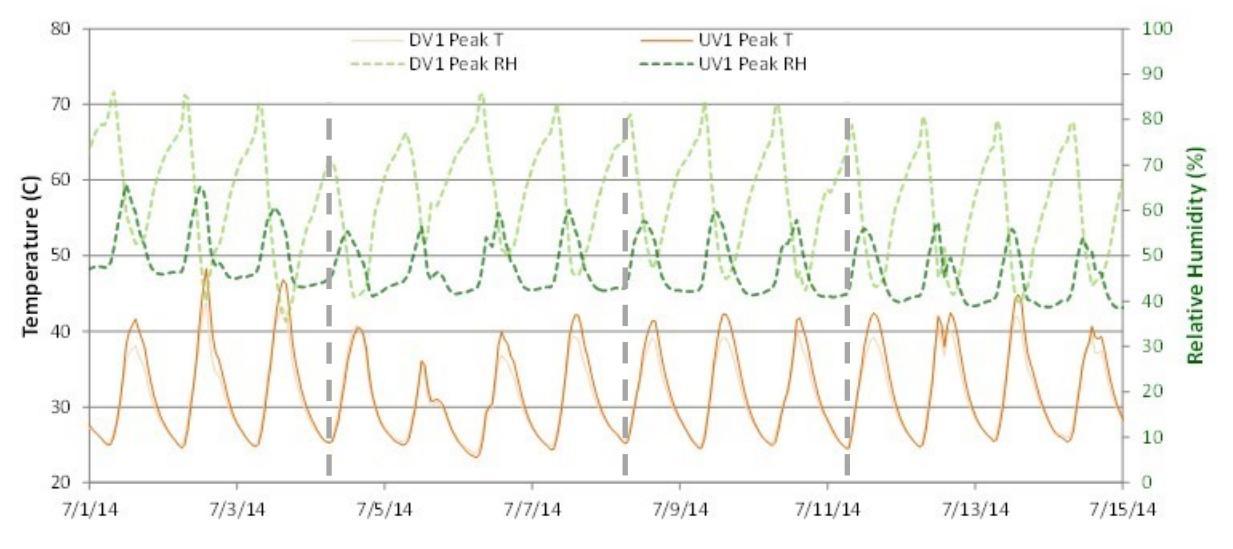
Ridge RHs were plotted with ridge temperatures (Figure 139) to determine if temperature anomalies caused the offset behavior. Ridge temperatures tracked identically between the two roofs. Rising temperatures correlated with (1) a drop in DV1 RH and (2) a rise in UV1 RH (gray lines). The diffusion vent roof typically had 5.5°F (3°C) lower peak temperatures than the unvented roof. This difference may reflect evaporative cooling from the diffusion vent roof.

Figure 139. DV1 and UV1 comparison (ridge RH and wafer), summertime detail

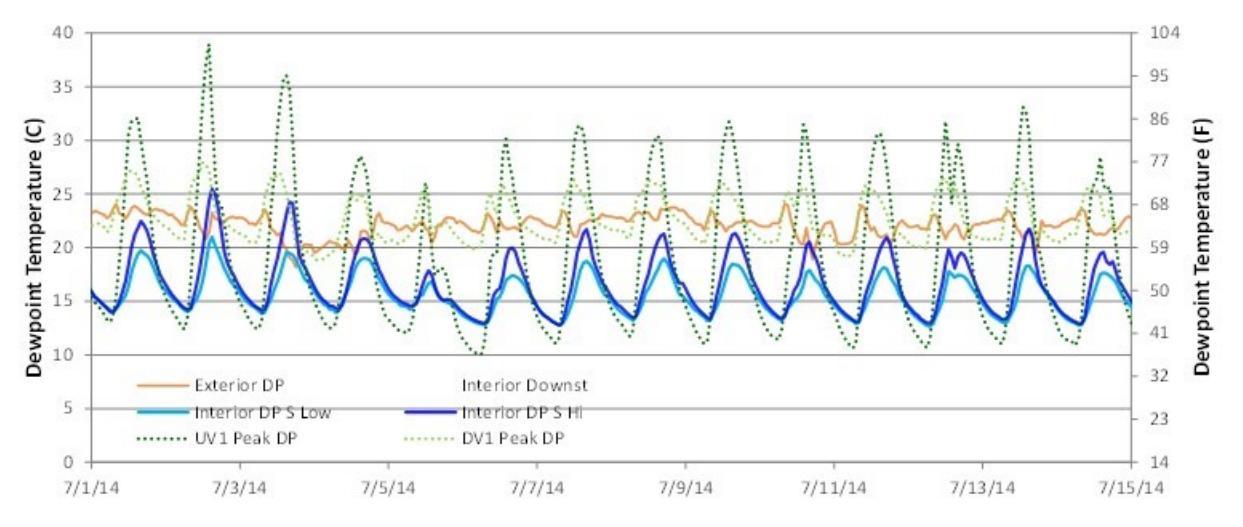
As another reference, the roof T/RH sensors are plotted in terms of dew point temperature (absolute air moisture content) with interior (attic) and exterior dew points (Figure 140). The dew point at the ridge rises higher than attic conditions (blue lines) and exterior conditions (orange). More importantly, in terms of absolute moisture content, the unvented roof has higher (wetter) peaks than the diffusion vent roof, so the order in Figure 138 is reversed.

Figure 140. Summertime dew point comparison: interior, attic, exterior, and UV1/DV1

In general, dew point spikes at the ridge are likely caused by the heating of roof sheathing, which in turn releases (desorbs) adsorbed moisture. This could easily drive dew points higher than interior conditions in the main attic space given moisture stratification.

In the afternoons and evenings the ridge dew points dropped. The unvented roof dew point dropped much lower than ambient conditions, and the diffusion vent roof tracked closer to ambient. This reflects the vapor-open ridge material, which coupled exterior and interior moisture conditions.

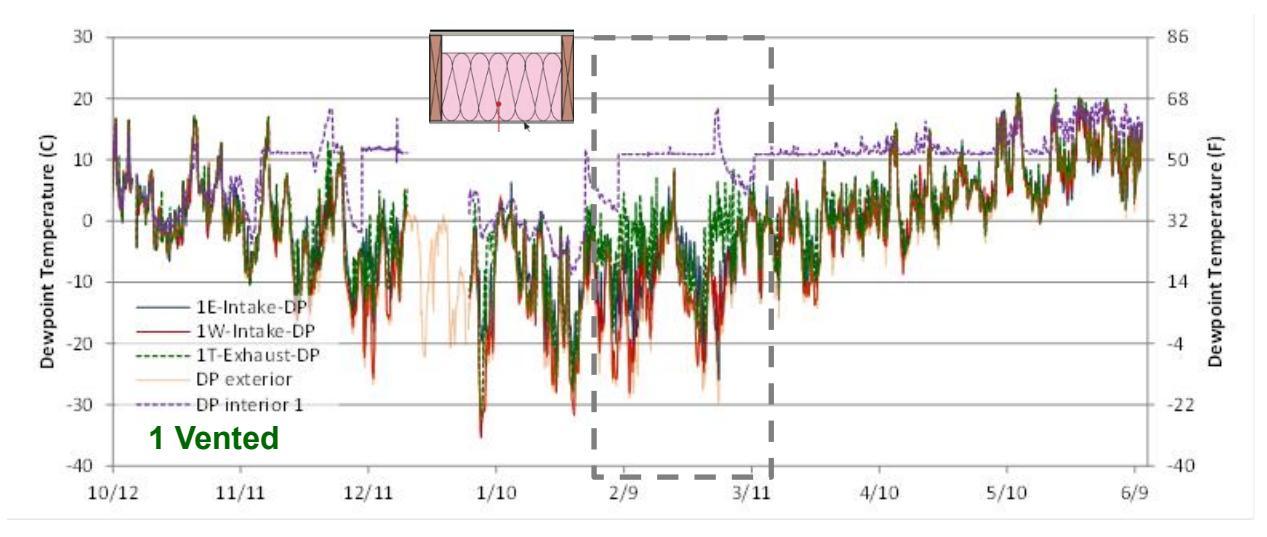
The intake (soffit/eave), exhaust (ridge), interior, and exterior dew point for the vented roof (1) are plotted in Figure 145. The general trend is that the ventilation space dew points mostly match exterior conditions. However, there is one period (highlighted in the gray rectangle) when the exhaust dew point is noticeably higher; these data are expanded in Figure 146.

Figure 145. Intake and exhaust dew points, interior and exterior (Roof 1-vented)

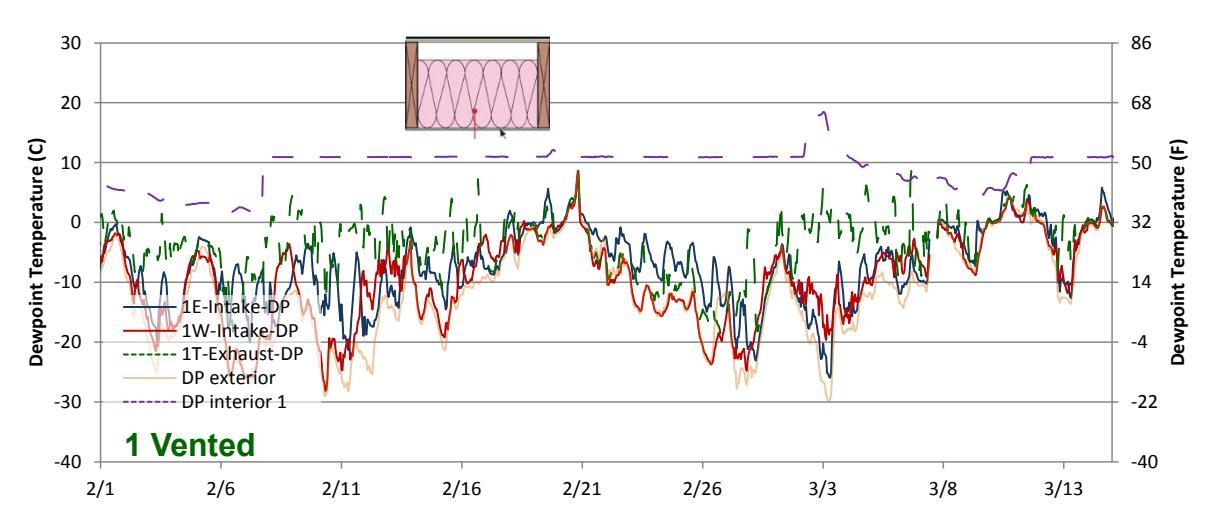
This expanded period appears to match when the humidification system was running during colder weather. This might indicate some level of moisture removal at low exterior dew points.

Figure 146. Intake and exhaust dew points, interior and exterior (Roof 1-vented) detail

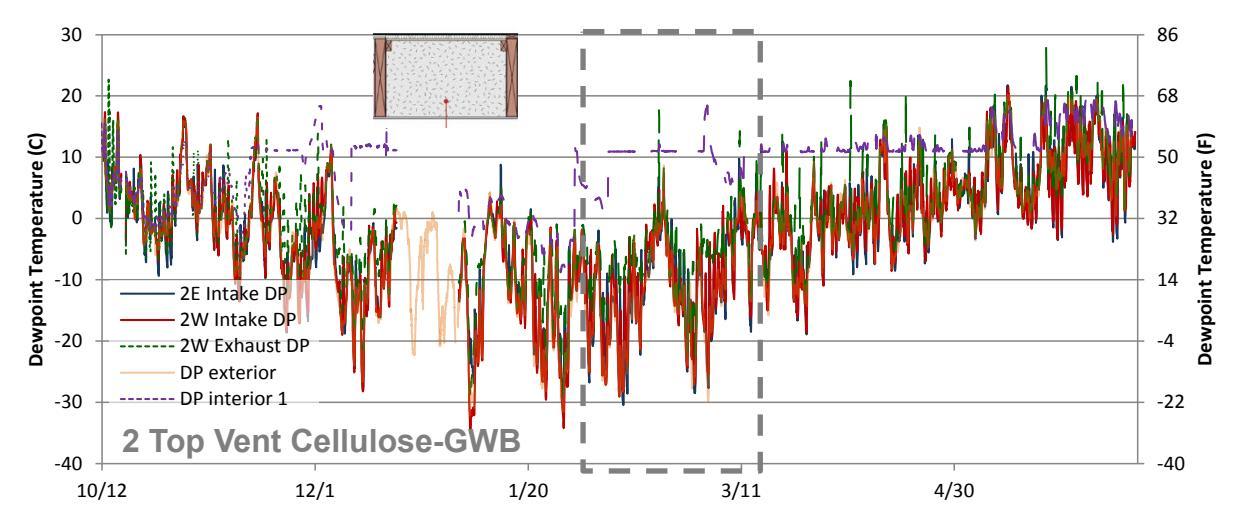
The data for the top vent cellulose roof with GWB (2) are shown in Figure 148; the highlighted period from Roof 1 is shown here, but in this roof, the dew points are all close to exterior conditions. A close-up of that period (Figure 149) seems to indicate that the exhaust dew point is slightly higher during this period, but not by the same degree as the vented assembly. This would indicate that more moisture is removed from the vented roof than from the top vent roof.

Figure 148. Intake and exhaust dew points, interior and exterior (Roof 2—top vent cellulose with GWB)

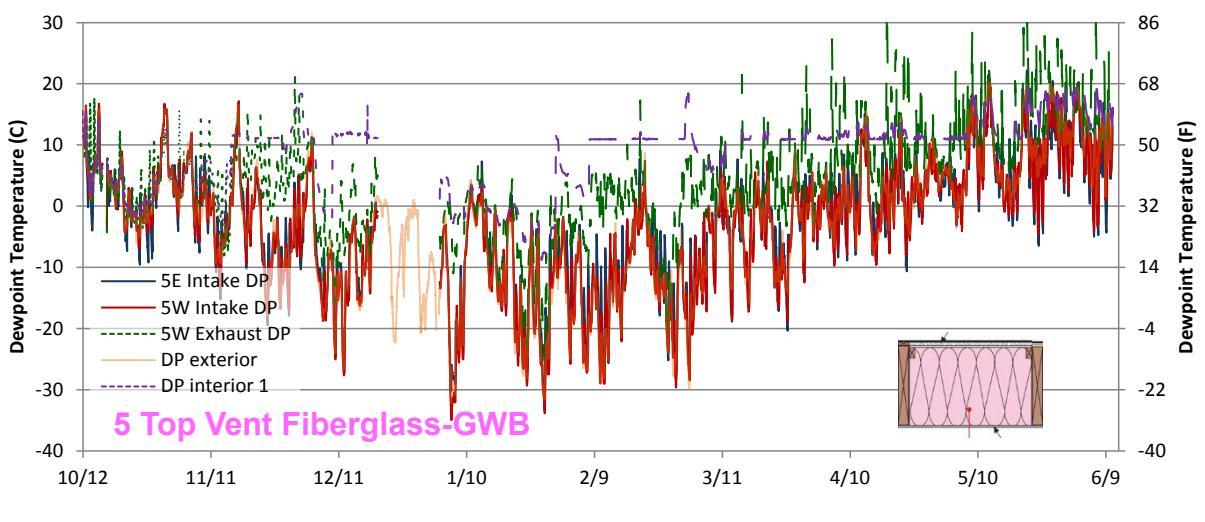
Dew points are plotted for the top vent fiberglass roofs with GWB (5) and without GWB (4) in Figure 152 and Figure 153, respectively. Roof 5 shows elevated exhaust dew points (compared to exterior/intake). Roof 4 shows smaller differences but greater variations.

Figure 152. Intake and exhaust dew points, interior and exterior (Roof 5—top vent fiberglass with GWB)

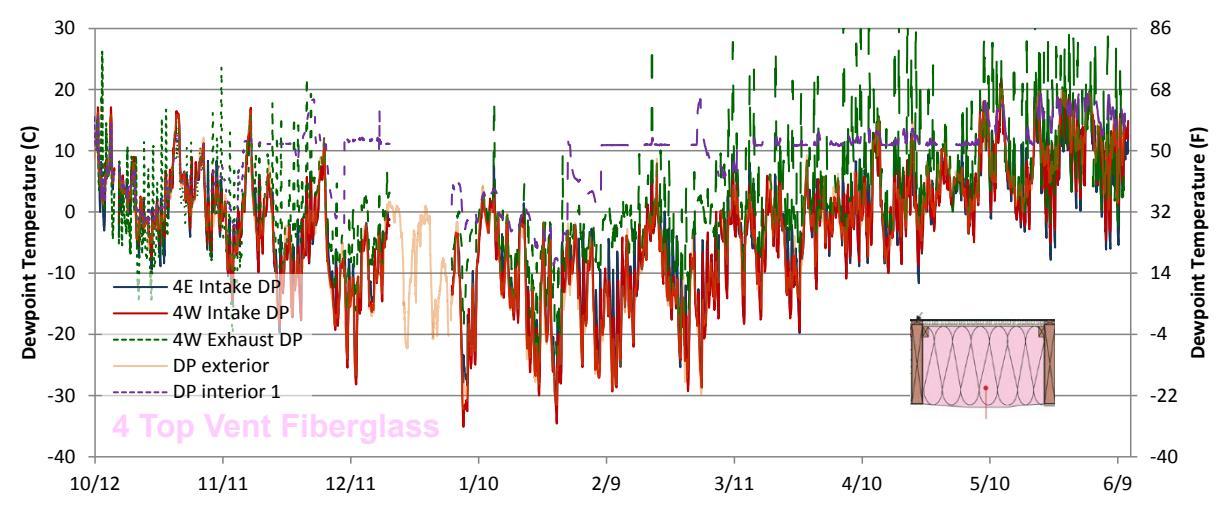
Figure 153. Intake and exhaust dew points, interior and exterior (Roof 4-top vent fiberglass)
