Wyandotte Neighborhood Stabilization Program: Retrofit of Two Homes

A. Lukachko, A. Grin, and D. Bergey
Building Science Corporation

April 2013

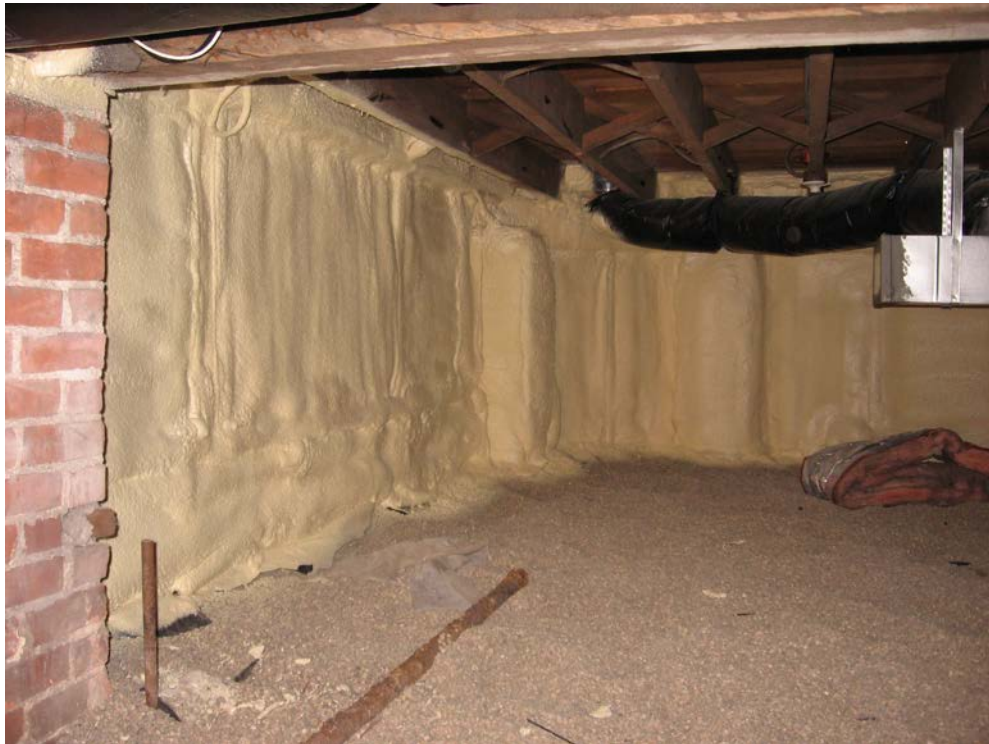
The foundation existing pre-retrofit at Cedar 1 was a combination of an uninsulated basement accessed from the exterior at the rear of the house, and an un-insulated, vented crawlspace at the front of the house. The strategy for the crawlspace was to seal, insulate, and condition this area as a conditioned crawlspace. A polyethylene sheet was placed on top of the ground and overlapped by the spray foam as a complete air barrier.

Figure 13. Spray foam installation in conditioned crawlspace at Cedar 1

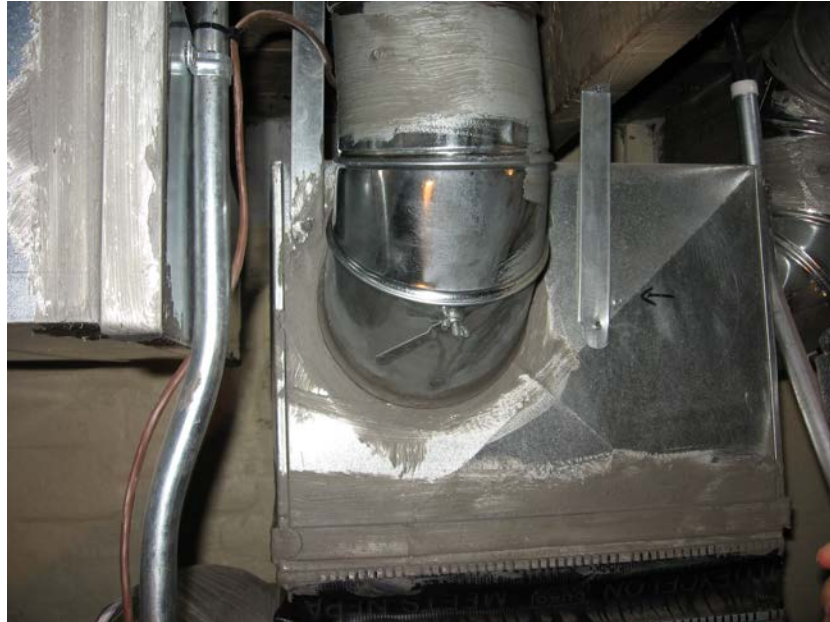
The HVAC equipment—a GSHP, hot water tank, and air handler—were installed and commissioned by the installer in Cedar 1 but not Cedar 2 at the time of this report. As specified, all ductwork joints and seals have been sealed with mastic (see Figure 14 below). Pressure testing of the ductwork system has not been completed. All ductwork has been installed inside the thermal enclosure as specified.

Figure 14. Typical ductwork sealing at takeoff from trunk; elbow to the site is sealed

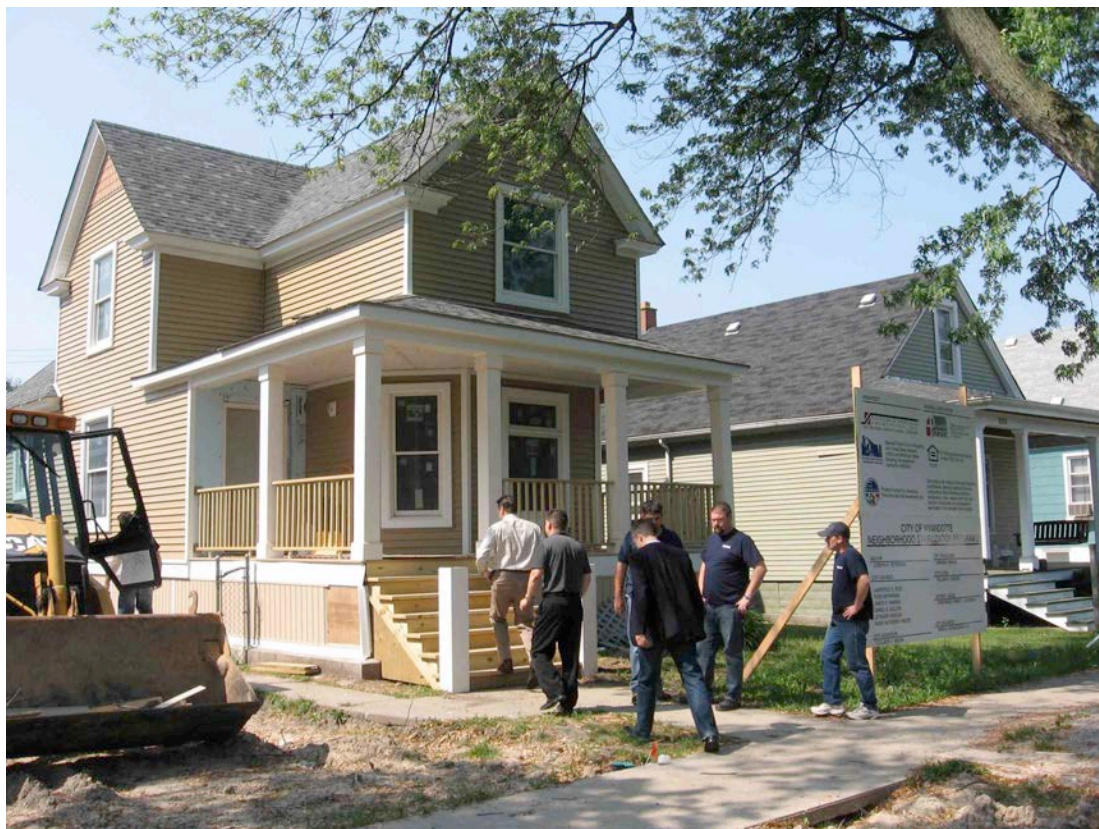
213 CEDAR STREET

This is a Bid Pack 1 retrofit project. Briefly, the house was gutted and refinished on the inside – full depth ccSPF in stud cavities. New mechanical including GSHP. The crawlspace was covered to a conditioned crawlspace. The attic was insulated as a conditioned attic. The roofing was new and left as found. The building was reclad with 1" of XPS and new vinyl. This house is ready for us to test on June 27 but we do not have pre-retrofit data on this house because construction was started during our funding gap.

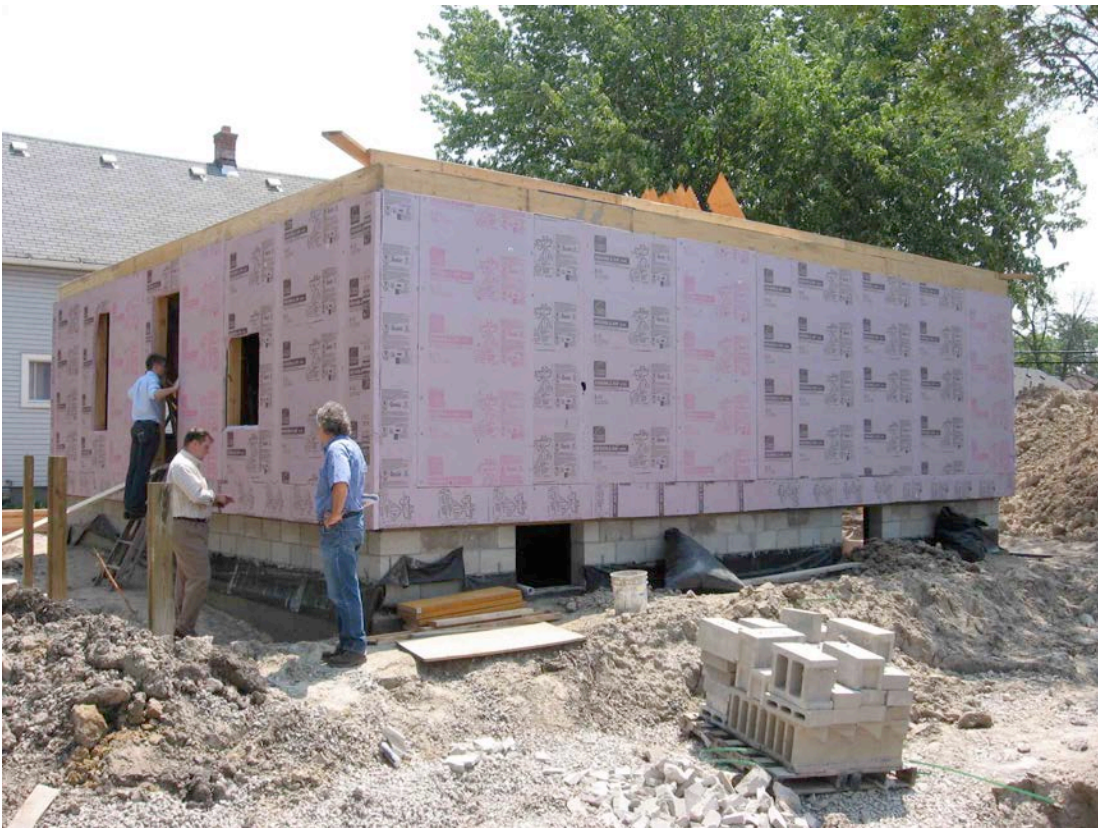
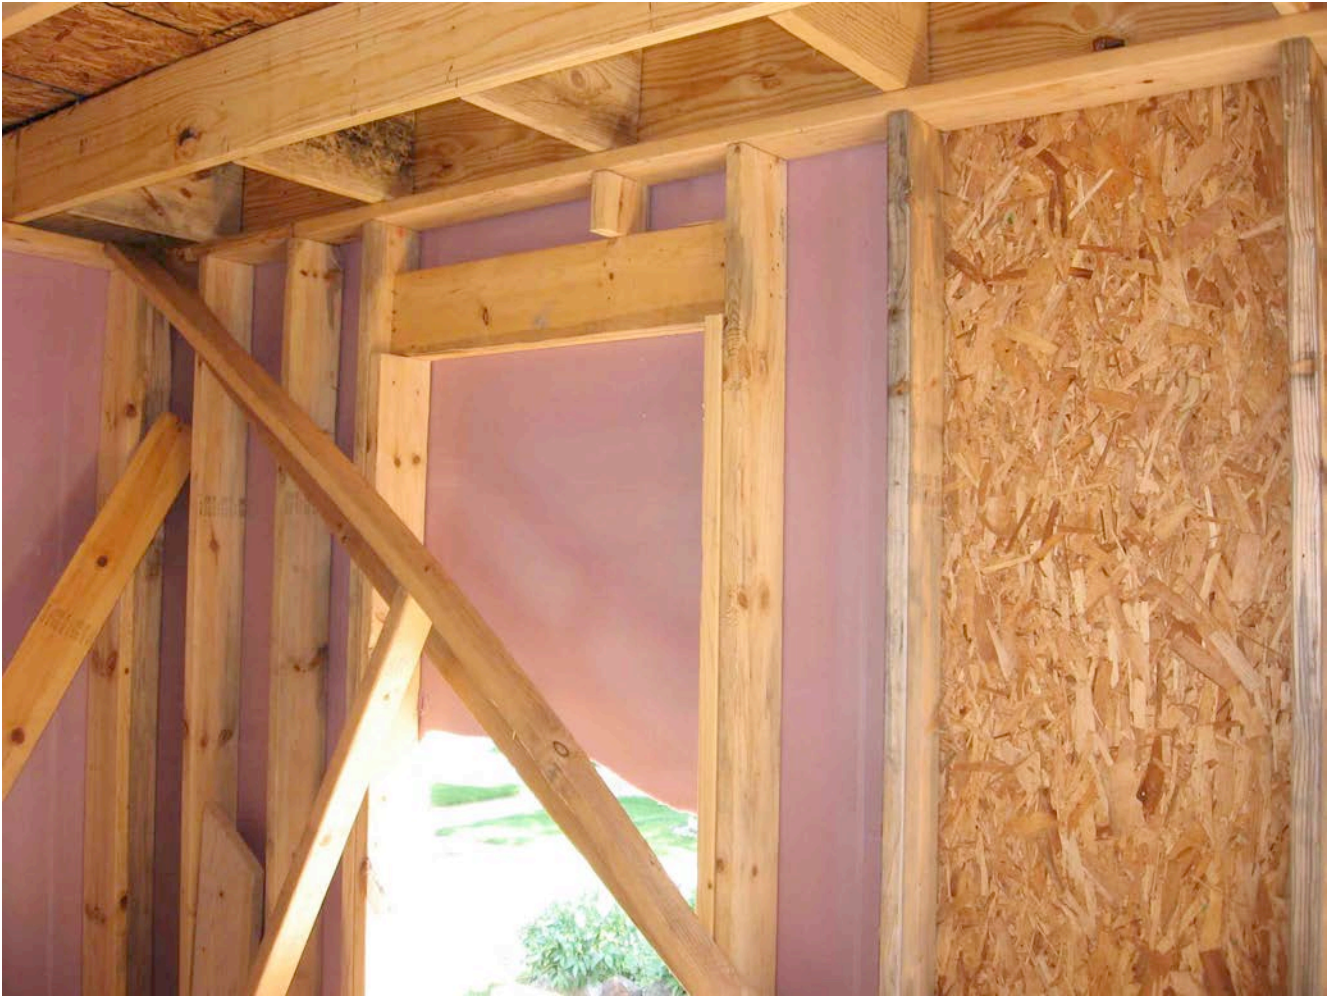
247 & 257 WALNUT STREET

These are the first two new houses in the NSP2 project. There were a number of changes made to the framing on the first one. Framing of the second house should be smoother. The above-grade portion of the basement foundation wall will be finished with brick and insulated with Thermax on the interior. 2" XPS as insulating sheathing and 3-4" ccSPF on the interior.

The window opening framing will be corrected. They were having some issues with alignment of the framing between walls and floors. This has been largely corrected by the architect. The meeting on-site included the GC, the framing crew, the lumber supplier, the mason, the architects and the City project manager. We talked through all of the details and gave them some guidance on corrections that need to be made. Aaron will issue a brief report to the architect with photos to help them with their site review. A major issue was that no framing drawings were produced. We discussed the value of this and it seems that everyone now understands what level of planning is required for these houses.

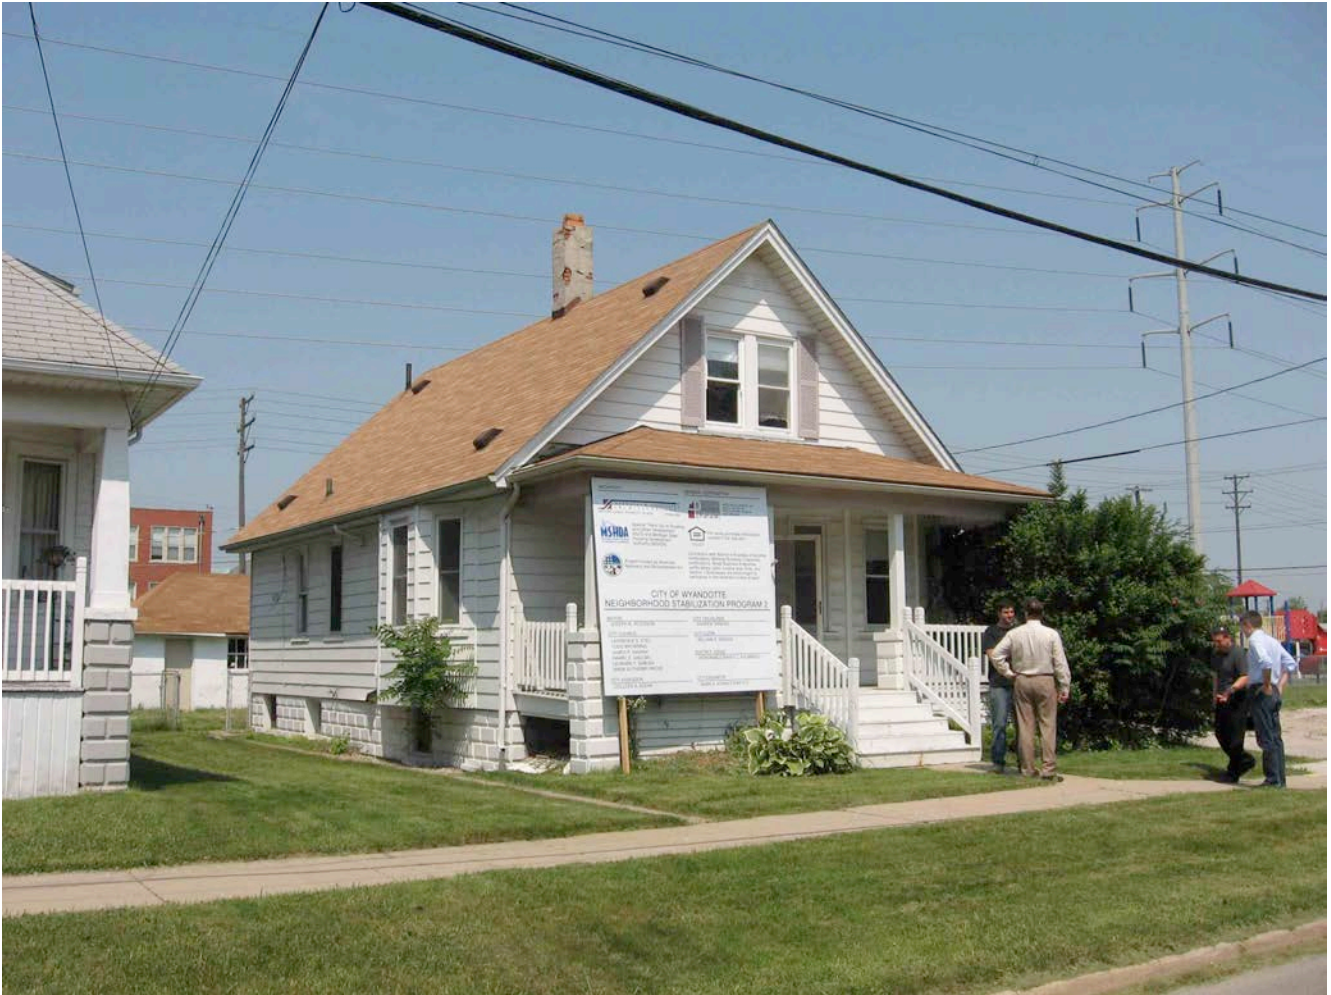
BID PACK 2 RETROFIT

This house has been assigned as part of Bid Pack 2, which was awarded to the builder who is completing work on the first houses mentioned in this report. This house will be a full rebuild from the interior with minor repairs to the exterior cladding. The basement has obvious water intrusion issues and the City is considering both trenching the exterior to install damproofing and replacing the concrete floor slab to install insulation and a capillary break.

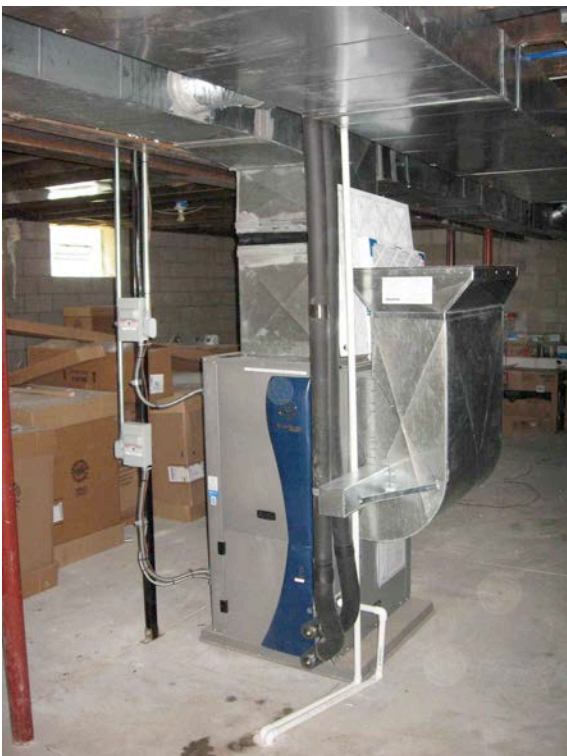
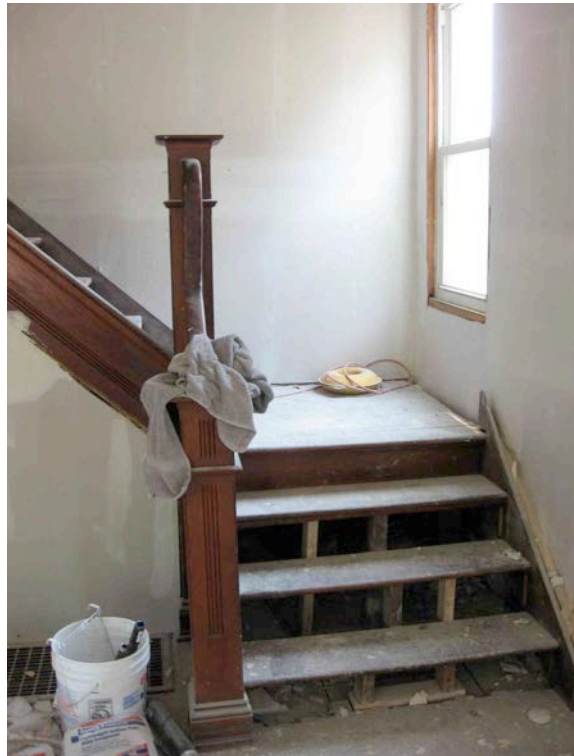
The above-grade walls have been filled with ocSPF (they are sending us the product information) and the entire exterior will be clad with XPS and new siding. I have no information about how they plan to tie the windows in to the drainage plane. There are a number of recommendations we could make if we wanted to support this project as part of the program.

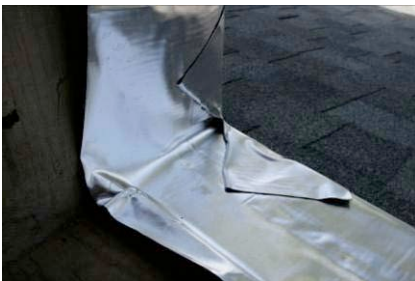
A window on the second floor had not been installed yet allowing a review of the sub-sill flashing. Care must be taken to ensure reversed flashings, gaps, or fish mouths do not occur. Shown in the photo below, a gap has been left in the corner flashing of the sub-sill flashing. This has the potential to direct water on the subsill flashing behind the insulating sheathing which is intended to be the drainage plane. This has the potential to cause moisture related damage to the structural sheathing.

2011-08-28 – Gap in corner flashing

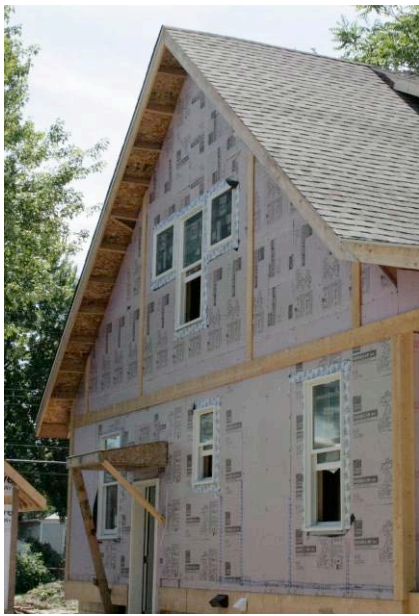
Water management details at the windows need some improvement - flashing was observed to be sealing the bottom of the window, rather than being drained. It was recommended that the flashing across the bottom of the window be slit or removed completely. BSC also recommended back dams on window openings. As recommended the flashing across the bottom of the window was removed in most areas. The east facing windows of the home on the first and second floor still require that the flashings along the bottoms of the windows be removed. There also areas within the field of the wall where the joints between the sheets of XPS must be sealed as the primary drainage plane. The windows above the front porch also require attention to repair the flashings.

Areas where flashings below the windows need to be removed

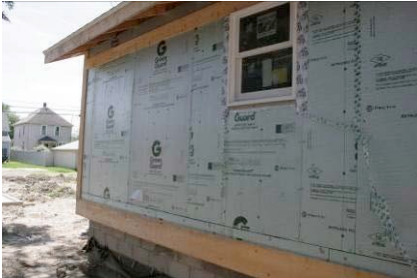
<p>Failing and completely missing tape</p>

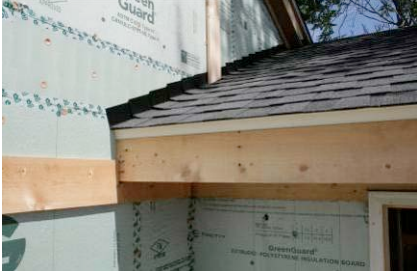
<p>Step flashing requiring integration to the drainage plane. Details to finish this flashing with a regletted cap flashing and tape can be found at:</p> <p>http://www.buildingscience.com/documents/information-sheets/common-flashing-details/files/bsc_info_303_common_flashing.pdf</p>

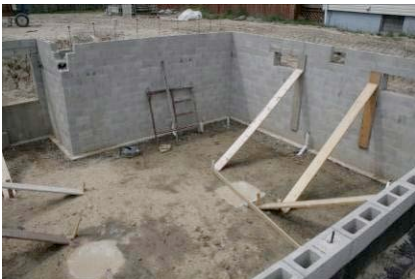
2406 8th Street (Mid, west side of the road)

2011-08-22 – Foundation complete, missing capillary break
2011-10-06 – Foundation complete, nothing else to report

During the August 22nd site visit it was found that the block foundation was complete for this house. Exterior parging and dampproofing were complete but a footing capillary break did not appear to be present. It was observed during the October visit that the foundation for this house was installed.

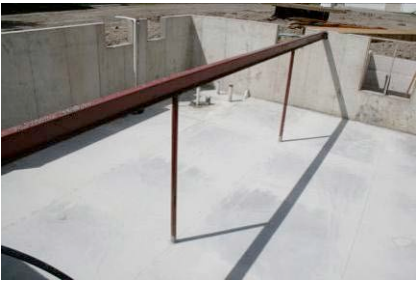
234 Chestnut

2011-08-22 – Foundation and basement floor complete. The status of the capillary break is unknown
2011-10-06 – Site not visited during this trip

During the August 22nd site visit it was found that the poured foundation was complete for this house. Exterior dampproofing was complete but it could not be determined if a footing capillary break was installed as the basement slab was already poured. This site was not visited during the October site visits.

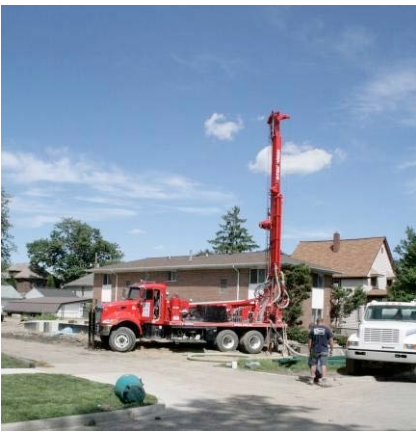
2011-08-22 – Drilling of the geothermal wells in progress

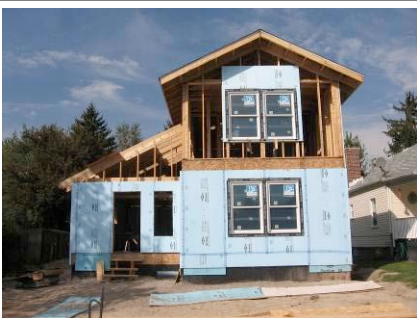
2011-10-06 – Framing substantially complete. Insulated sheathing was removed in locations to determine fastening pattern for SIS.

During the August 22nd site visit it was found that the poured foundation was complete for this house. Exterior dampproofing was complete but it appeared that the footing capillary break was improperly installed at the inside joint between the footing and the foundation rather than between the footing and the foundation before the foundation was poured. The crack appears to be due to the fact that the foundation was back filled before the floor of the house was installed and, as reported by Ralph Hope, before shoring was installed.

During the October site visit this site seemed to be in a state of disassembly and repair. Sections of roofing were left uninstalled. Areas of the exterior insulation and SIS had been removed while the electrical and mechanical was at rough-in.
