## **Codes and Standards Analysis**

Dr. Michael R. Swain  
Patrick Filoso  
Dr. Matthew N. Swain  
University of Miami  
Coral Gables, FL 33124

The following report contains work on three separate tasks. They are as follows:

Task A -- Safety Analysis of California Fuel Cell Partnership Building  
Task B -- Development of Method to Determine Hydrogen Sensor Placement  
Task C -- Safety Analysis for writing of codes

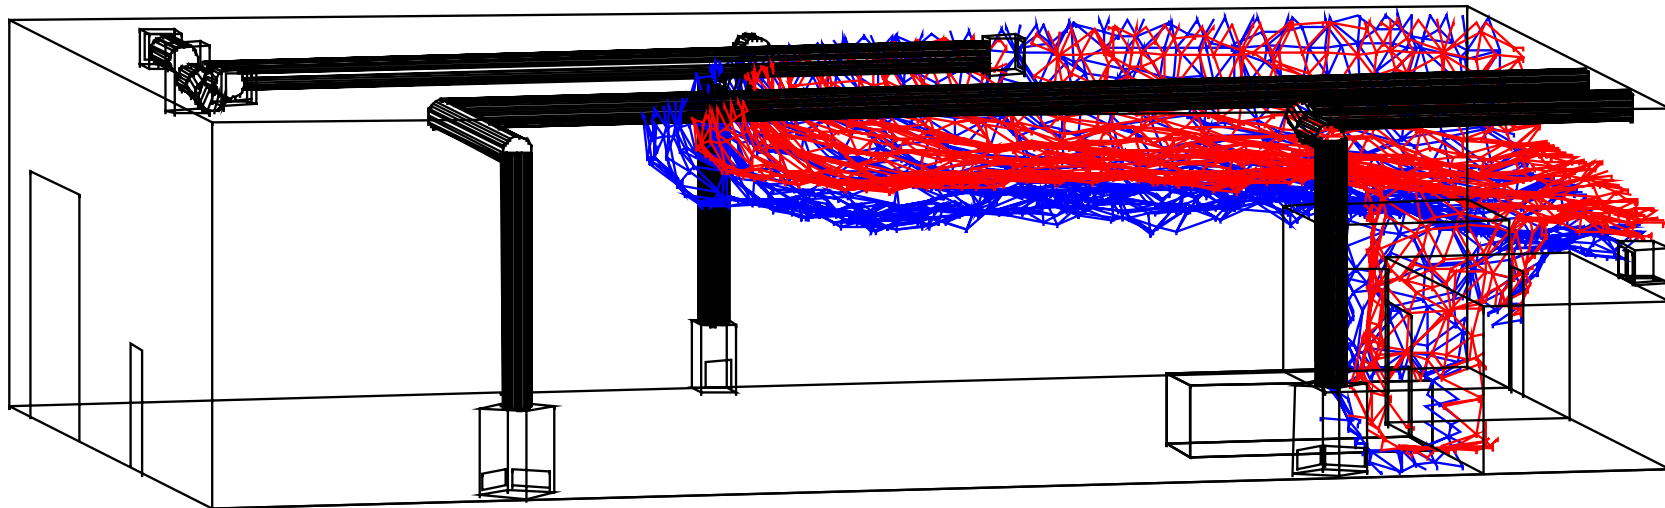
**Figure A 12**

Exhaust: 2100 SCFM  
A/C: 4400 SCFM  
H<sub>2</sub> Leak: PRD release  
Red – 4.1%  
Blue – 1.0%

10 seconds

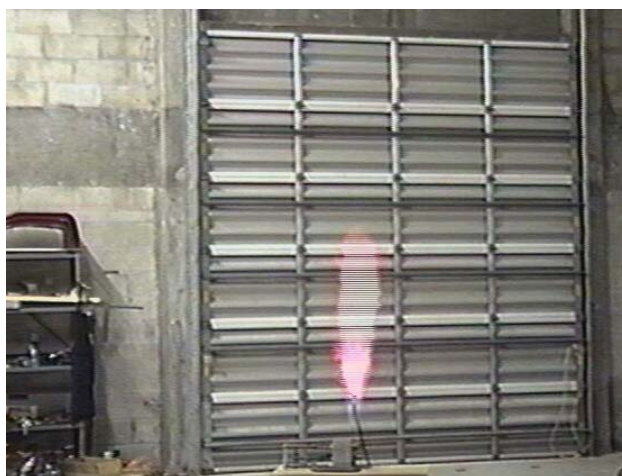
**Figure A 17 - First frame from video**

Two frames from a video of the leak (figures A17 and A18) show the flame propagation. Each frame contains two pictures of the flame taken 1/60 second apart. As can be seen in figure A17 during a portion of the first 1/60 second that the flame reaches a height of 0.41 m (1.3 ft). During the following 1/60 second the flame reaches a height of 1.22 m (4.0 ft). As can be seen in figure A18 the flame reaches a maximum height of 1.52 m (5.0 ft) in the third 1/60 of a second. And finally settles into a standing flame during the last 1/60 of a second.

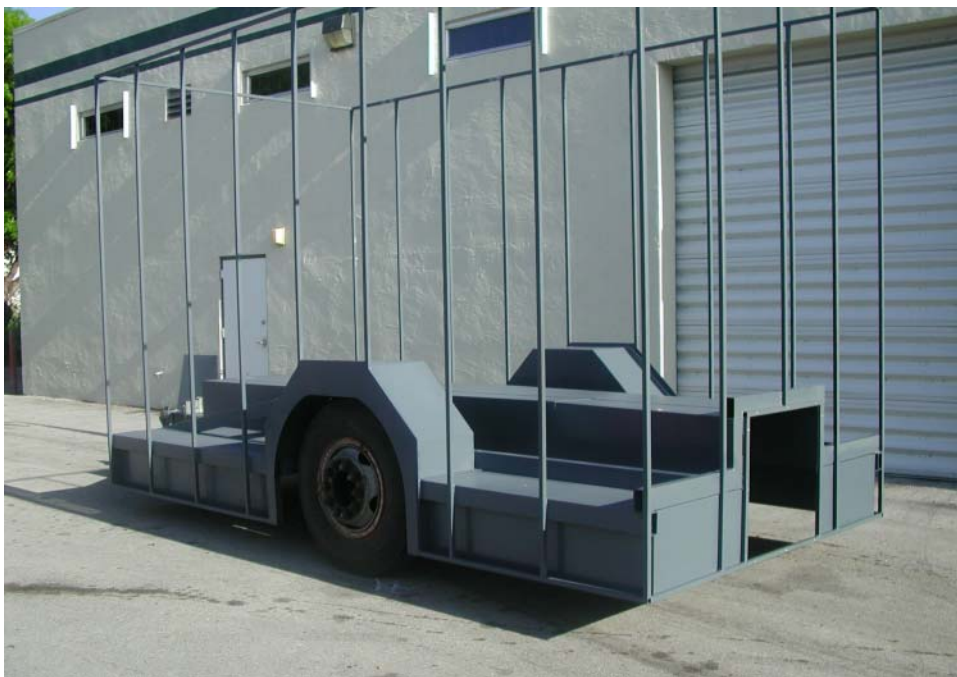
**Figure A 20 – Full scale model of front half of bus**

The ignition of hydrogen air mixtures trapped under vehicles creates a rapid pressure increase under the vehicle. This is called overpressure, referring to the increase above atmospheric pressure. These have been previously measured for hydrogen air mixtures trapped in a bus wheel well and were found to be less than 1.37 kPa (0.2 psi) for leak rates up to 5 SCFM of pure hydrogen. Those values were substantially lower than the theoretical supplementary predictions because the constraints of fluid dynamics cause most of the hydrogen air mixture to be either too rich or too lean to burn rapidly. This work is to show the possible overpressure created by ignition of hydrogen air mixtures trapped under vehicles. A full-scale model of the front half of a bus was constructed (Figures A20 and A21). It was used to experimentally determine how large an overpressure can be created by hydrogen leaking under the vehicle. Leakage rates up to 13 CFM were tested (Figures A22 and A23). Overpressures never exceeded the 0.21 kPa (0.03 psi) detectability limit of the instrumentation.

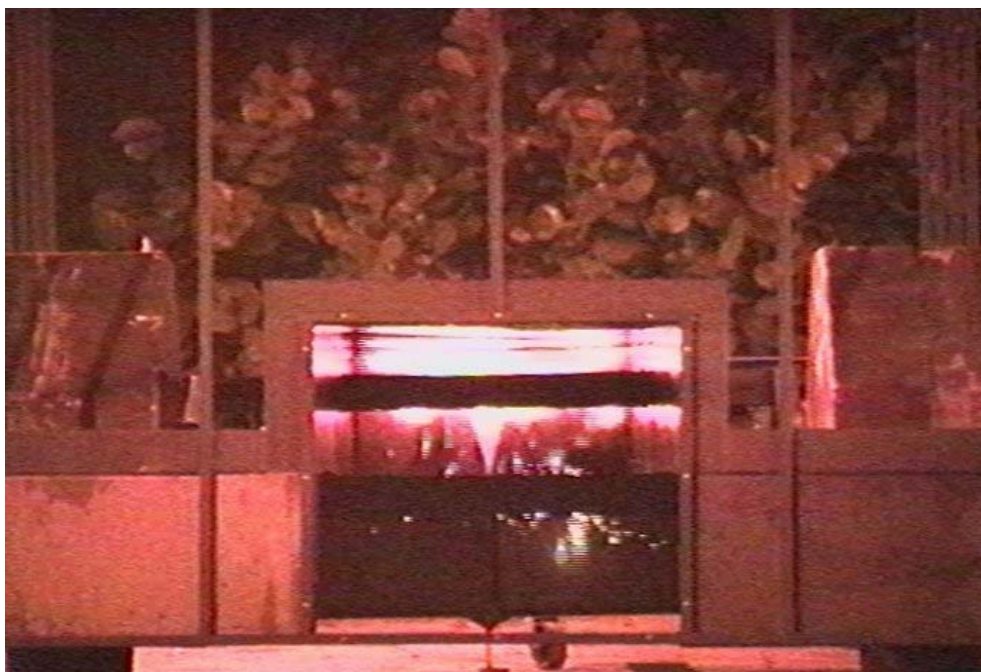
**Figure A 23 – Ignition of 13 SCFM hydrogen leak under bus**

The tunnel was the first volume to fill with hydrogen. The battery storage areas could have been vented to further reduce hydrogen accumulation, but such vents were not used for these tests. Figure A 22 is a computer model of hydrogen leakage into the tunnel. Surfaces of constant hydrogen concentration are displayed in various colors on the figure. The value of hydrogen concentration as indicated by the color. The leak occurred at the left end of the tunnel. Note that there are higher concentrations closer to leak. The tunnel was closed at the left end. Hydrogen could not exit that and of the tunnel unless it was lower than 0.9 ft. from the ground. The hydrogen air mixture was ignited directly above the leak where the gas mixture was in excess of 25% hydrogen. Leaks were ignited after forty minutes of leakage when the flow had stabilized. Figure A 23 shows an ignition of the hydrogen. The leak is seen as a triangular wedge of flame extending up from the leak source.

6. The maximum recorded overpressure created by 13 SCFM hydrogen leak under the full-scale model of the front half of a hydrogen fueled bus was less than 0.21 kPa (0.03 psi).

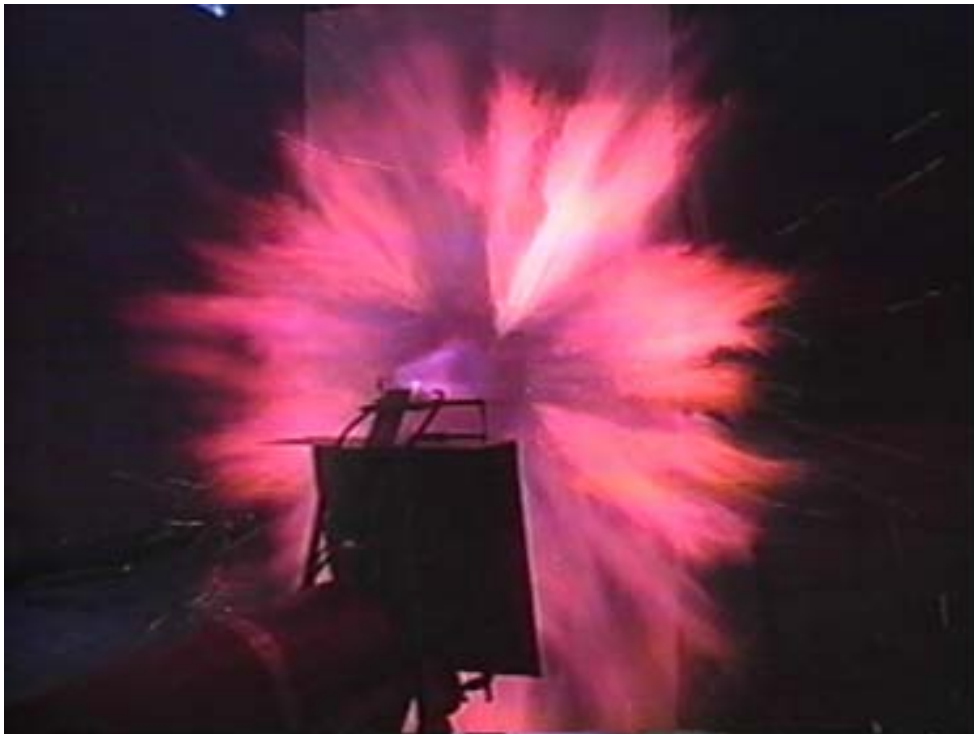
**Figure C 2 – Hydrogen flame impingement, early in burn**

The use of hydrogen fuel vehicles inside wood frame structures may result in hydrogen flame impingement on interior walls. The gypsum board that covers the wood frame can be installed in a variety of ways dependent on code requirements. Tests were run to determine the amount of damage done by hydrogen flame impingement on gypsum board mounted on two by four wood frames. The test utilized 0.77 kg (1.7 lbs) of hydrogen vented in 100 seconds beginning at a flow rate of 1000 SCFM. The jet was placed 0.76 m (2.5 ft) away from the gypsum board as this distance was found to produce the maximum heat transfer in previous tests. Five tests were performed (See Table C1). Figure C1 – C3 show photos of the testing.

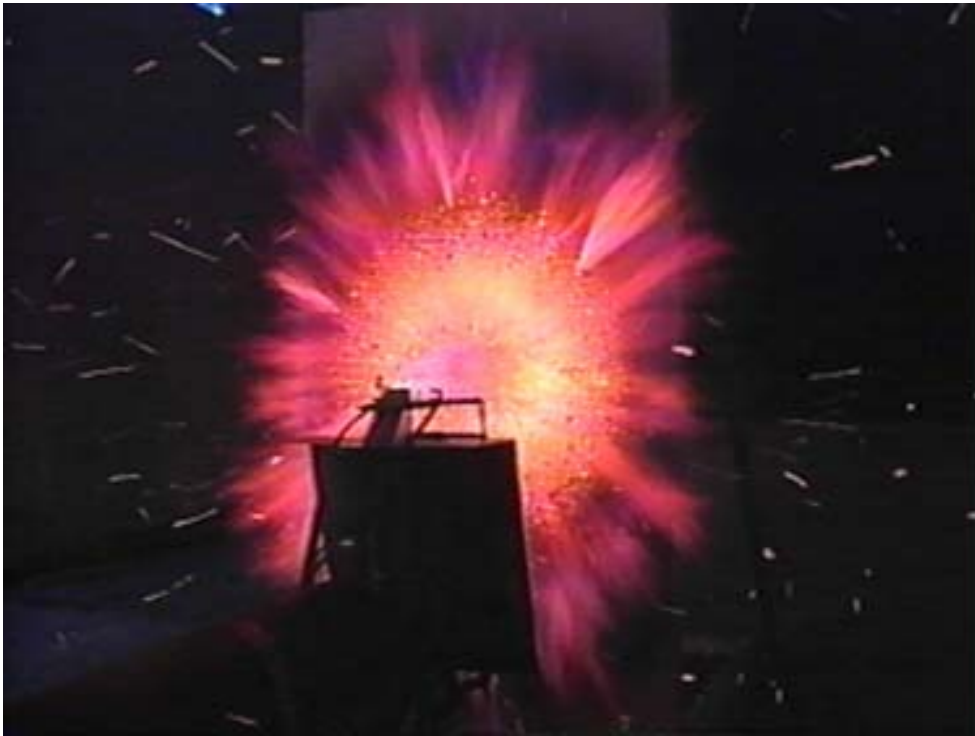
Figure C 3 – Hydrogen flame impingement on gypsum wallboard (paper cover burning)
