## Builders Challenge

Comprehensive Energy Retrofit

# Clifton View Homes

Clifton View Homes's remodel of a 1962 rambler cut energy costs by two-thirds.

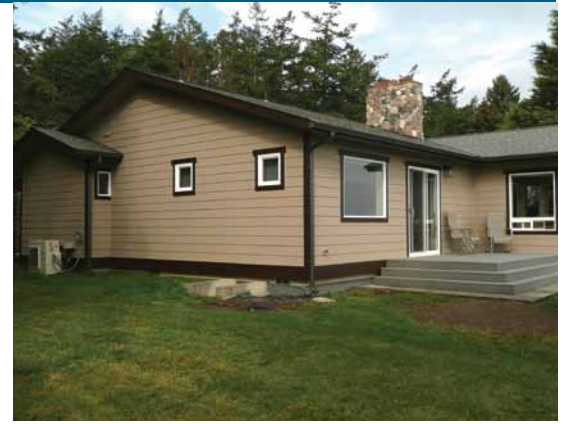
Visible here on the home's southeast side is one of the outside units for the ductless heat pump system that replaced the home's ancient furnace and leaky ducts, providing efficient, ductless, zoned heating and cooling.

The 48-year old furnace and patchwork of leaky ducts were replaced with a 9-HSPF ductless mini-split heat pump system consisting of two outside units (one at each end of the house) and eight inside heads for energy-efficient, zoned heating and cooling.
