## COMPREHENSIVE ENERGY RETROFIT

### Case Study: Asdal Builders, LLC Pittsburgh, PA

Asdal Builders achieved a HERS score of 65 and cut energy use by 80% with a gut-rehab of this 1930s era Pittsburgh home.

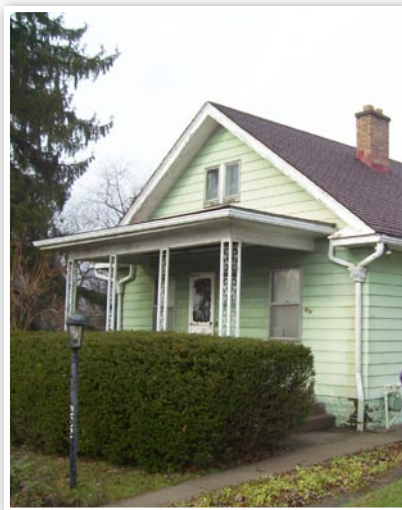
Pittsburgh home pre-retrofit.

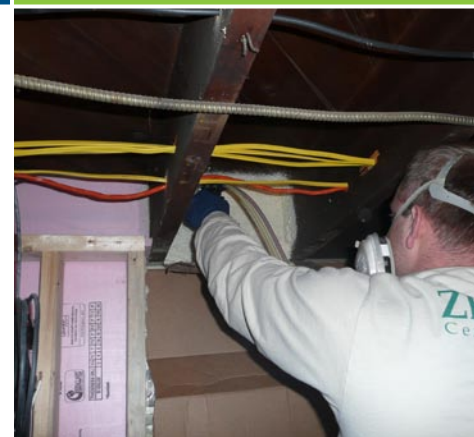
Spray foam was applied around piping and wiring holes and around pieces of rigid foam fitted in the rim joists

Band joist areas air sealed with spray foam and rigid foam

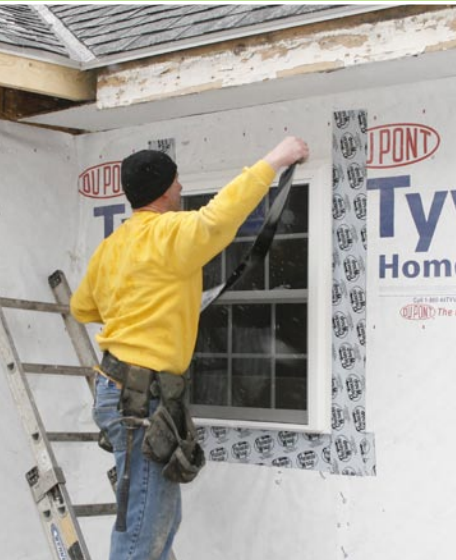
Energy-efficient windows were flashed and integrated into the housewrap.
