Operation Helping Hands Green Dream 2 Prototype

Case Study
New Orleans, Louisiana

OVERVIEW

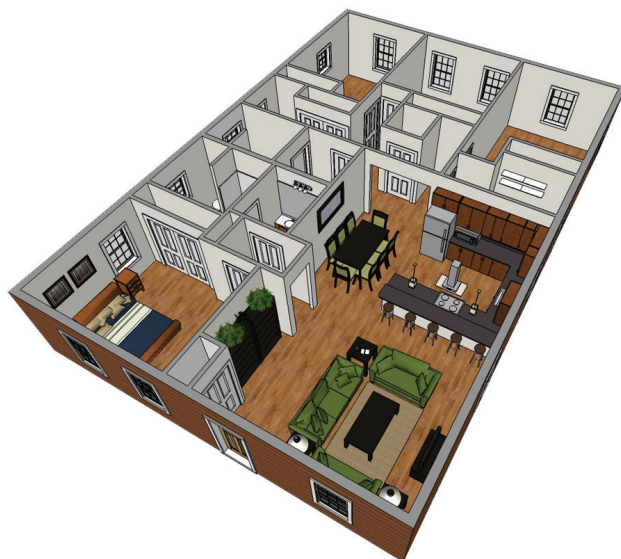
U.S. Department of Energy
EnergySmart Home ScaleSM

Estimated annual energy usage:
Electric (kWh) 7291
Natural Gas (therms) 182

Estimated monthly energy costs: \$131

56

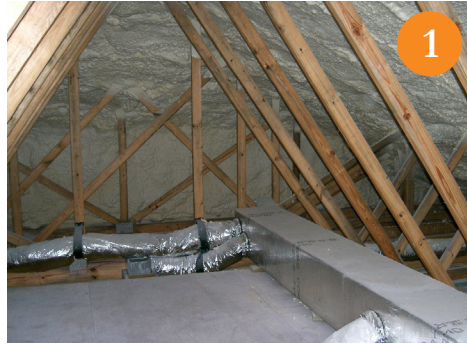
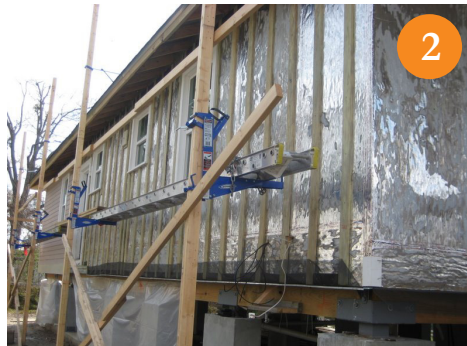
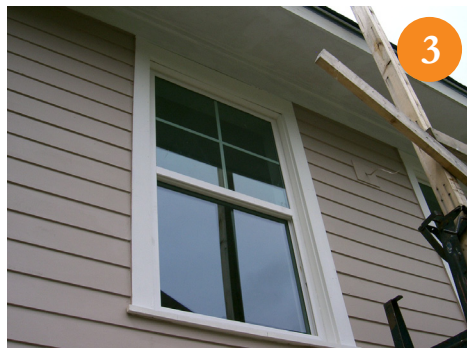
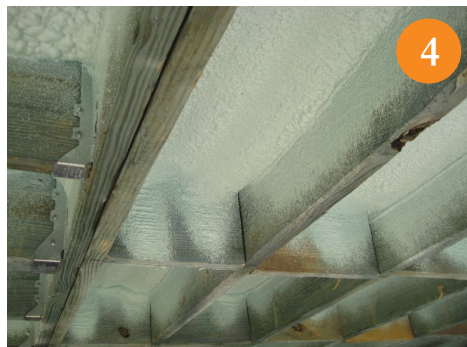
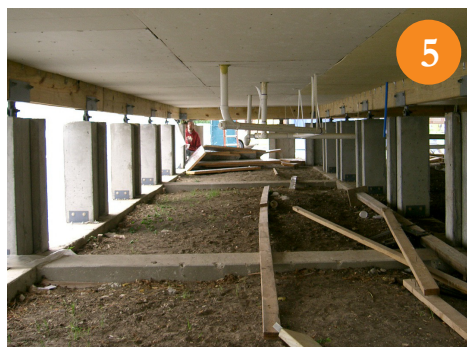
ENCLOSURE DESIGN

1 Roof Assembly: Truss-framed unvented attic with R-30 roof insulation: 7" medium-density (0.8 pcf) open cell spray foam below roof sheathing, 5/8" treated plywood roof sheathing, fully-adhered roof membrane, high wind-rated asphalt shingles installed over the trusses, 1/2" paperless drywall installed below trusses.

2 Wall Assembly: 2x4 treated walls at 16" o.c. with R-13 wall insulation: stud bays left open, 1/2" treated plywood, housewrap, 2" foil-faced polyisocyanurate insulating sheathing, 3/4" treated furring strips and fiber cement siding installed on outside face of studs, 1/2" paperless drywall installed on inside face of studs.

3 Window Specifications: Showcase Custom Vinyl Windows and Doors single-hung, double pane, spectrally selective, impact rated Low-E: U=0.40, SHGC=0.21.

4 Air Sealing: Maximum 2.5 in² leakage area per 100 ft² of enclosure area. Critical seal air sealing approach with spray foam in both roof and floor assemblies and airtight drywall approach used in wall assembly. Adhesives and sealants used between framing members, around windows and doors, and at all mechanical and electrical penetrations through the enclosure.

5 Foundation and Floor Assembly: Wood pile, concrete grade beam and adjustable pier foundation, treated joist-framed floor on treated sill beam with R-15 floor insulation: 2.5" high-density (2.0 pcf) closed cell spray foam between floor joists, 1/2" fiber cement protection board installed below floor joists.

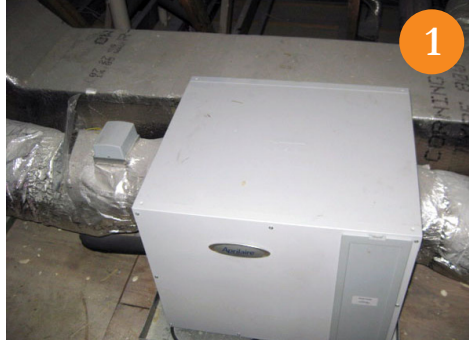
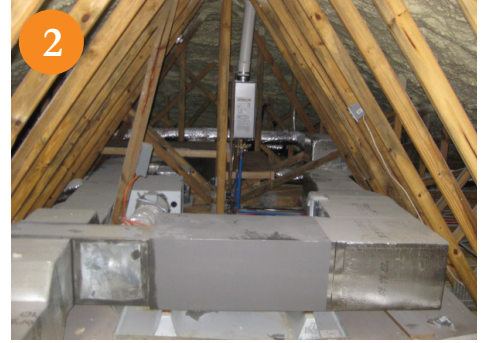
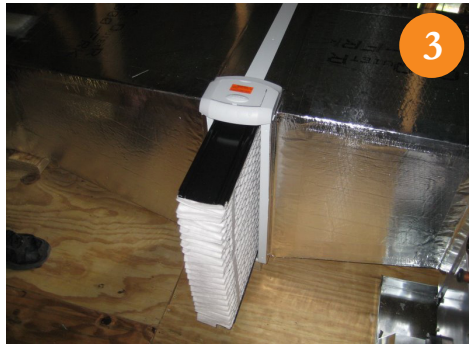
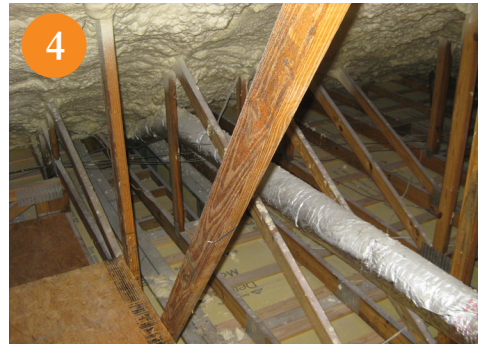
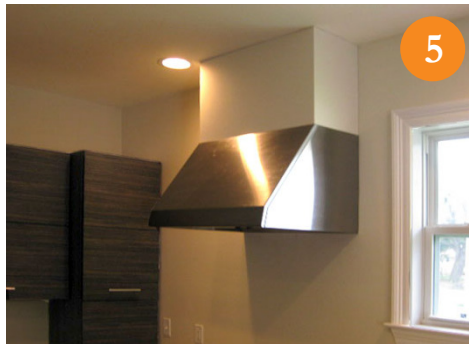
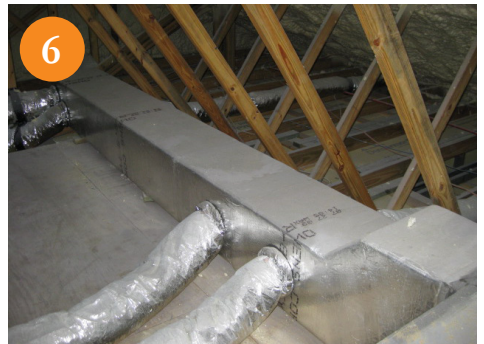
MECHANICAL DESIGN

Heating, Cooling and Dehumidification: 9.0 HSPF/15.5 SEER air source heat pump split system with ① supplemental whole house dehumidification. ② Interior unit installed in conditioned attic with ③ MERV 13 filter.

Ventilation: Central fan-integrated with supply only ventilation system controlled with built-in controls in dehumidifier. ④ Outside air ducted to the return side of the air handler including both motorized and manual dampers.

Local Exhaust Ventilation: Intermittent spot exhaust provided in bathrooms and ⑤ kitchen.

Space Conditioning Distribution: Air handler with sheet metal plenums and ⑥ R-6 duct board supply trunk and R-6 flex duct run-outs installed in conditioned space. Ducted central return, dehumidifier return and transfer grilles above bedroom doors.

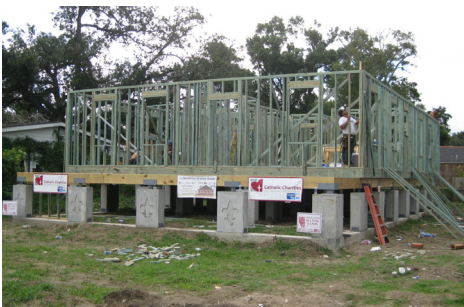
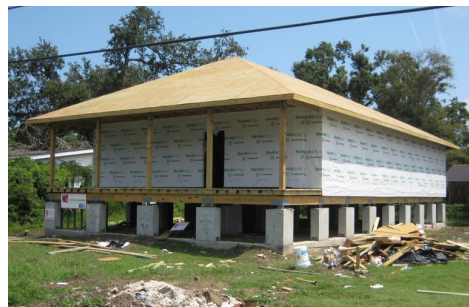
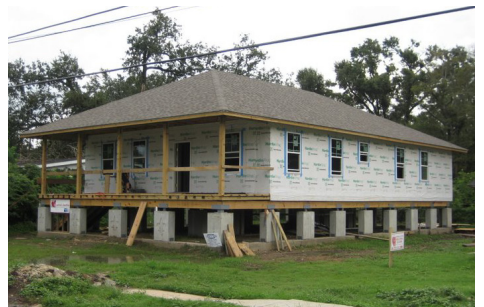
CONSTRUCTION

Construction began in June 2009 with the driving of the wood piles for the foundation. Concrete grade beams were poured over the piles and telescoping concrete piers were set on the grade beams. On top of this foundation, both borate pressure treated and ACQ pressure treated wood was used to frame the house and porches. Throughout the construction, a Catholic Charities

Once the housewrap was in place on the treated plywood, the project team held a window installation demonstration for volunteers and industry professionals.

The window installation sequence from the drawing set was followed step by step as project team members assisted volunteers in installing Green Dream 2's sixteen windows.

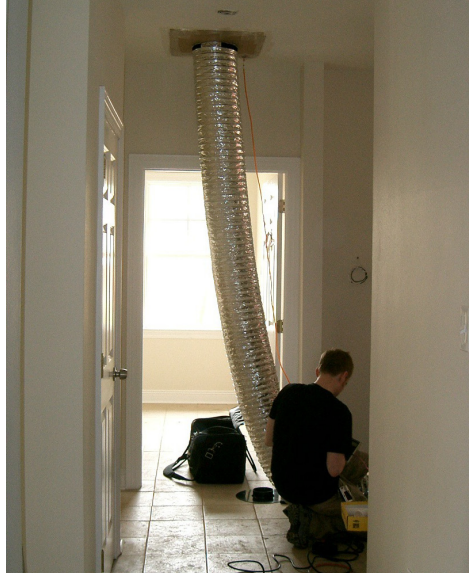
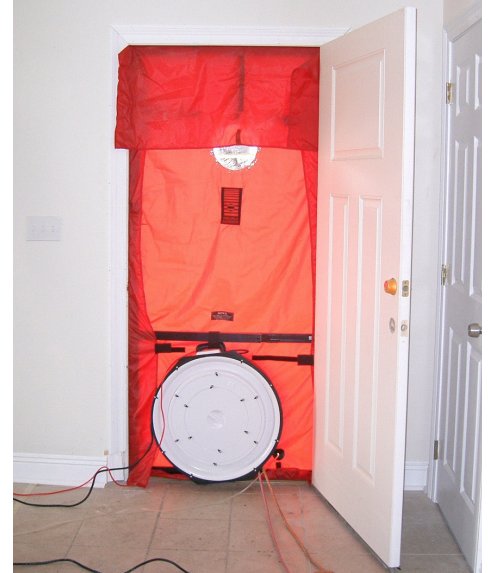
TESTING

During the design phase of the project, performance goals for overall house airtightness and duct leakage were set for Green Dream 2. While construction was wrapping up, BSC performed both a blower door test and a duct blaster test to find out if the goals were met.

BSC's maximum air leakage target is 2.5 in² per 100 ft² of enclosure area. For Green Dream 2, this is equal to 1590 CFM 50. When tested, the air leakage was 1123 CFM 50, well below the maximum CFM 50, meeting our set goal. BSC's performance target for total duct leakage is 10% of total system CFM while the performance target for duct leakage to outside is 5% of total system CFM. Green Dream 2 has a 2-ton system installed, equal to 800 total system CFM (400 CFM per ton). Results from the duct blaster showed no measurable duct leakage to outside and only 50 CFM total duct leakage. Both

results greatly surpass the targets of 40 CFM duct leakage to outside and 80 CFM total duct leakage. In addition to the duct blaster and blower door tests, room by room air flows were tested using a flow hood and all found to be as designed.

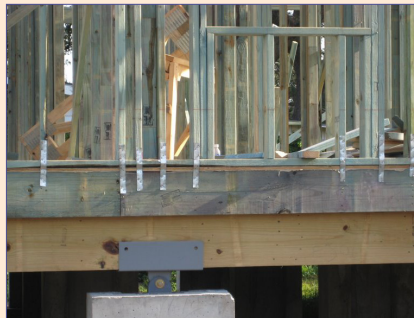
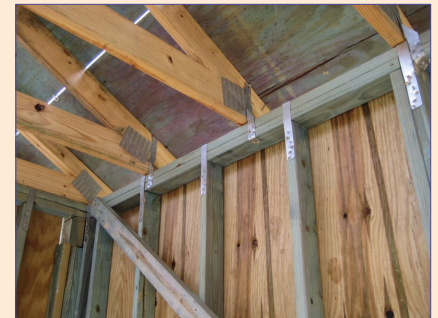
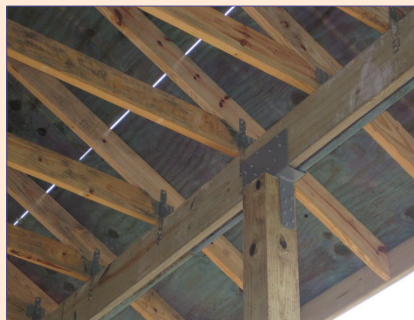
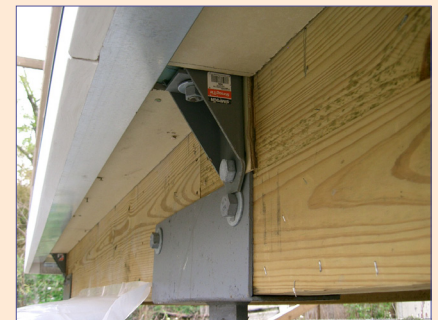
DESIGN HIGHLIGHT: HIGH-WIND CONNECTORS, THE PRESCRIPTIVE PATH

Upon opening the International Residential Code, you will quickly find that the IRC does not cover framing for houses in high-wind zones. Rather, it suggests you design your structure using any of the given references. Green Dream 2 was designed using the Wood Frame Construction Manual, 130 mph, Exposure B. The prescriptive path in the manual was followed, and along with catalogs of high-wind connectors, a schedule of types, quantities and locations was created. Installed correctly, the combination of high-wind connectors ensures the home will resist loads present during a high-wind event.
