DOE ZERO ENERGY READY HOME™ CASE STUDY

BPC Green Builders

New Fairfield, CT

• Name: Candlewood Hills Rebuild

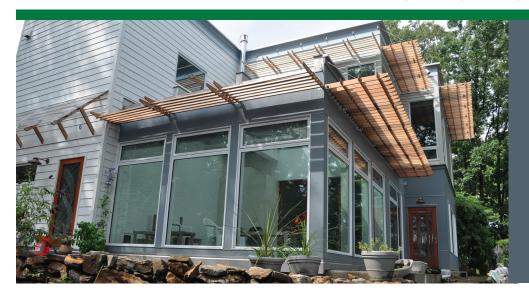
Nearly every room and closet in the home receives natural light through triple-pane low-emissivity windows or insulated solar tubes. Extra attention to air sealing helped the home achieve a very low air leakage rate of 0.45 ACH 50.
