**DOE CHALLENGE HOME  
CASE STUDY****Weiss Building &  
Development, LLC**System Home  
River Forest, IL

**BUILDER PROFILE****Weiss Building & Development LLC**Brandon Weiss, builder  
630-485-1818, Brandon@weissbd.com  
Chicago, IL  
[www.weissbd.com](http://www.weissbd.com)**FEATURED HOME/DEVELOPMENT:****Project Data:**

- Name: Chicagoland's First Certified Passive House
- Location: River Forest, IL
- Layout: 5 bedroom, 4.5 baths, 3 floors
- Conditioned Space: 4,763 ft<sup>2</sup> w/ bsmnt
- Completion: January 2013
- Climate Zone: 5A
- Category: System

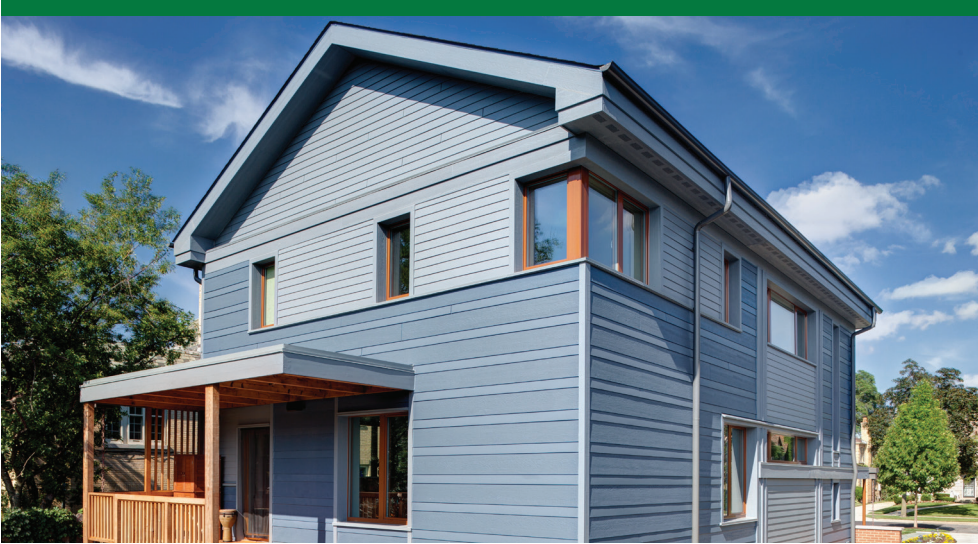
The home meets the Passive House Institute's strict criteria for air tightness and insulation. The builder employed several types of insulation and flashing in the 19-inch-thick walls and roof to provide redundant layers of protection against the elements.
