## **E. Aluminum Automotive Closure-Panel Corrosion Test Program (AMD 309<sup>i</sup>)**

### **Objective**

- Develop a standardized cosmetic corrosion test for finished aluminum (Al) automotive body panels that provides a good correlation with in-service testing and field performance.

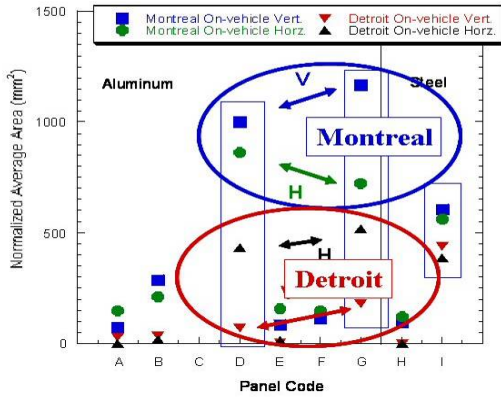
**Figure 2.** Normalized average area: Detroit and Montreal with two years exposure.

From the preliminary on-vehicle results it is apparent that the panels with metal finishing (D & G) generally have more corrosion than the other Al substrates and that the cold-rolled steel (I) has more corrosion than the electro-galvanized steel (H). The normalized average area from on-vehicle service relevant exposures in Detroit and Montreal are plotted in Figure 2. Based on these preliminary on-vehicle results, accelerated tests that also show a significant difference between the substrates with metal finishing (i.e., sanding) and those without metal finishing would appear to correlate better with the preliminary observations from on-vehicle testing. Many of the accelerated lab tests in the initial round of tests did not show a significant difference between the substrates with and without metal finishing. Of the initial set of laboratory test methods evaluated in the program, only the APGE (one lab only), ASTM G85-A2 test and HCl dip tests appeared to show a significant difference in corrosion performance between the substrates with metal finishing (i.e., sanding) and those without metal finishing.

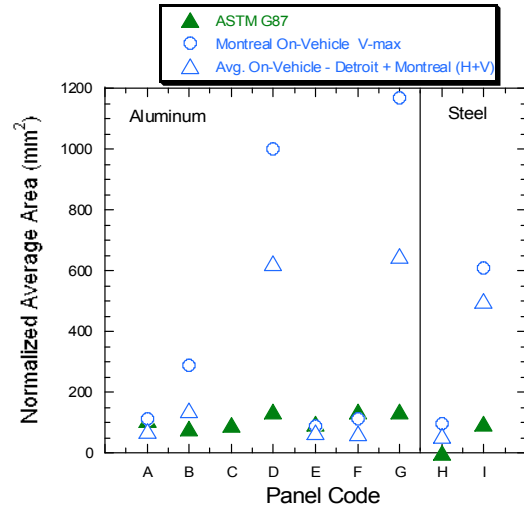
**Figure 9.** ASTM G87 round-robin tests – 500 hours with results from the worst-case on-vehicle (Montreal).

The limited results from the two sulfur bearing tests are shown in Figures 8 and 9. To date, these tests have only been run at one lab each. The results for the salt/SO<sub>2</sub> fog test (ASTM G85-A4) show significant corrosion on most of the panels.

The lone set of results for the moist SO<sub>2</sub> test (ASTMG87) illustrated in Figure 9 shows very little corrosion on any of the substrates and does not appear to have differentiated the substrate groups in the manner observed in the on-vehicle tests.

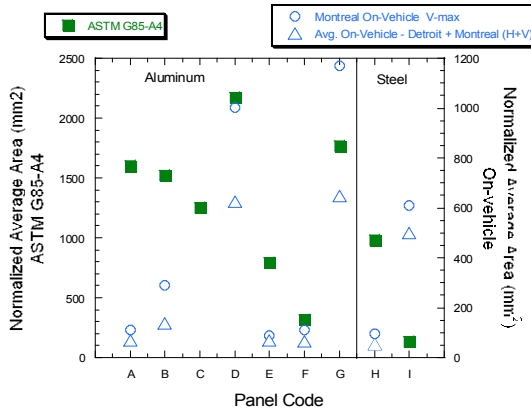
**Figure 8.** ASTM G85-A4 round-robin tests – 500 hours with results from the worst- case on-vehicle (Montreal).

Although the D and G substrates have the most corrosion, this test method as conducted does not appropriately differentiate D and G from the other substrates (A, B, E) which have far less corrosion in the on-vehicle exposures than was observed in the ASTM G85-A4 test. This test method also appears to be more severe for galvanized steel than for cold-rolled steel which is opposite of the on-vehicle exposures as illustrated in Figure 8.
