Initial results of IEC 62804 *draft* round robin testing

Peter Hacke and Kent Terwilliger NREL, USA Simon Koch, Thomas Weber, and Juliane Berghold PI-Berlin, DE Stephan Hoffmann and Michael Koehl Fraunhofer ISE, DE Sascha Dietrich and Matthias Ebert Fraunhofer CSP, DE Gerhard Mathiak TÜV Rheinland, DE

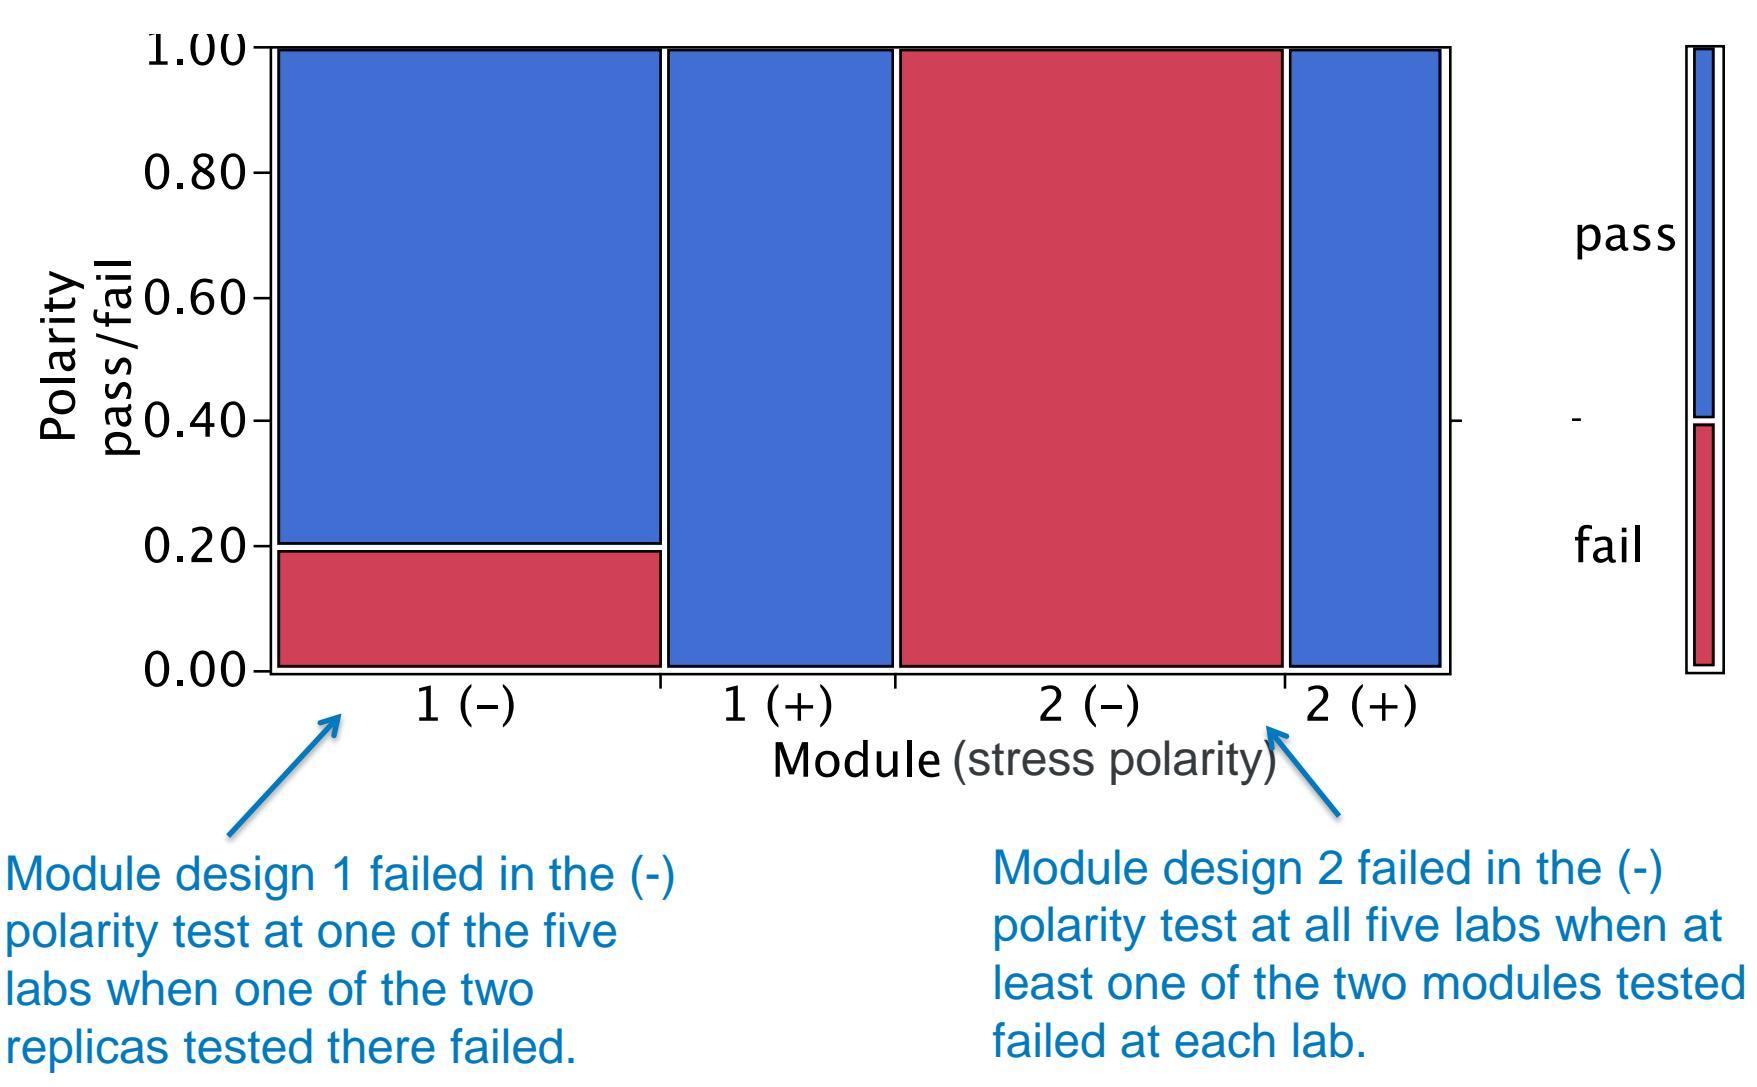
Overview of pass/fail results of two different module designs tested at 5 labs

Pass/fail condition: If 1 or 2 modules tested in a polarity fail (Pmax drop > 5%), that design is considered failed in that polarity at the given test lab

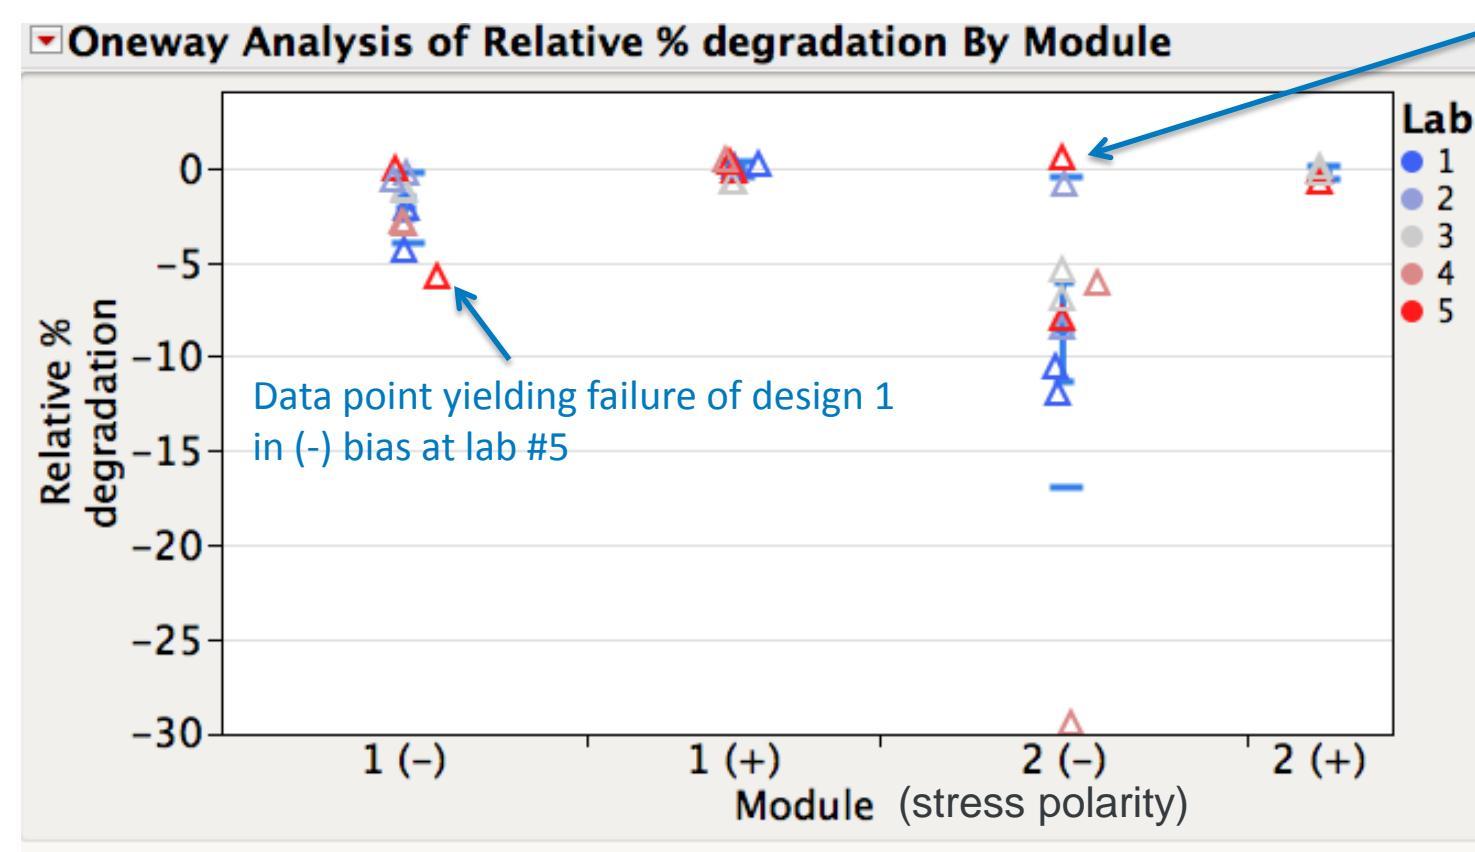
Considering stress in (-) bias, module design 1 shows both smaller mean degradation and standard deviation of degradation than design 2

Std Err		
Level	Number	Mean	Std Dev	Mean	Lower 95%	Upper 95%
1 (-)	10	-2.1240	1.87072	0.5916	-3.46	-0.786
1 (+)	8	-0.1021	0.43217	0.1528	-0.46	0.259
2 (-)	10	-8.6960	8.22389	2.6006	-14.58	-2.813
2 (+)	4	-0.2900	0.31602	0.1580	-0.79	0.213

What is the probability of both those 2 modules that degraded less than 5% arriving at one lab, and thus passing the stress test in the (-) polarity at that one lab?

There are 45 different combinations when the number of samples is 10 with 2 samples in each combination. The probability of those two passing modules ending up at one lab is 1/45 (2.22%).

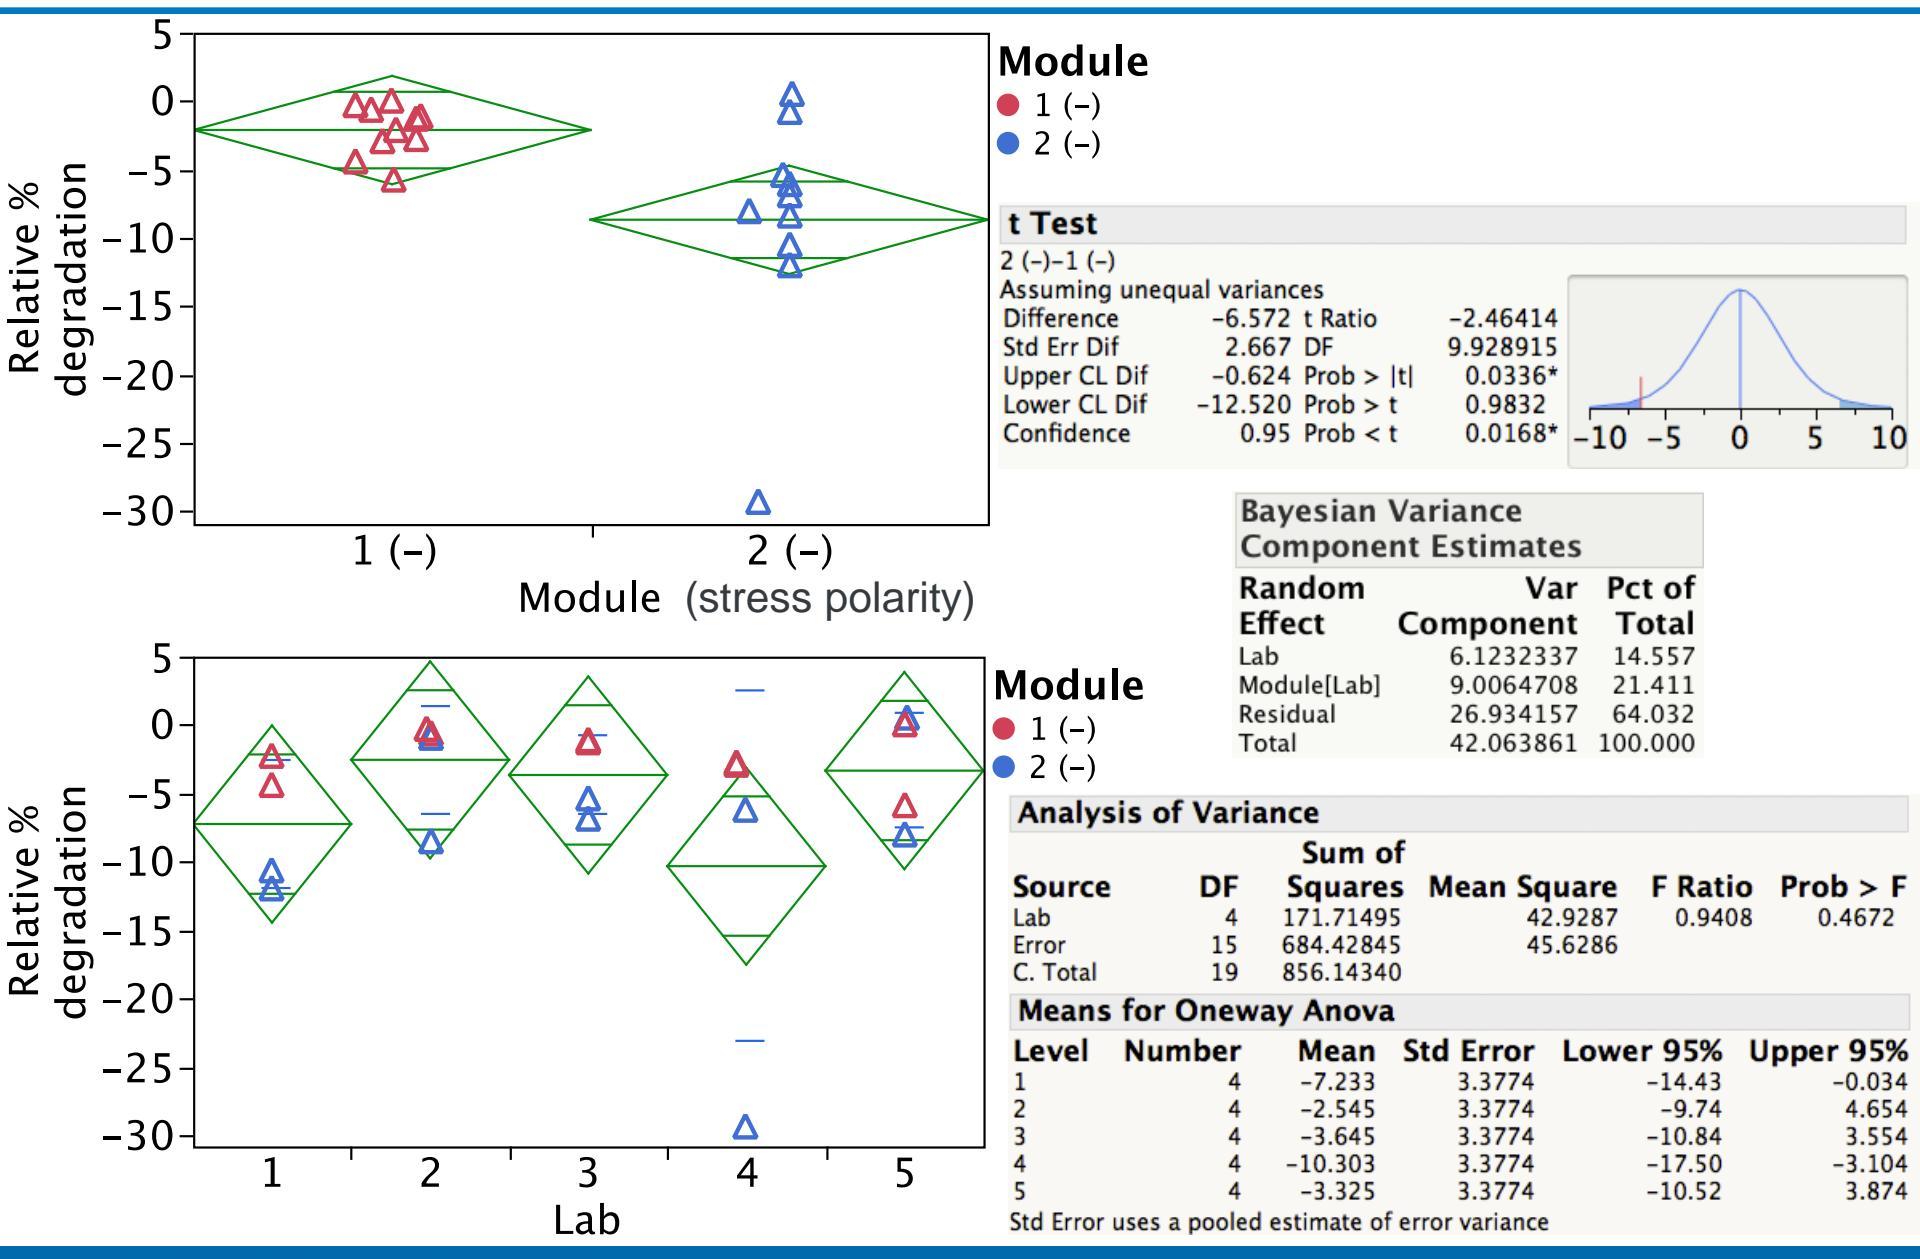
Results are controlled by module design, no conclusive proof that results are controlled by lab

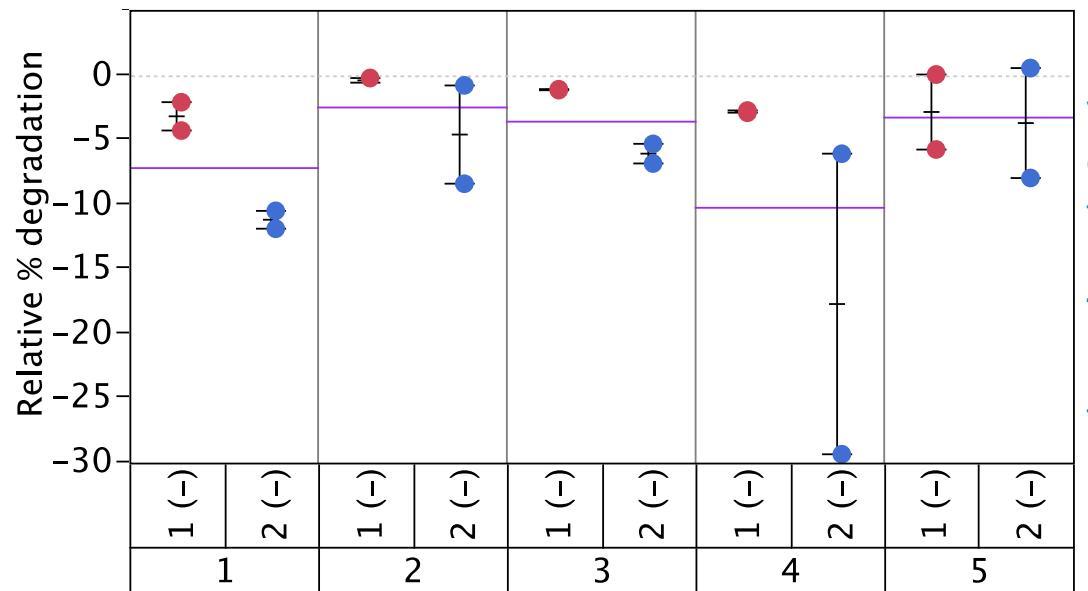
Module degradation [(-) bias only] viewed as a function of lab to determine if any labs are more severe than others.

The analysis shows that the choice of lab is the least influential component of the variation, the type of module is the next important factor, but variation of the modules within a given module type (residual) is the most influential.

nt Estimates						
Random	Var	Pct of					
Effect	Component	Total					
Lab	6.1232337	14.557					
Module[Lab]	9.0064708	21.411					
Residual	26.934157	64.032					
Total	42.063861	100.000					
Variance O	Components						
	v	ar					
Componer	nt Compone	nt % of	Total	20	40	60	80
Lab	6.1232	34	14.6				
Module[Lab]	9.0064	71	21.4				
Within	26.9341	57	64.0				
	42.0638		100.0

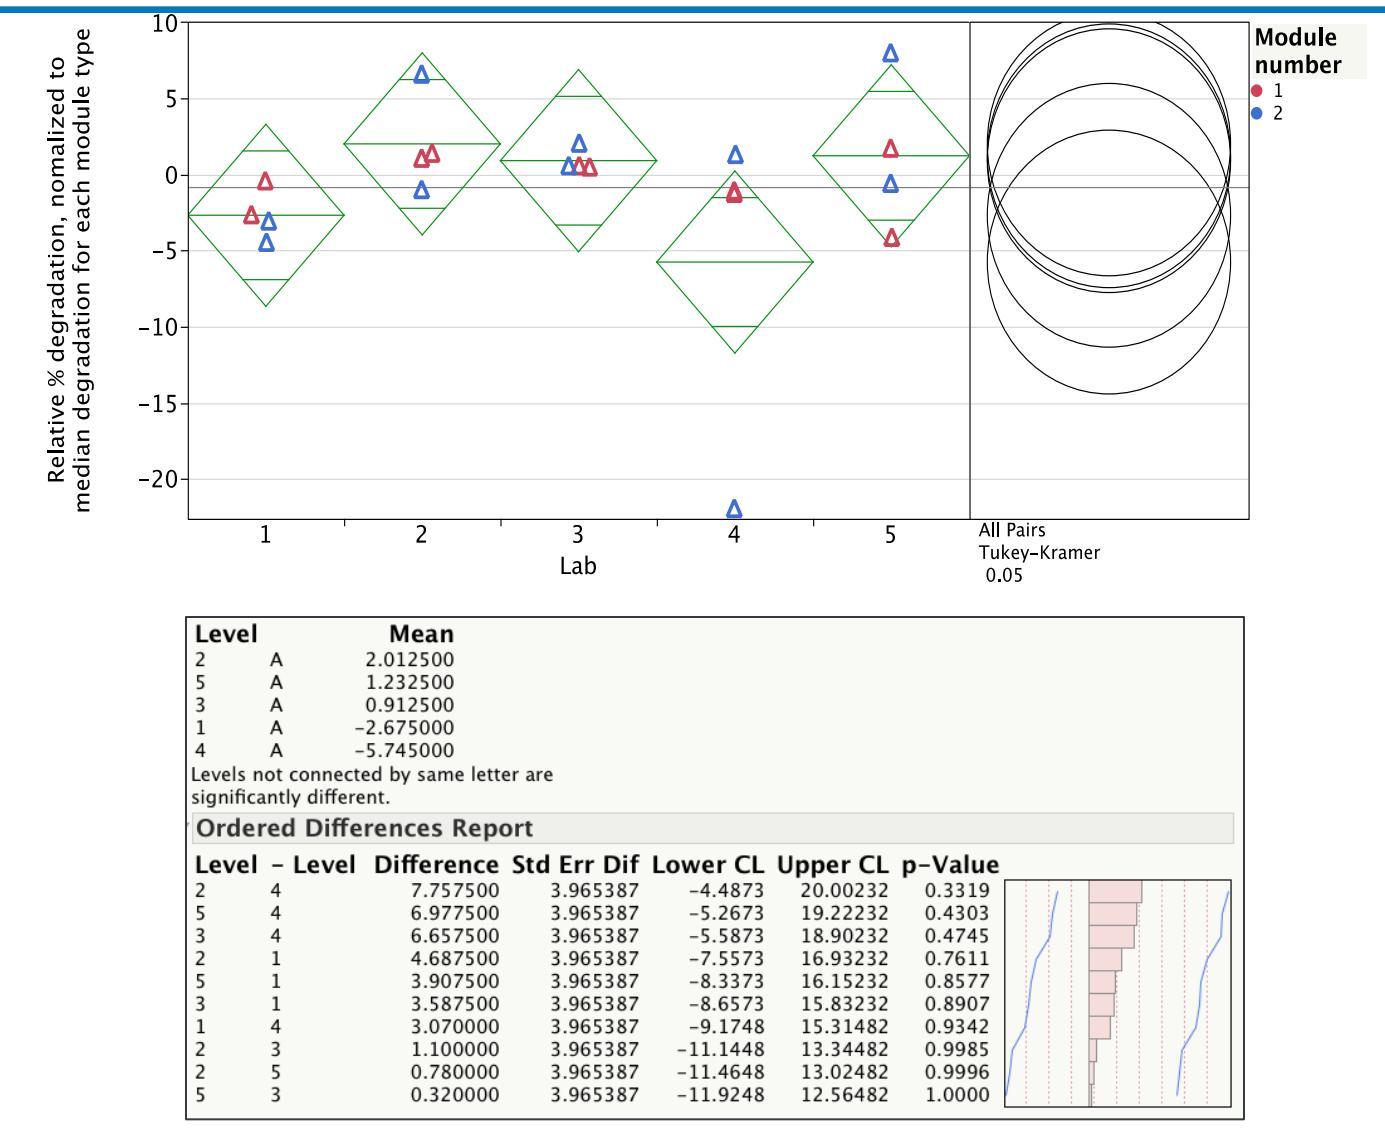
Examination of lab to lab variability

Subtracting median degradation for each module type also failed to show a statistically significant difference between labs

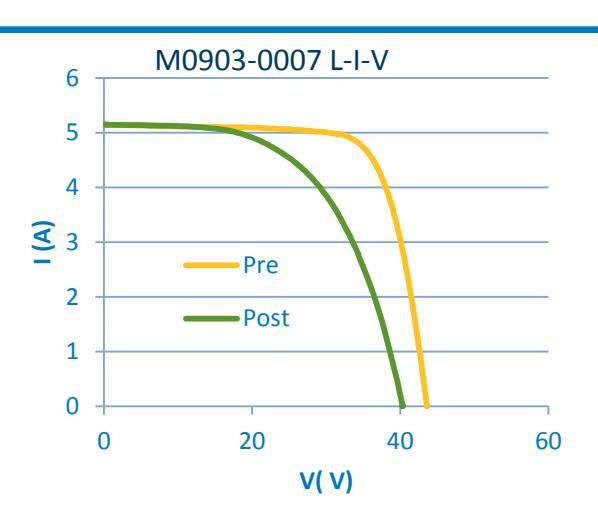
EL: M0903-0007, pre

NREL ID	Round	Sequence	Voc (V)	lsc (A)	FF (%)	Vmax (V)	Imax (A)	Pmax (W)	Pmax change (%)
M0903-0007	0	-1000V	43.59	5.14	74.03	34.97	4.74	165.80	
M0903-0007	96hr	-1000V	40.32	5.15	56.41	28.2	4.15	117.13	-29.36
M0903-0014	0	-1000V	43.57	5.17	73.14	34.64	4.76	164.92	
M0903-0014	96hr	-1000V	43.43	5.19	68.71	34.42	4.5	154.82	-6.12

Potential-induced degradation in the most degraded module design
