Moisture Risk in Unvented Attics Due to Air Leakage Paths

D. Prahl and M. Shaffer *IBACOS, Inc.*

November 2014

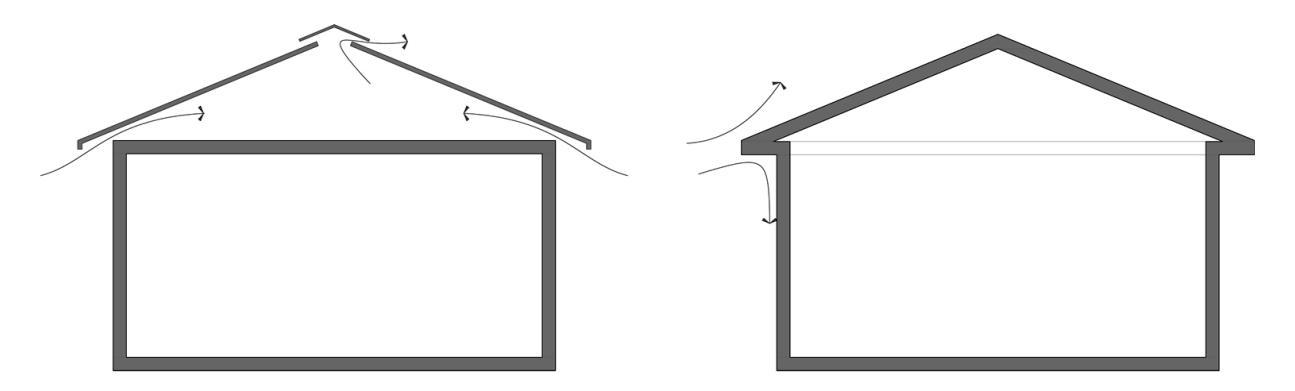
Figure 1. Airflow paths for (left) a vented (conventional) attic and (right) an unvented (cathedralized) attic

As Figure 1 illustrates, a vented attic allows air to move through the attic space. One disadvantage of a vented attic space that also houses space conditioning equipment and ducts is that the temperature of the attic can become hot during summer and correspondingly cold in winter. If an air handler unit and/or ducts are located within that vented attic, the hot or cold attic air will increase the space conditioning load on the house.

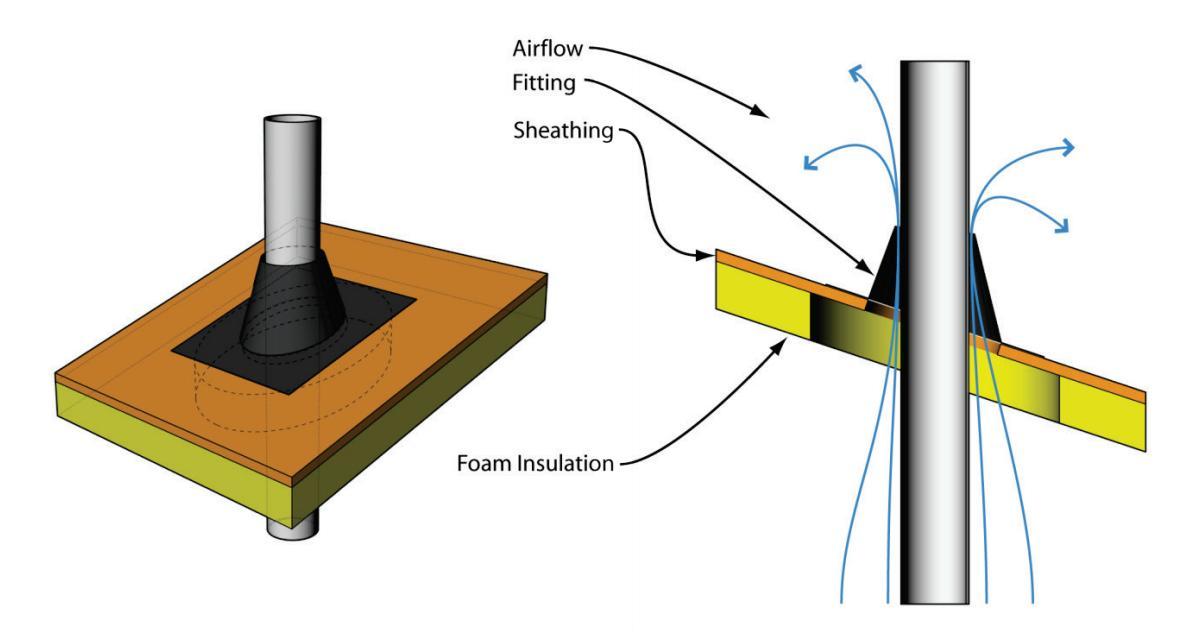
Figure 7. Plumbing, bath fan venting, or flue vent airflow path

The research team then used the photos to make 3D models of the airflow paths. The arrows in Figure 7 through Figure 9 illustrate the direction of airflow out of the attic space. The assumption at both the surface and ridge vent cracks was that the ccSPF would delaminate from the wood framing (as illustrated in Figure 4) and that the preexisting opening was not completely sealed with foam. Delamination of ccSPF can occur due to improper ccSPF installation practices.

Figure 3 through Figure 9 illustrate that some of the building materials (e.g., shingles) are not present in the model. The research team chose to complete the analysis without some of the building materials because the restriction of a properly installed roof system would have very little air leakage, yet the field measurements presented in this report indicate otherwise. This assumption provides a starting point to help understand the potential airflow from a family of defined airflow paths. A more accurate method would be to quantify the actual air leakage at identified leakage pathways in a statistically significant number of houses in multiple climate zones, which is beyond the scope of this project.

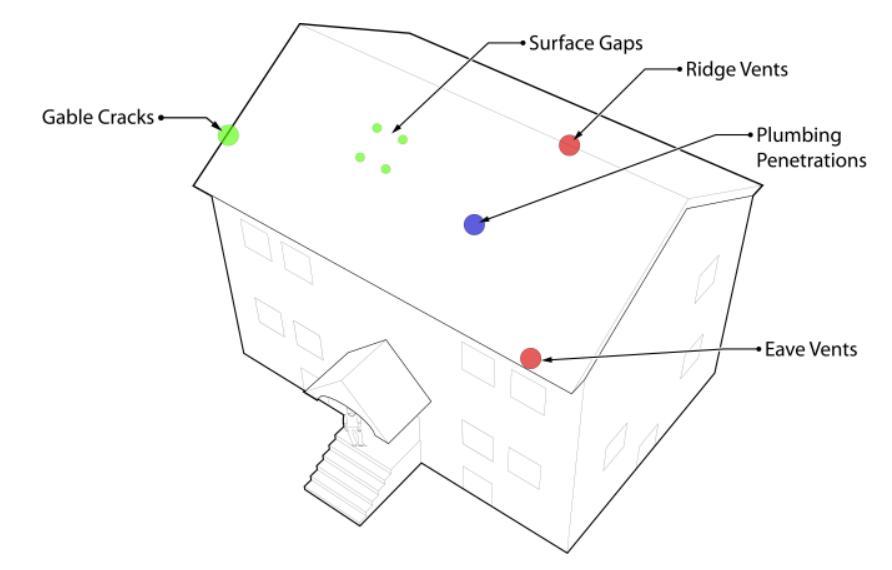
Figure 11. Location of attic airflow paths on the CONTAM model

The number of cracks indicated in Table 3 represents a surface crack at every roof sheathing intersection and rafter interface. Attic ridge and eave cracks were added at every rafter. Two plumbing cracks were included, and 16 gable cracks were included. Figure 11 illustrates the general crack locations for a few of the airflow paths.

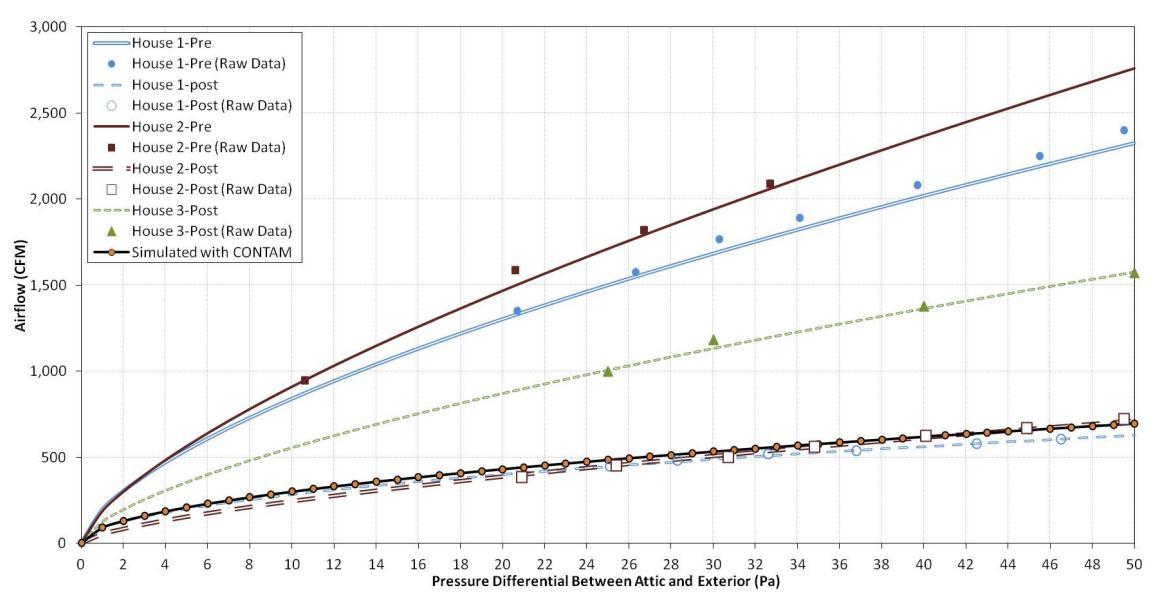
Figure 12. Airflow pressure relationship (between attic interior and exterior) for the family of airflow paths input into CONTAM

Once the cracks were added to the CONTAM model, the research team evaluated the airflow rate and pressure relationship curve by driving CONTAM with a range of interior pressures inside the house to simulate a multipoint blower door test without wind. Figure 12 illustrates the resulting airflow as a function of pressure curve for the family of airflow paths added to the CONTAM model. The flow coefficient and exponent are 90.3 CFM/Paⁿ and 0.5214 dimensionless.

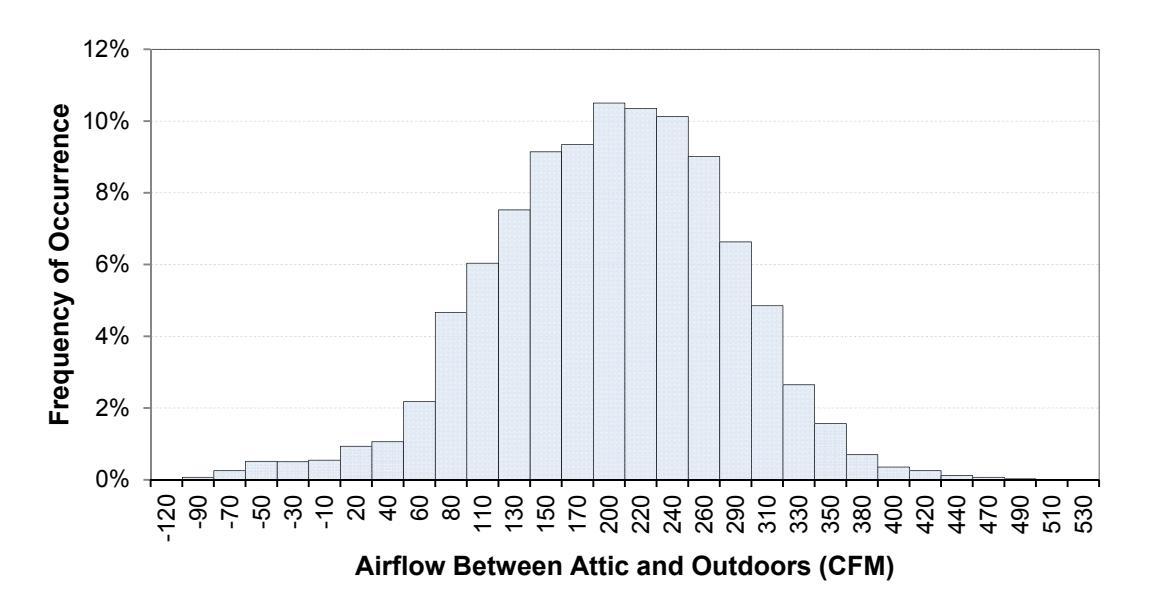
Figure 13. Histogram of CONTAM simulated hourly exfiltration and infiltration airflow rates through a ccSPF-insulated unvented attic in Minneapolis, Minnesota. Negative values indicate outdoor air flowing into the attic space.

Once IBACOS was comfortable with the air leakage rates of the family of airflow paths input into the CONTAM model, the team simulated the air leakage of the attic using a TMY3 weather file for Minneapolis, Minnesota, and a constant indoor temperature of 70°F and no airborne water vapor to produce hourly air leakage rates. Figure 13 presents the airflow rates through the family of airflow paths simulated with the CONTAM model and their frequency of occurrence.

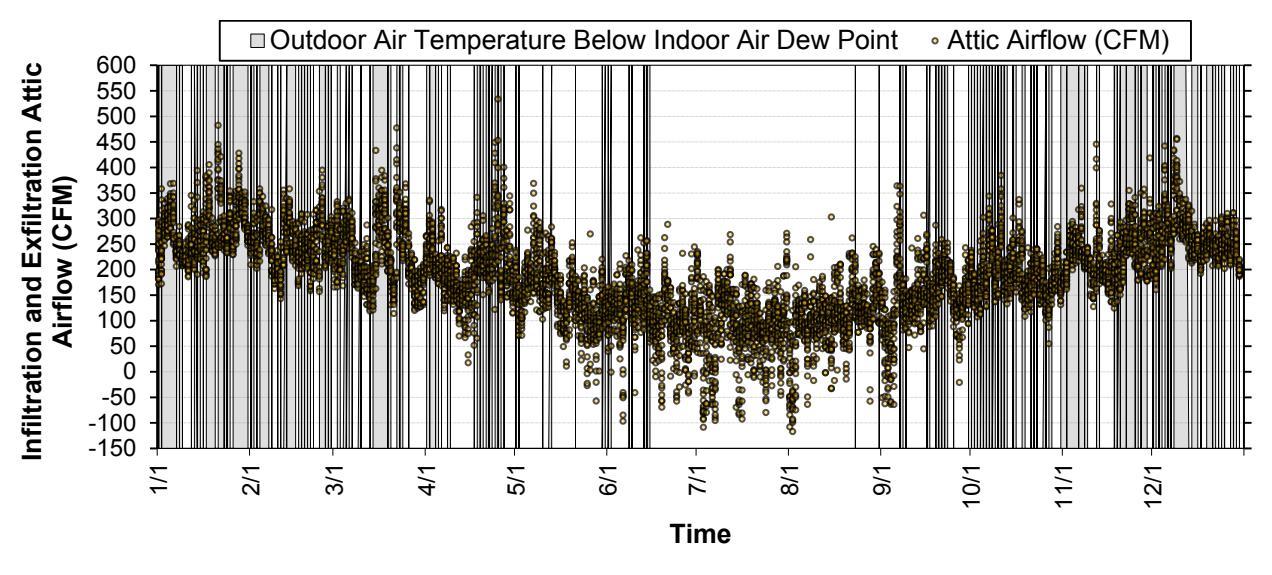
Figure 14. CONTAM attic airflow rates determined for Minneapolis, Minnesota. The shaded regions indicate instances when the outdoor temperature was lower than the dew point of the airflow moving through the attic cracks.

As an exercise to better understand the condensation events that might occur, the team calculated the dew point temperature of the air flowing out of the attic space for each hour. Next, the team compared the outdoor temperature to the dew point temperature of the air flowing through the crack; the results are presented in Figure 14. This figure illustrates the airflow rate for each hour using round black dots and gray vertical bars to indicate that a condensation event is possible (i.e., when the outdoor temperature is equal to or lower than the dew point temperature of the indoor air).

The project team analyzed the data presented in Figure 14 to determine the number of continuous hours that a condensation event might occur. Figure 15 presents the results of that analysis.

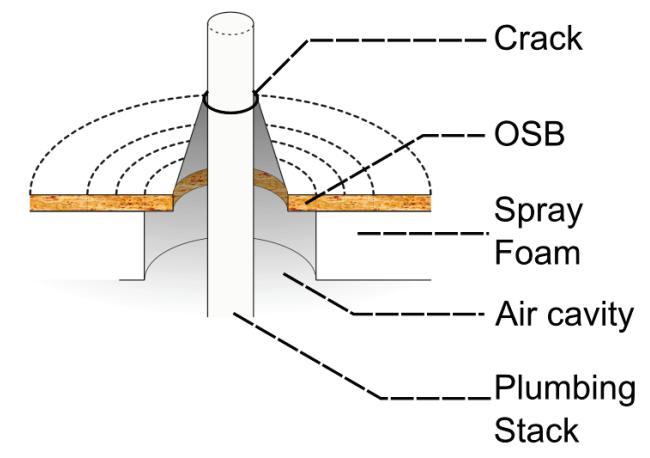
Figure 16. Schematic view of the WUFI 2D model for the plumbing airflow path⁸

WUFI two-dimensional (2D) modeling was used to simulate the moisture content of the building material surrounding the airflow path. The airflow path selected for analysis was the plumbing vent. The plumbing vent was presented above and included a small airflow path along the round plumbing vent that allowed air to flow over the building materials (the foam and roof sheathing). Figure 16 is an image of the 2D model and indicates the materials used in the simulation.

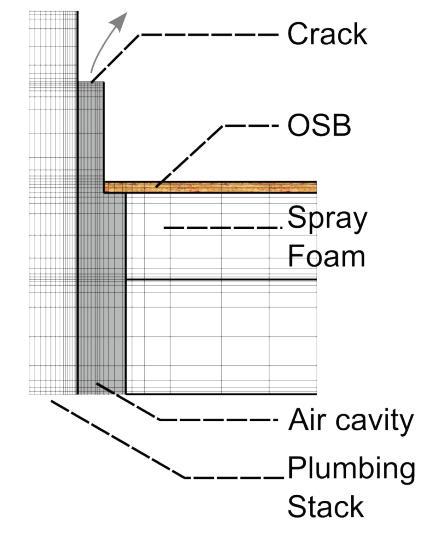
Figure 17. WUFI representation of the airflow path

Figure 17 is an image of the model that was entered into WUFI 2D.

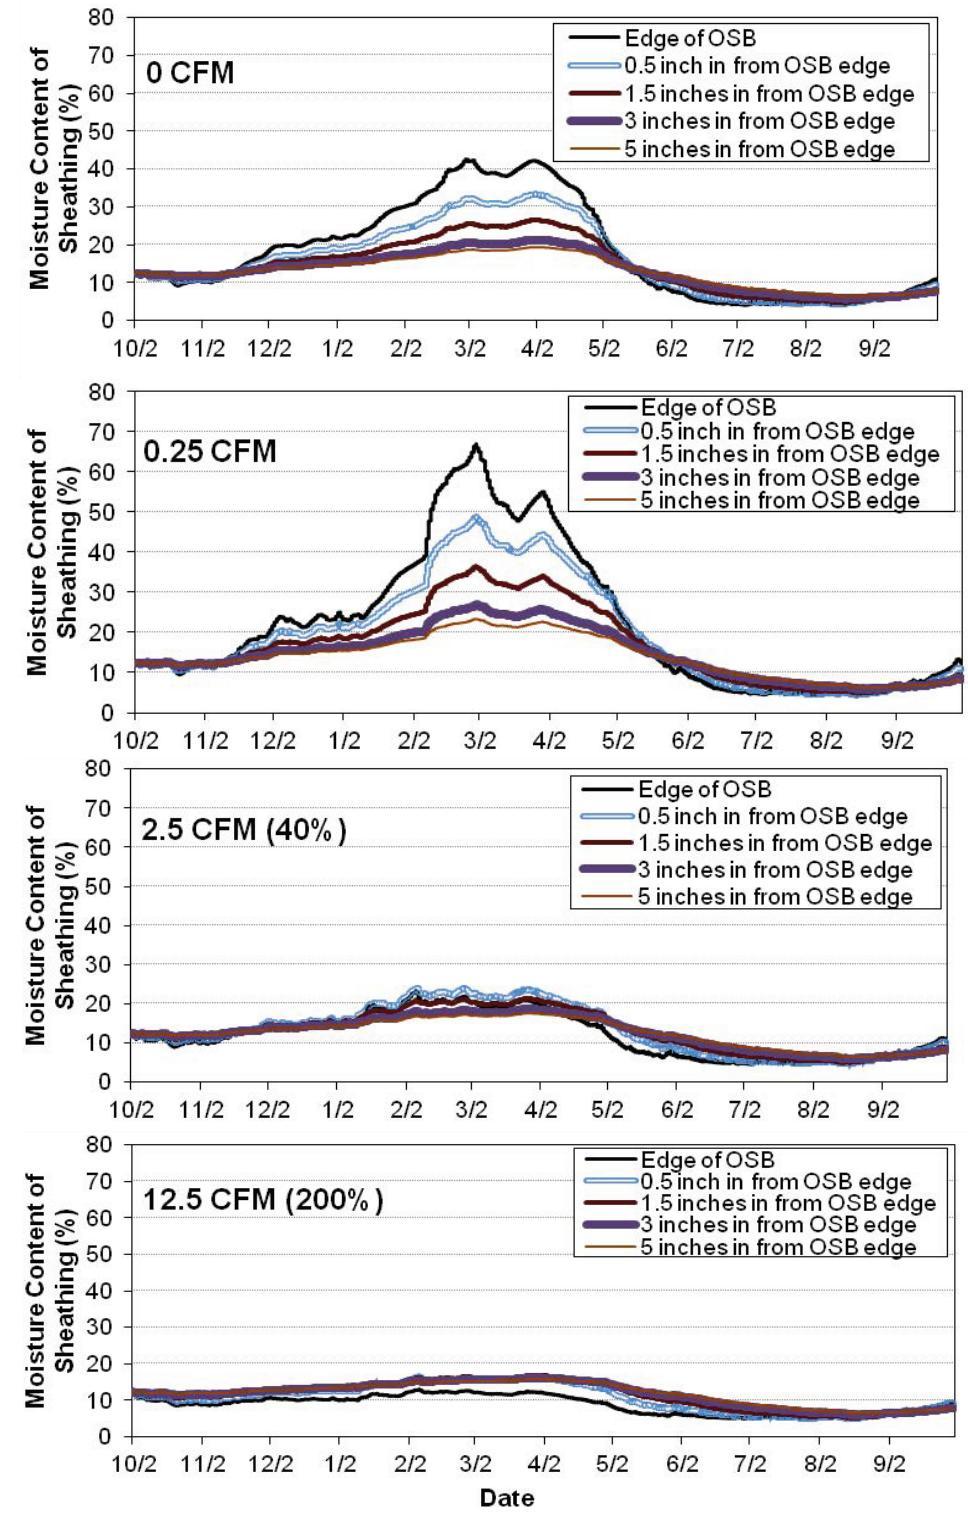
Figure 18. Hygrothermal results indicating the OSB moisture content at various distances from the edge of the airflow path

Figure 18 presents the hygrothermal results.

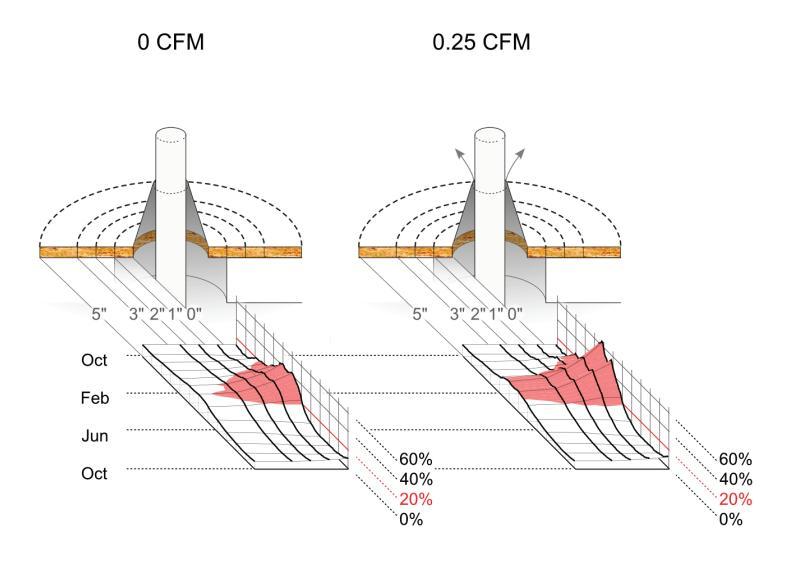
Figure 19. Hygrothermal results for plumbing airflow path with 0 and 0.25 CFM airflow

A spatial/temporal representation of the moisture content in the OSB sheathing was made and is provided in Figure 19 and Figure 20. In these figures, the red shaded areas show moisture content in the OSB above 20%; the axis moving toward the reader from the page indicates the time of year, and the horizontal axis indicates the distance away from the edge of the air leakage pathway.
