Strategy Guideline: Energy **Retrofits for Low-Rise Multifamily Buildings in Cold Climates**

K. Brozyna IBACOS, Inc.

L. Badger Vermont Energy Investment Corporation

April 2013

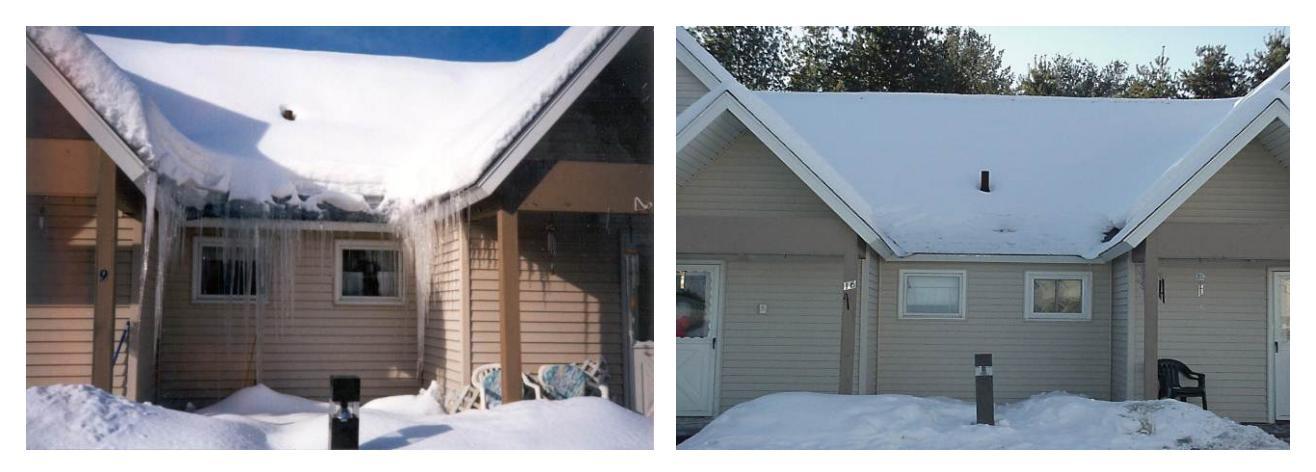
Figure 2. Before (left) and after (right) air sealing penetrations into any unconditioned roof cavities (Housing Vermont 2010) (Photos courtesy Efficiency Vermont)

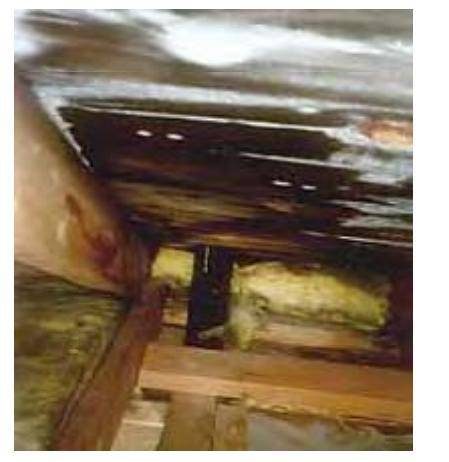
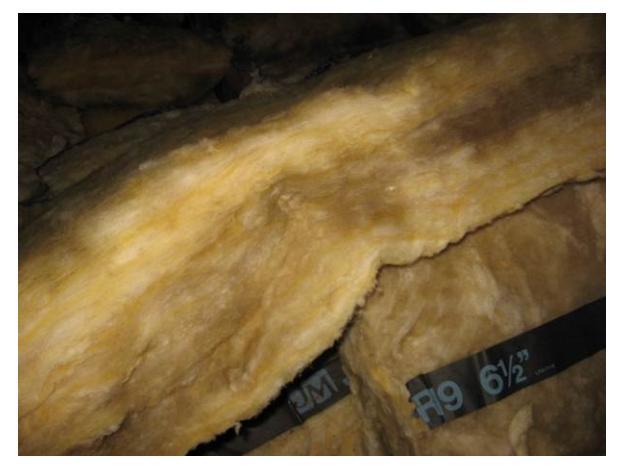
Figure 3 shows visual evidence of poor air sealing and insulation performance. The photo on the left shows mold growing on the underside of the roof sheathing. This happens when warm, moist air condenses on the cold sheathing surface. The photo on the right shows fibrous insulation discoloration caused by the filtering of particulates as air passes through it.

Figure 3. Mold growing on the underside of roof sheathing (left) (DOE 2011); discoloration of insulation (right)

These symptoms are indicative of poor air sealing or insulation levels (usually both). Both conditions can result in long-term energy performance and durability issues in the structure. To address these symptoms and to increase the long-term durability of the roof assembly, ensure proper air sealing and adequate insulation levels. Section 2.2 provides an in-depth discussion of the building science associated with these energy efficiency measures.

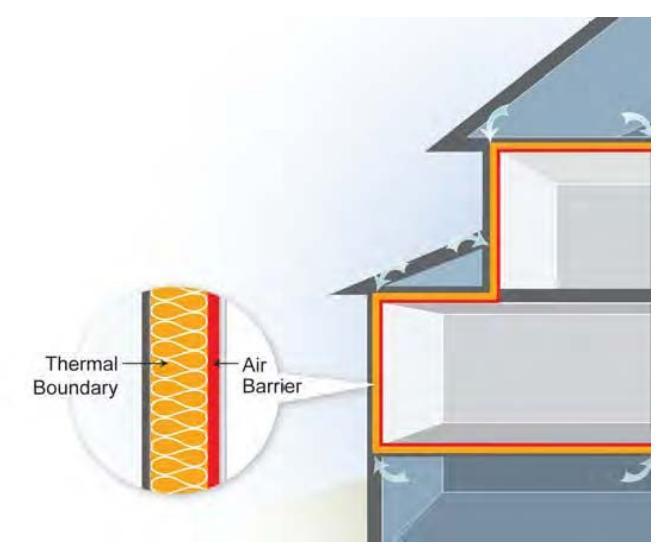
Figure 4. The thermal boundary and air barrier separate the unconditioned space from the conditioned space of a structure, preventing air infiltration indicated by the arrows (DOE 2011)

In Figure 4, the attic space is unconditioned. In buildings where the attic space is considered to be conditioned, the thermal boundary and air barrier would extend upward along the roof assembly. The thermal boundary must be continuous around the building envelope.

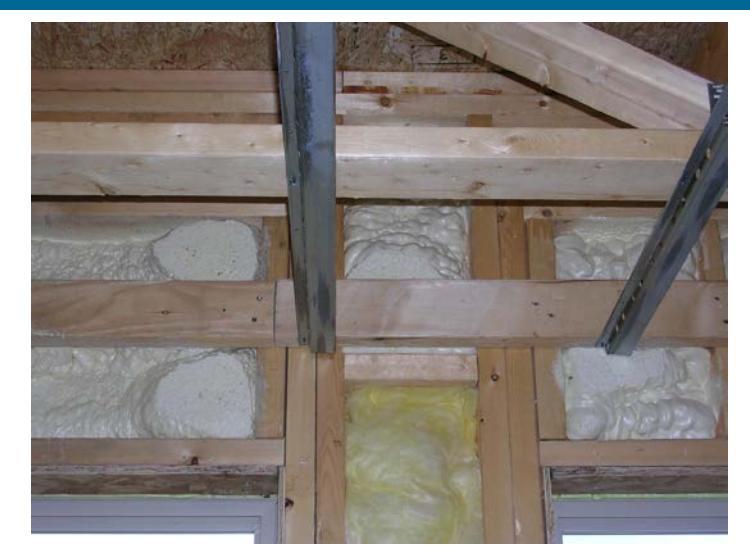
Figure 5. The air sealing benefits of spray foam make it a great option to insulate around rim or band joists

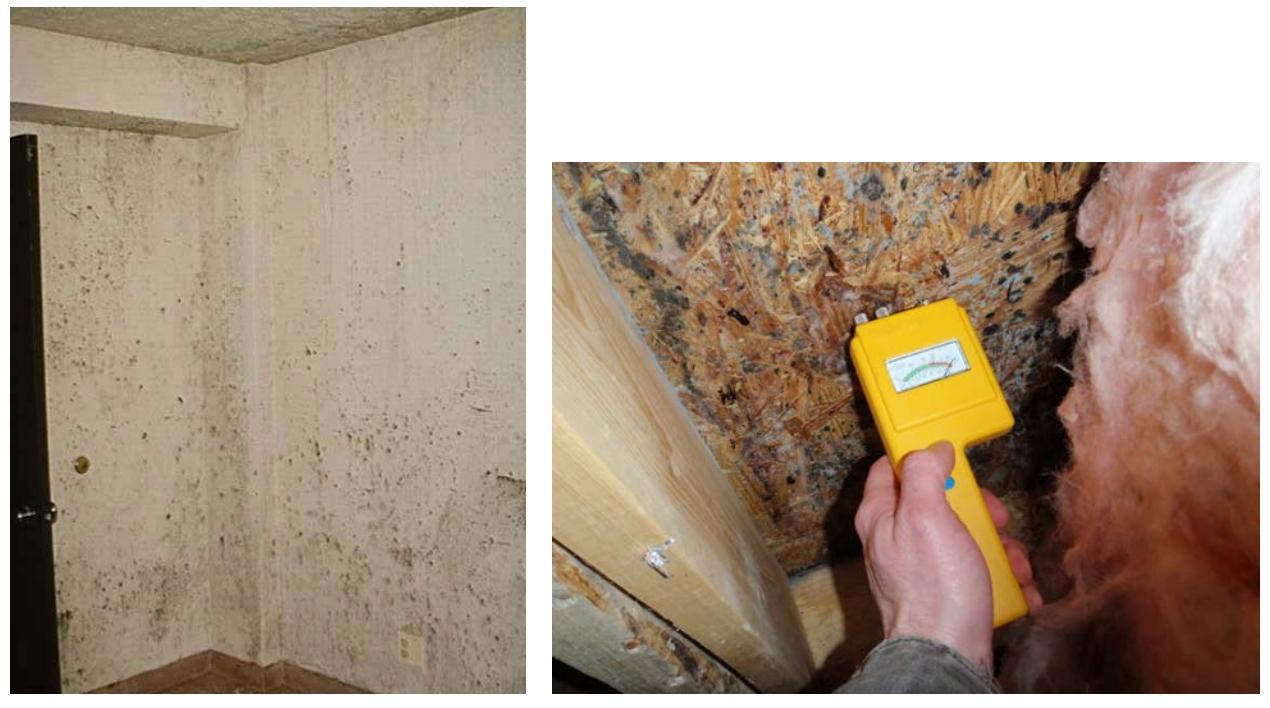
Figure 6. Mold growth on the inside surface of exterior walls (left) and inside the wall cavity (right). Both conditions are likely caused by an improperly air sealed and insulated wood-framed wall assembly.

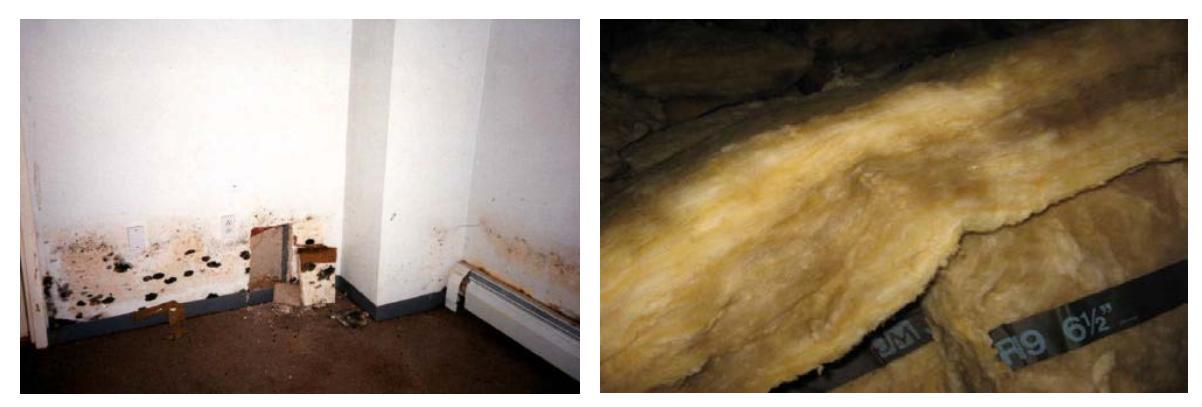
Visual evidence of poor air sealing and insulation performance is shown in Figure 7. The image on the left shows mold growth on the interior walls as a result of poor air sealing at the floor. The image on the right shows fibrous insulation discoloration caused by the filtering of particulates as air passes through it. These symptoms are indicative of poor air sealing or insulation levels (usually both). To address these symptoms and to increase the long-term durability of the wall assembly, ensure proper air sealing and adequate insulation levels.

Figure 7. Signs of poor air sealing and insulation performance (BSC 2008, Housing Vermont 2010) (Left photo courtesy Building Science Corporation; right photo courtesy Efficiency Vermont)

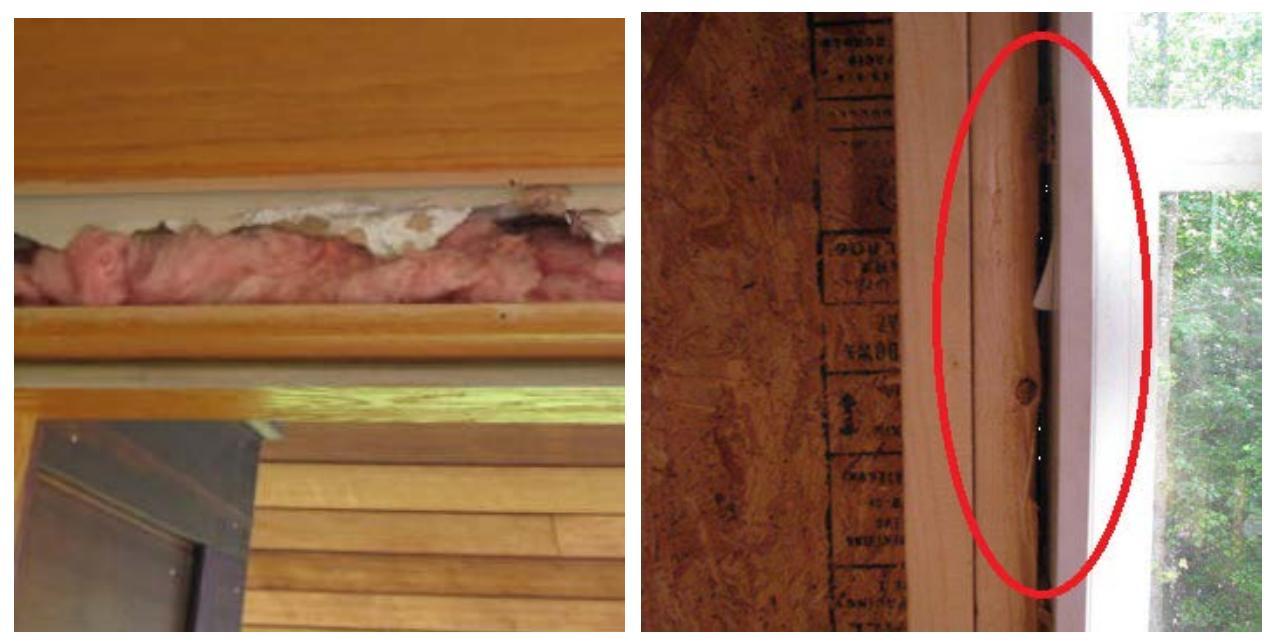
Figure 8. Poor air sealing around windows (ENERGY STAR 2011c) (Left photo courtesy Efficiency Vermont; right photo courtesy U.S. Department of Energy)

The interior surface (drywall) is a key component of the thermal boundary system and air barrier. Once insulation has been reinstalled and the wall cavity has been enclosed, complete air sealing of the drywall is a critical detail. Any remaining air gaps can be identified by using a blower door in conjunction with an infrared camera or smoke pencil. Figure 8 shows examples of poor air sealing around doors and windows. In the photo on the left, fibrous insulation has been jammed into the gap above the door frame. Fibrous insulation is not an air barrier; it acts only as a filter and allows air to move freely between the interior and exterior. In the photo on the right, the gap between the window and the rough opening is not sealed at all. By contrast, Figure 9 shows two examples of good air sealing with low-expansion spray foam.

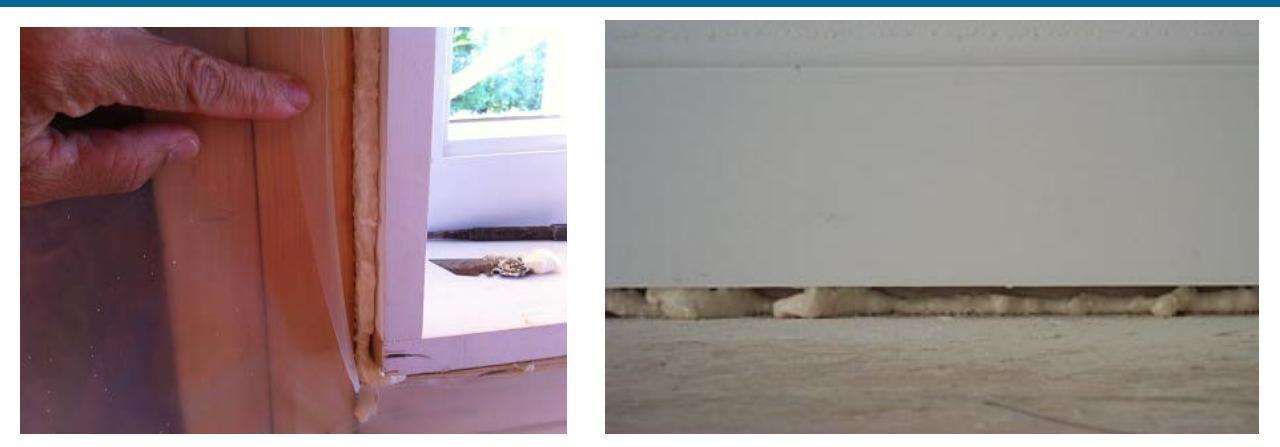
Figure 9. (Left) Good air sealing around windows and (right) between drywall and subfloor (Photos courtesy Efficiency Vermont)

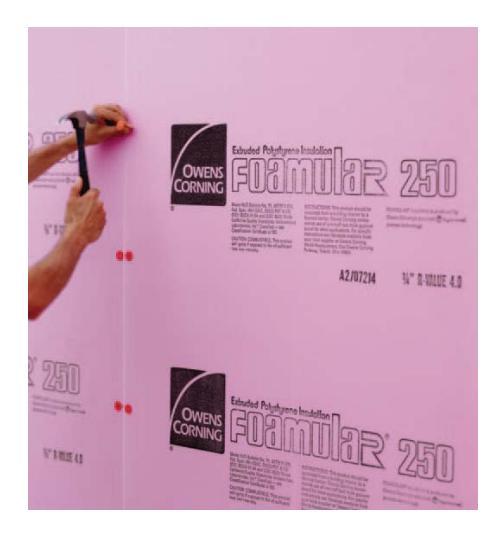
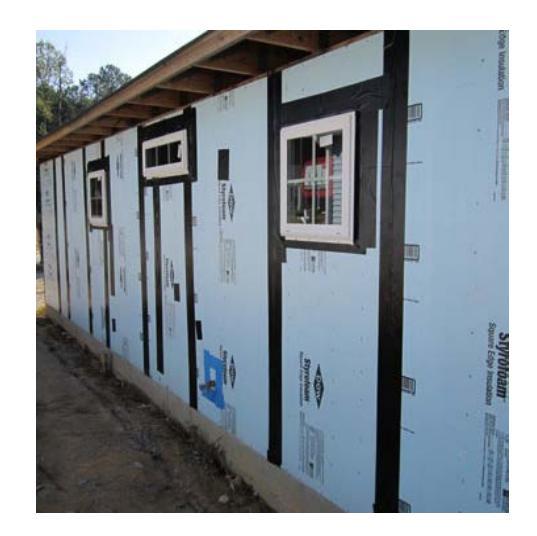
Figure 10 shows examples of proper installation of rigid foam, which may be installed on the interiors or exteriors of walls. Cap nails should be used, and all seams should be sealed completely.

Figure 10. Proper installation of continuous rigid foam (ENERGY STAR 2011c), showing the use of cap nails and proper sealing of seams

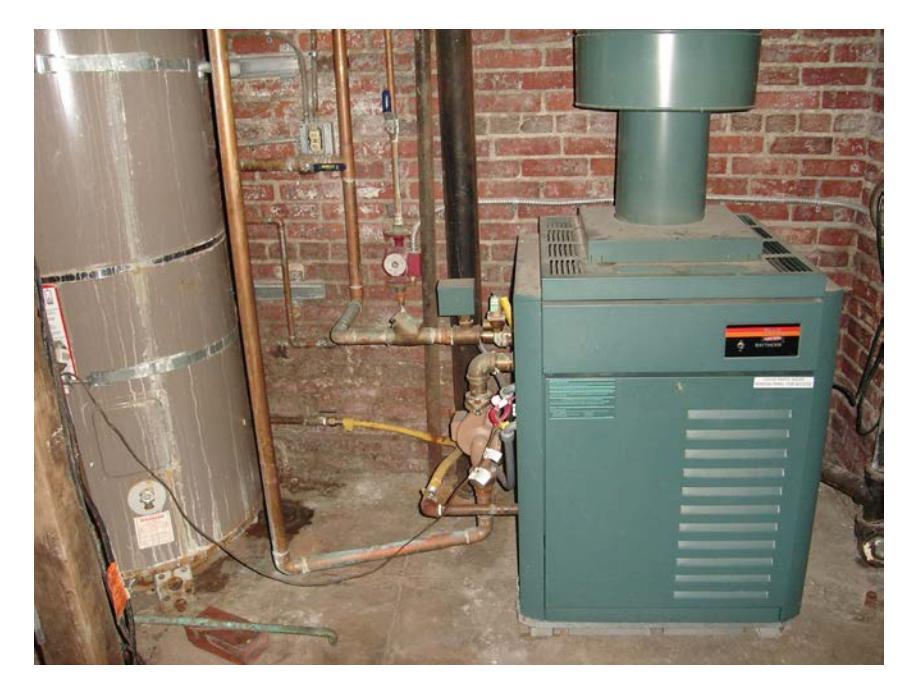
Figure 11 shows a typical heating unit for a multifamily building. With such a system, a lack of microprocessor controls provides a good opportunity for retrofit.

Figure 11. Typical multifamily heating unit without microprocessor controls (Klein 2011) (Photo courtesy Gary Klein, Affiliated International Management, LLC)

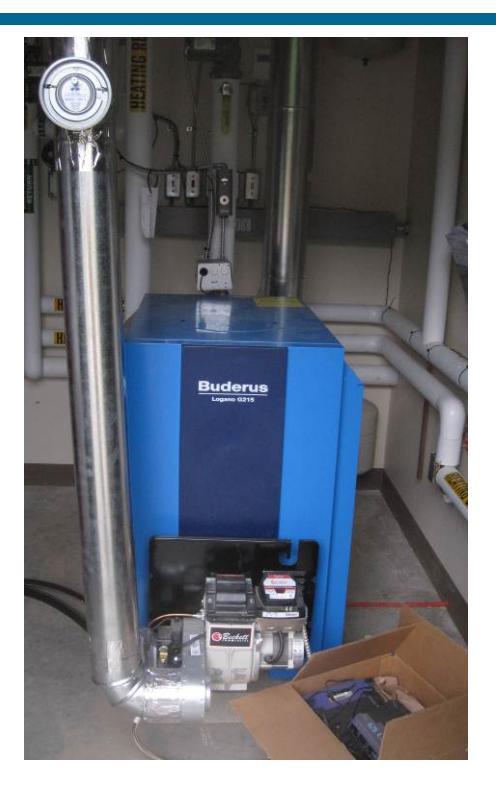
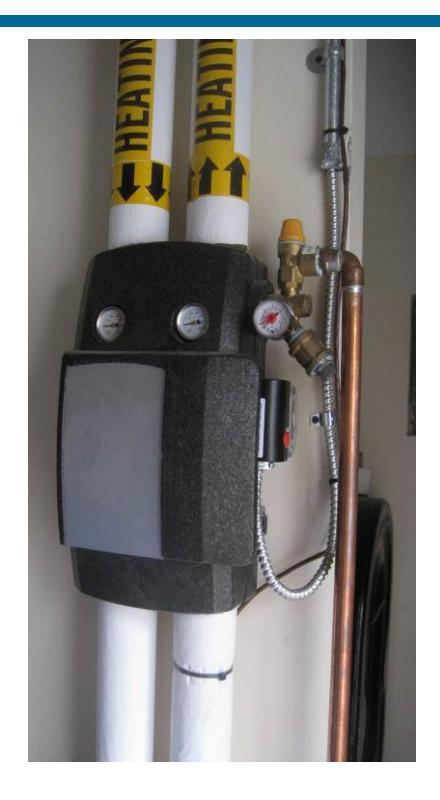
Figure 12 shows a replacement boiler with integrated processor controls and associated water flow control.

Figure 12. Replacement boiler with microprocessor controls (left); associated water flow control (right)

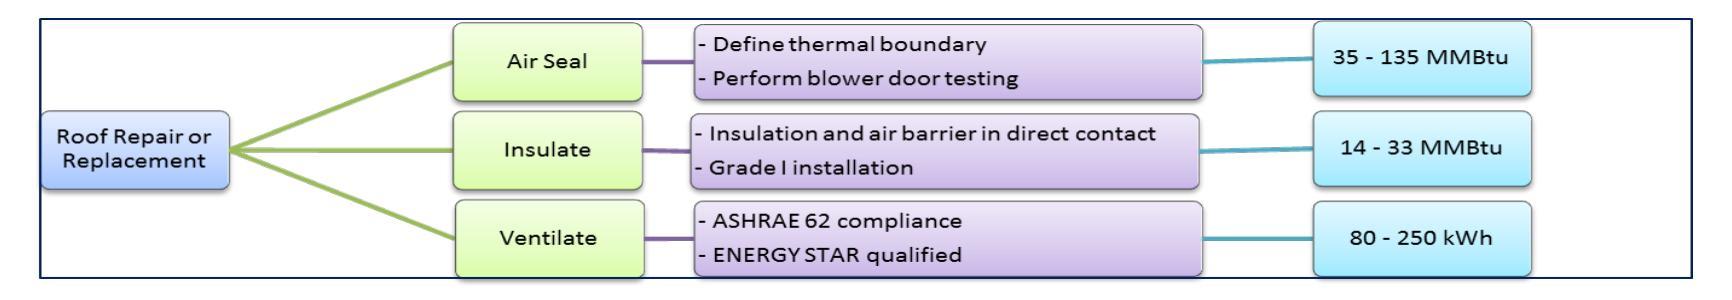
Figure 13. Roof repair or replacement retrofit measure

Figure 13 through Figure 15 provide an overview of each common building retrofit measure. Tied to each retrofit measure are the recommended energy efficiency measures that could be implemented at the time of retrofit, as well as important points to keep in mind when performing these retrofits. Potential energy savings ranges are provided for each energy efficiency retrofit measure.

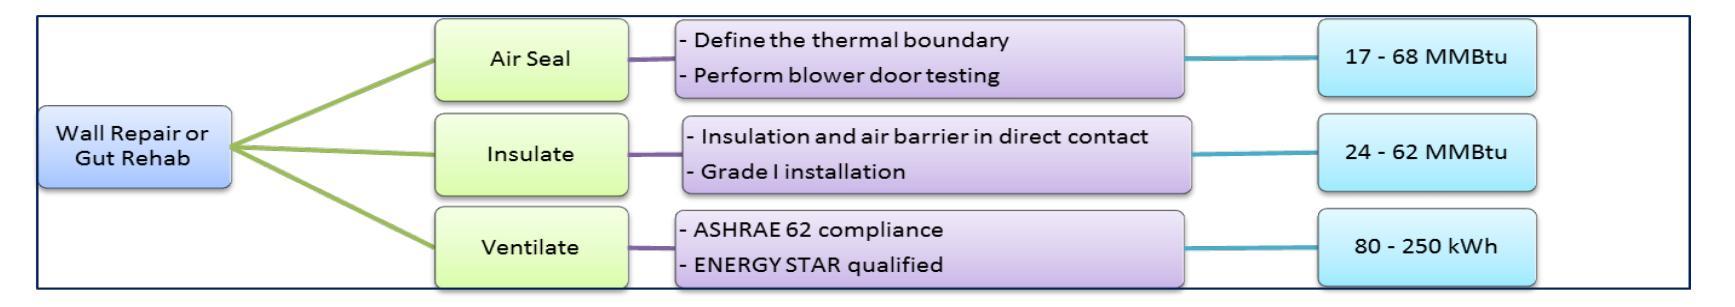
Figure 14. Wall repair or gut rehab retrofit measure

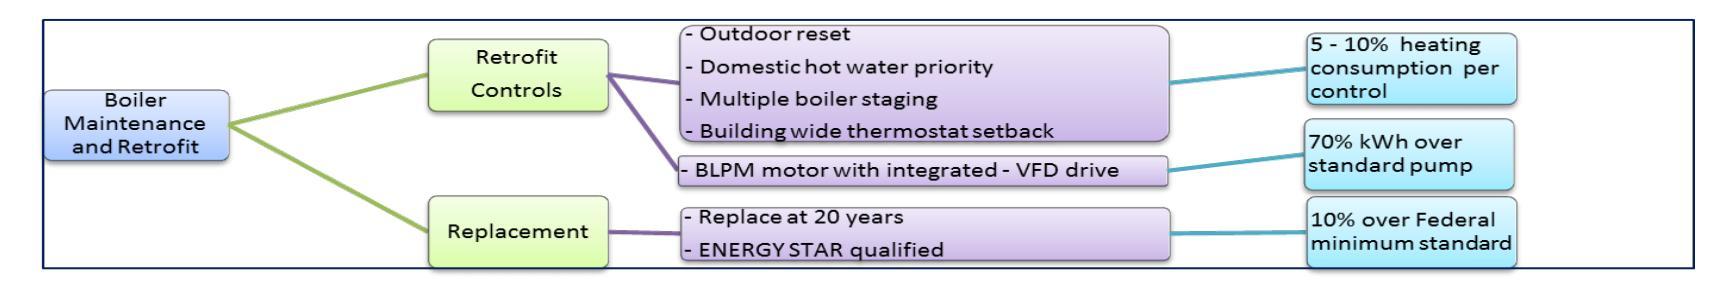
Figure 15. Boiler maintenance and retrofit measure
