# Air Leakage and Air Transfer Between Garage and Living Space

Armin Rudd  
*Building Science Corporation*

September 2014

On behalf of the U.S. Department of Energy's Building America Program

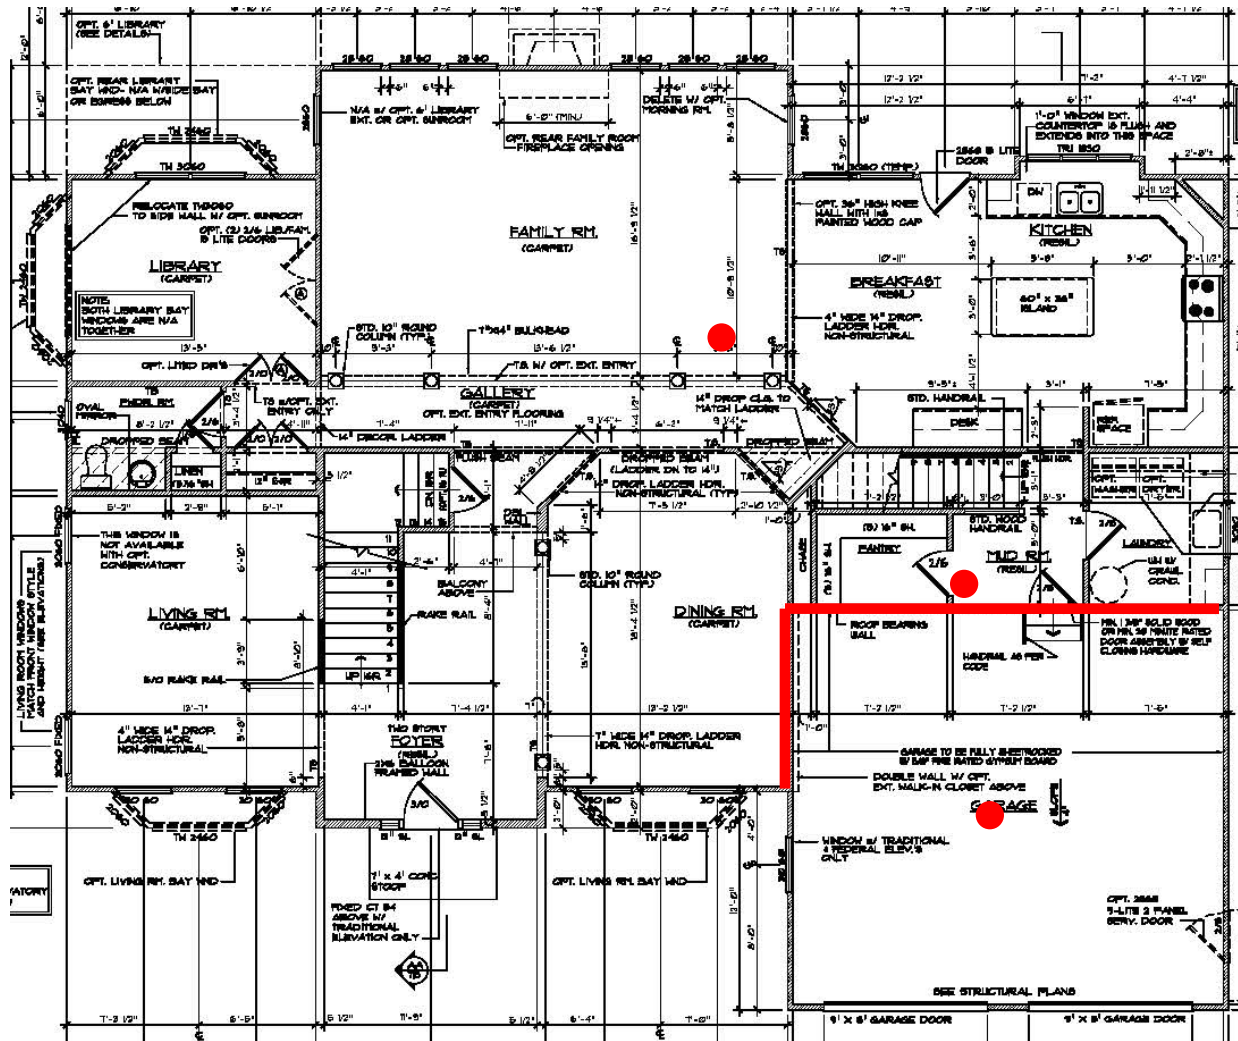
Figure 2. First-floor plan, with garage-to-house interface walls marked with thick red lines, and with red dots marking measurement station locations

A suitable test home was found that had a medium to low level of garage-to-house connection. One long side of the garage and a little less than half of the short side were adjacent to the first story of the house. A second-story bathroom and a walk-in closet were adjacent to the garage attic. There was no tuck-under portion where the garage ceiling was adjacent to a conditioned space floor above. Figure 2 and Figure 3 show a plan view of this configuration for the first and second floors, respectively.

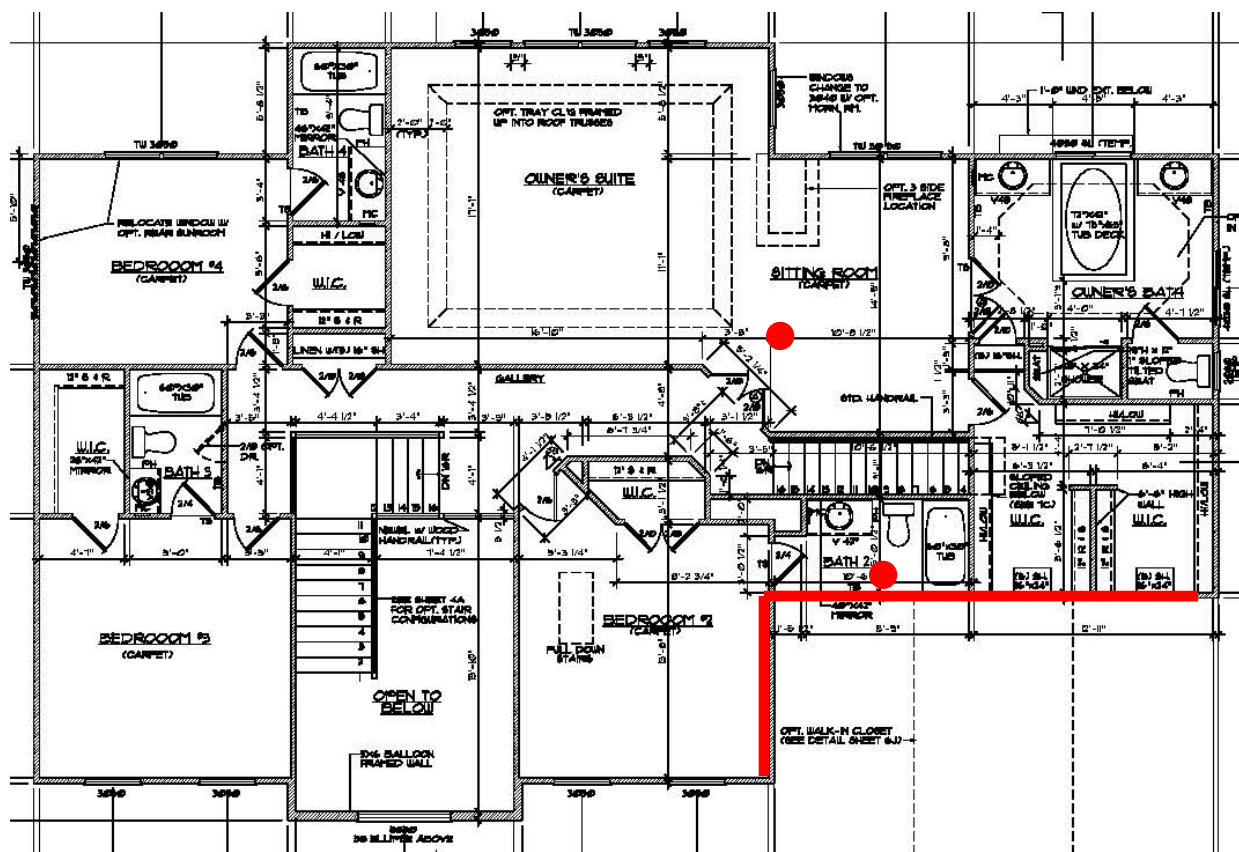
**Figure 3. Second-floor plan, with garage attic-to-house interface walls marked with thick red lines, and with red dots indicating measurement station locations**

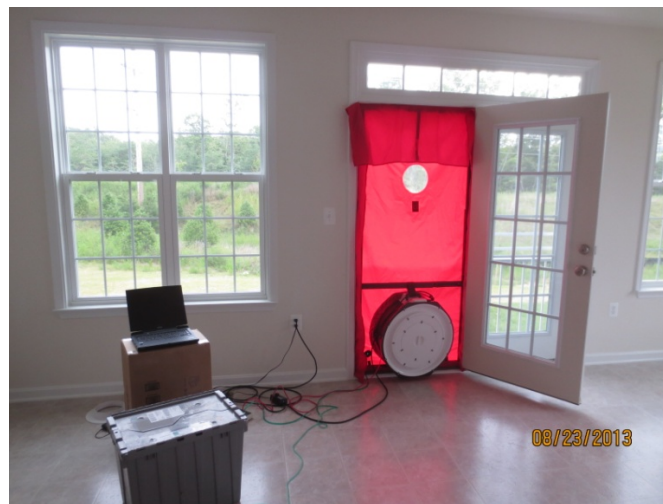
**Figure 4. Location of the house-to-outdoors fan pressurization testing equipment**

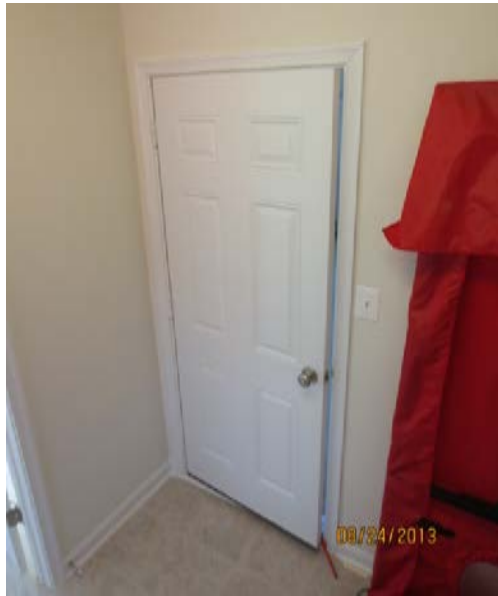
**Figure 5. Location of garage-to-house fan pressurization testing equipment**

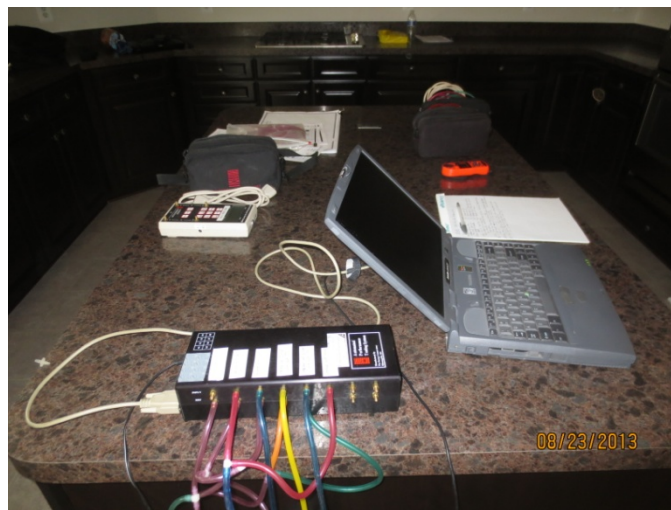
**Figure 6. Six channels of pressure monitoring, using Energy Conservatory digital pressure gauge having auto ranging resolution of 0.1 Pa and accuracy of  $\pm 1\%$  of reading or 2 times the resolution, whichever is greater**

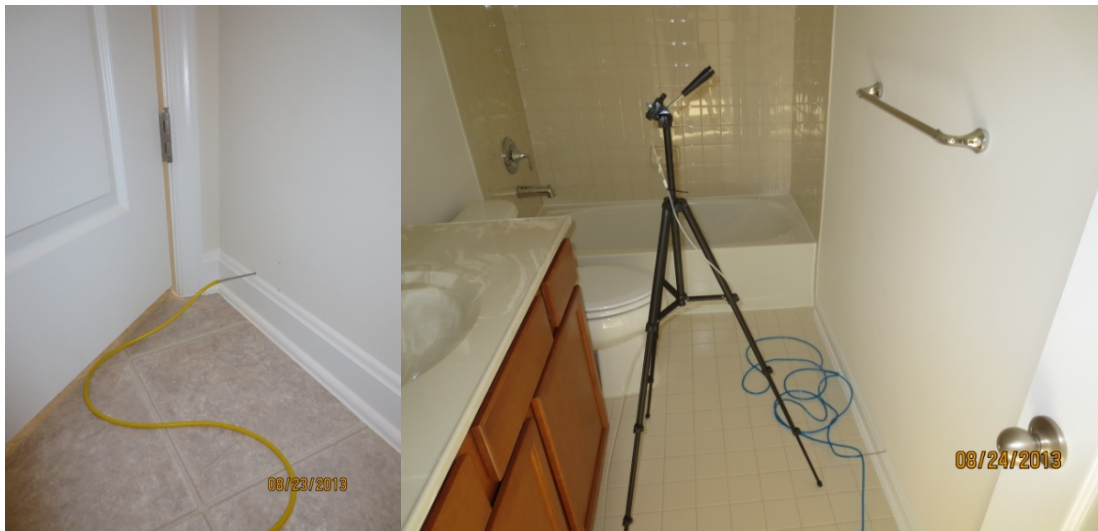
**Figure 7. First-floor garage-to-house wall cavity pressure measurement location, and second-floor garage attic-to-house wall cavity pressure measurement and room air sampling location**

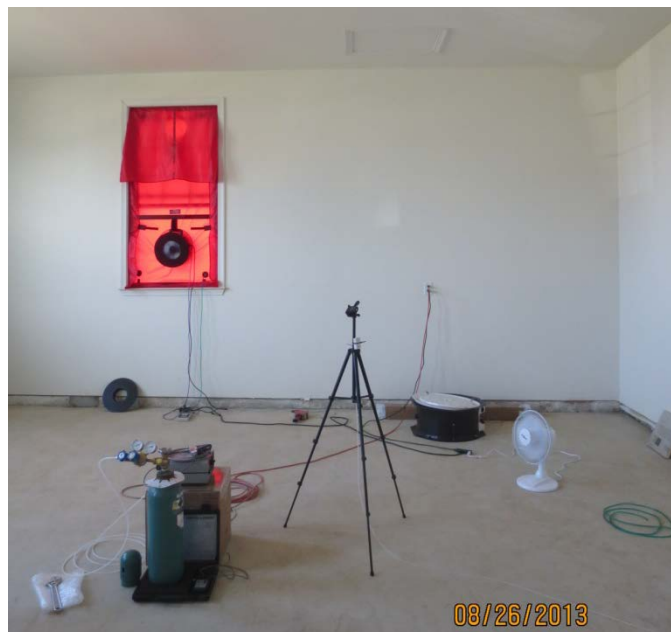
**Figure 9. Testing equipment located in the garage: SF<sub>6</sub> tracer gas on a scale and mass flow controller for tracer gas injection (lower left); calibrated fan for garage exhaust (upper left); garage air concentration and temperature/RH sampling station (tripod in center); mixing fan (right); garage air pressure sampling tube (far right)**

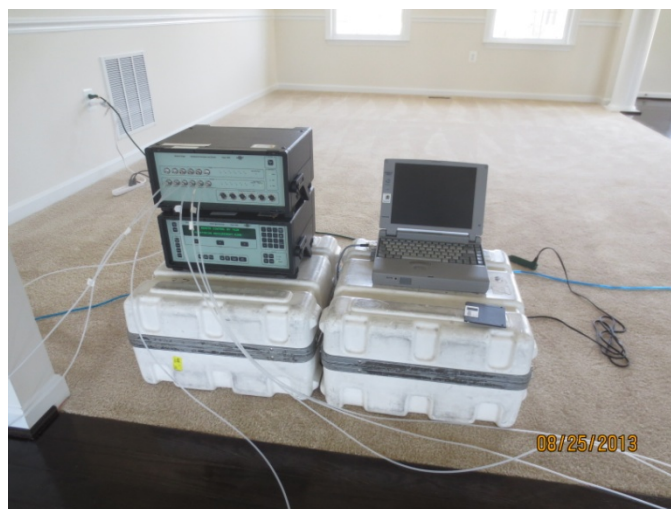
**Figure 10. Six channels of tracer gas concentration monitoring, using a Bruel & Kjaer 1302 photoacoustic gas analyzer with internal temperature and water-vapor compensation, SF<sub>6</sub> detection limit of 5 ppb, and a repeatability specification of 1% of measured value**

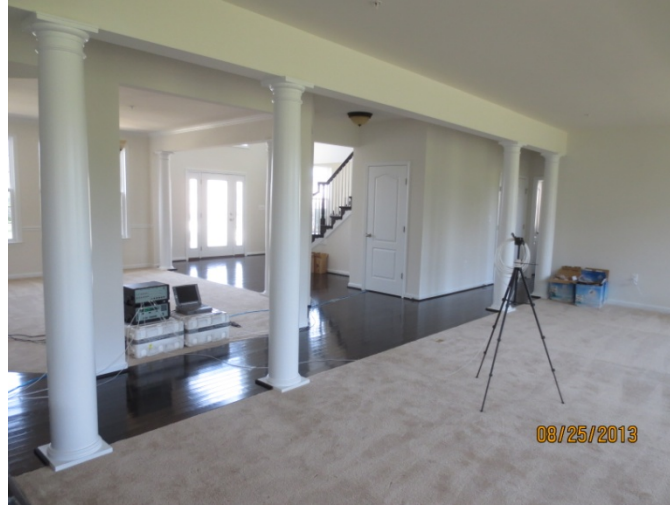
**Figure 11. First-floor main air sampling station**

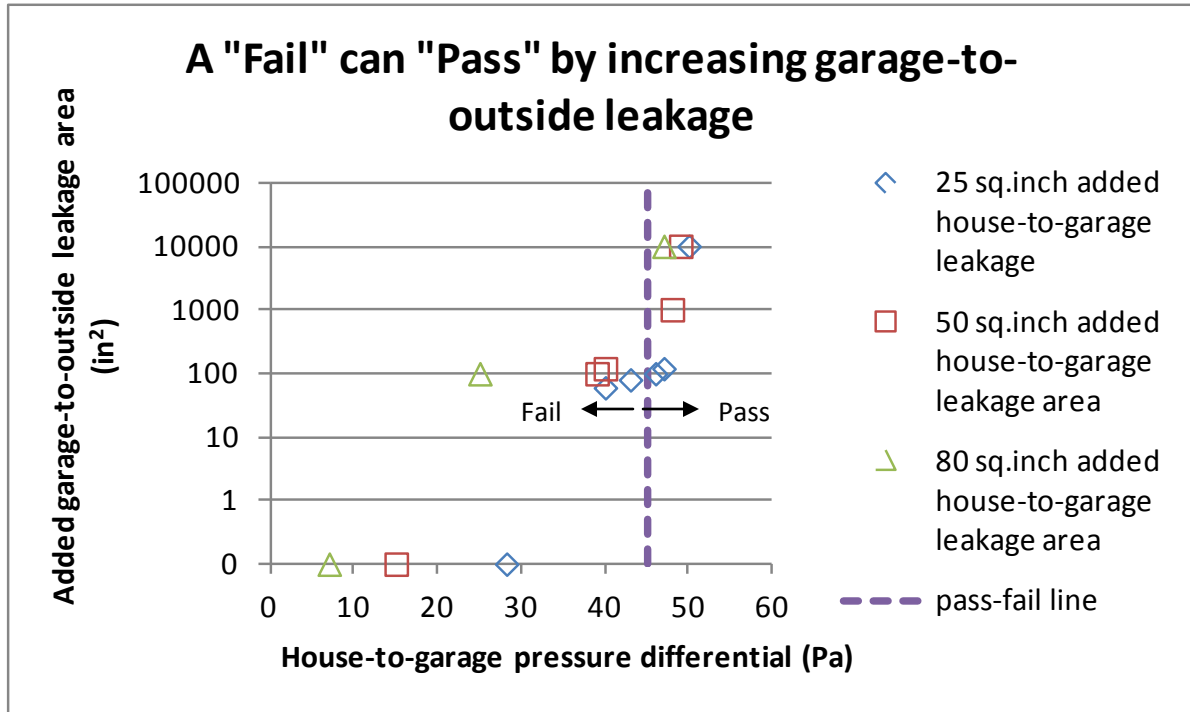
Figure 12. Test results showing inadequacy of house-to-garage pressure differential as a single criterion for house-to-garage airtightness

Additional testing to confirm those same results was done via Tests 14–18, and Tests 19–21. In each case, an initially failing garage-to-house interface was made to pass by adding garage-to-outside leakage area, resulting in a false positive. This is illustrated in Figure 12, which shows the inadequacy of house-to-garage pressure differential as a single criterion for house-to-garage airtightness.

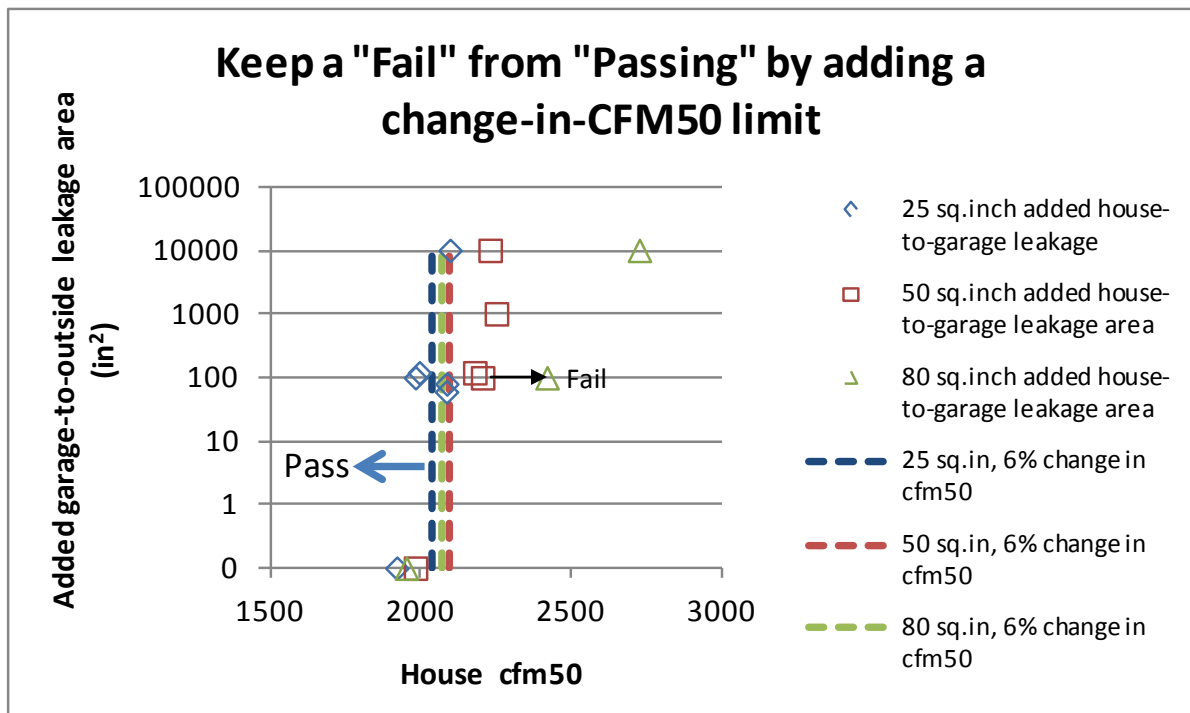
Figure 13. Elimination of false positives was found by adding a second criterion limiting the increase in house CFM50 to 6% with the overhead garage door open compared to closed

Figure 13 illustrates the elimination of false positives found by adding a second criterion limiting the increase in house CFM50 to 6% with the overhead garage door open compared to closed. Symbols to the left of the dashed line of the same color should pass because the change in House CFM50 was less than 6%. Symbols to the right of the dashed line of the same color should fail because the change in House CFM50 was greater than 6%.

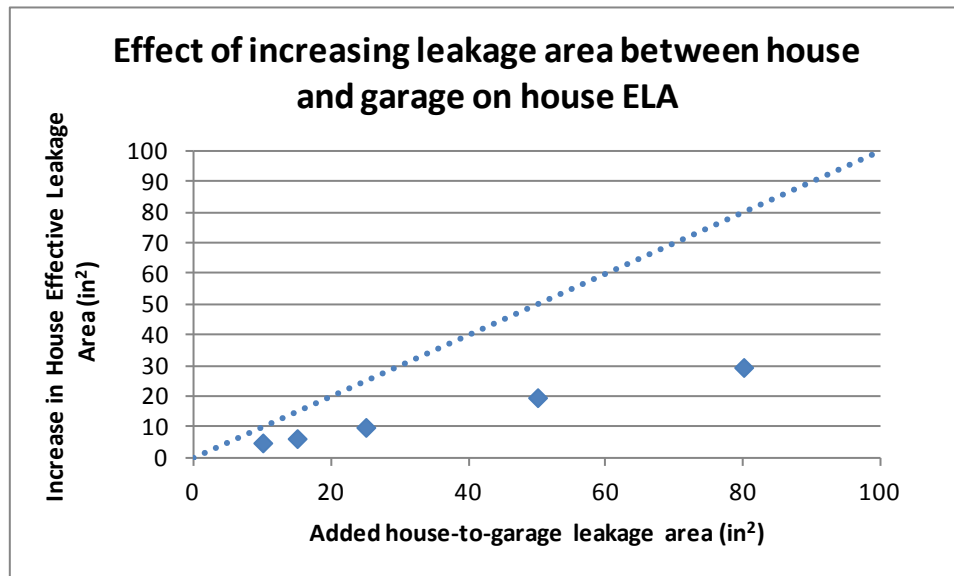
**Figure 14. House leakage area increased by less than half the physical house-to-garage opening area added**

Referring to Figure 14, a plot of the added house-to-garage leakage area illustrates that the house effective leakage area was impacted by less than half the amount that was added. This is due to the series leakage resistance from the house-to-garage and the garage-to-outside.

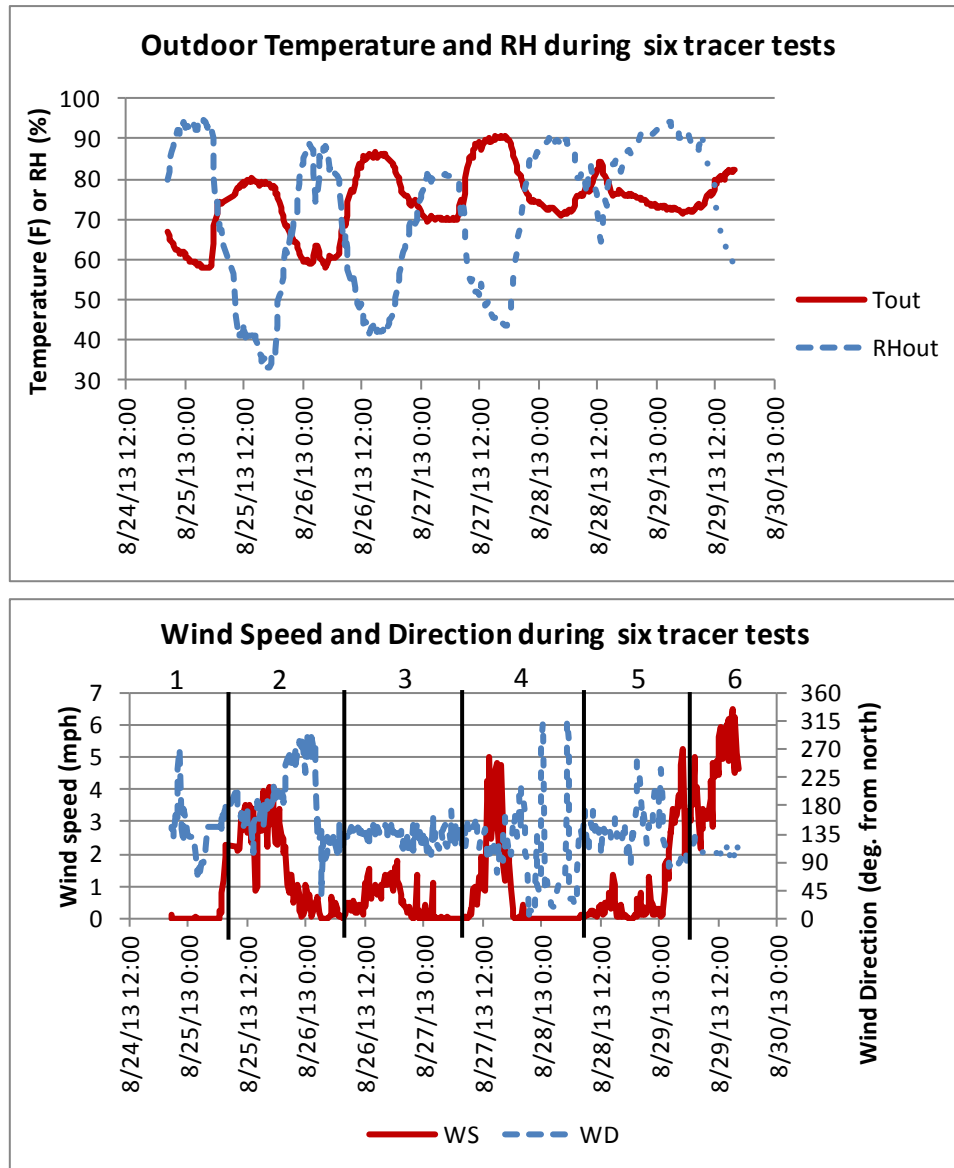
Figure 15. Weather conditions during the six tracer gas testing periods

Figure 15 shows the outdoor weather conditions of dry bulb temperature, RH, wind speed, and wind direction during the six tracer gas testing periods. Outdoor temperature generally ranged from lows of 60°–70°F at night to highs of 80°–90°F during the day. Wind speed ranged between 0 and 6 mph. Wind direction was most prominently from the southeast.

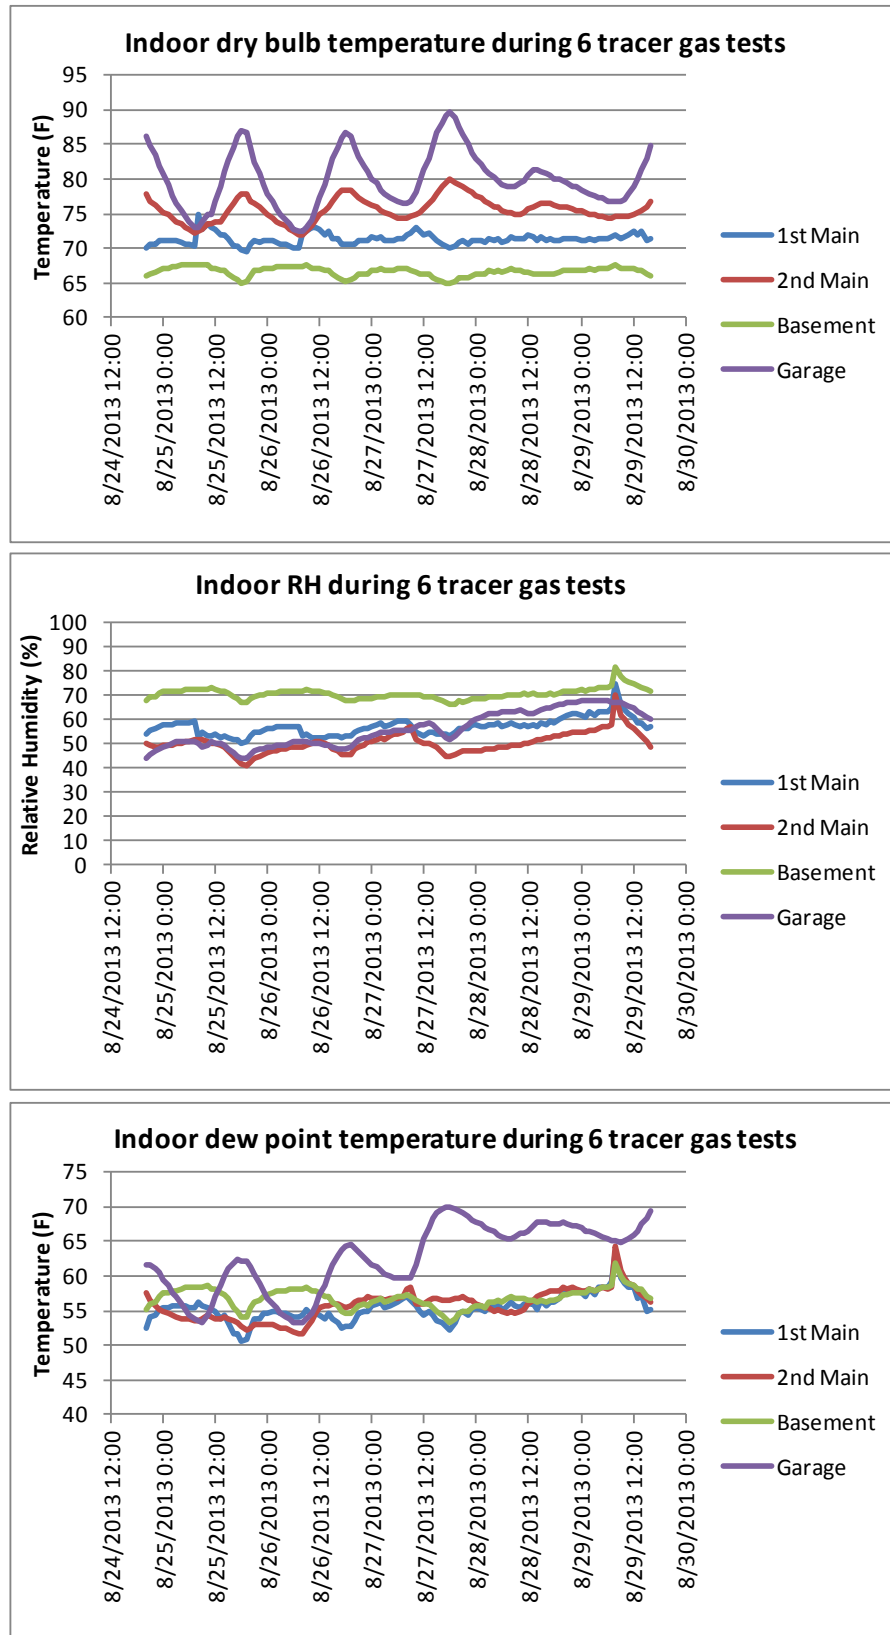
Figure 16. Indoor temperature and humidity conditions during the six tracer gas tests

Indoor air environmental conditions during the tracer gas testing are shown in Figure 16. The first floor dry bulb temperature was generally about 72°F, with maximum variation between 70°F and 75°F. The second floor was warmer and varied more (between 73°F and 80°F) because the central system fan serving the second floor was non-functional during the tracer gas testing period. For the tracer gas measurements, the first and second floors, with no separation between them were intended to be treated as a single zone. Mixing between floors helps them behave more as a single zone. Two inline fans with ducts were used to circulate air between the first and second floor, located at both stairways. The basement dry bulb temperature was typically about 67°F, with only small variation between 65°F and 68°F.

In the first and second floor living space, RH typically varied between 40% and 60%. The indoor dew point temperature generally varied between 50°F and 58°F throughout the testing, on all three levels. RH in the basement was about 70%, due to the cooler temperature (67°F dry bulb and 57°F dew point yields 70% RH). The spike in indoor conditions near the end of the testing occurred while the house was being flushed of SF<sub>6</sub> between Tests 5 and 6.

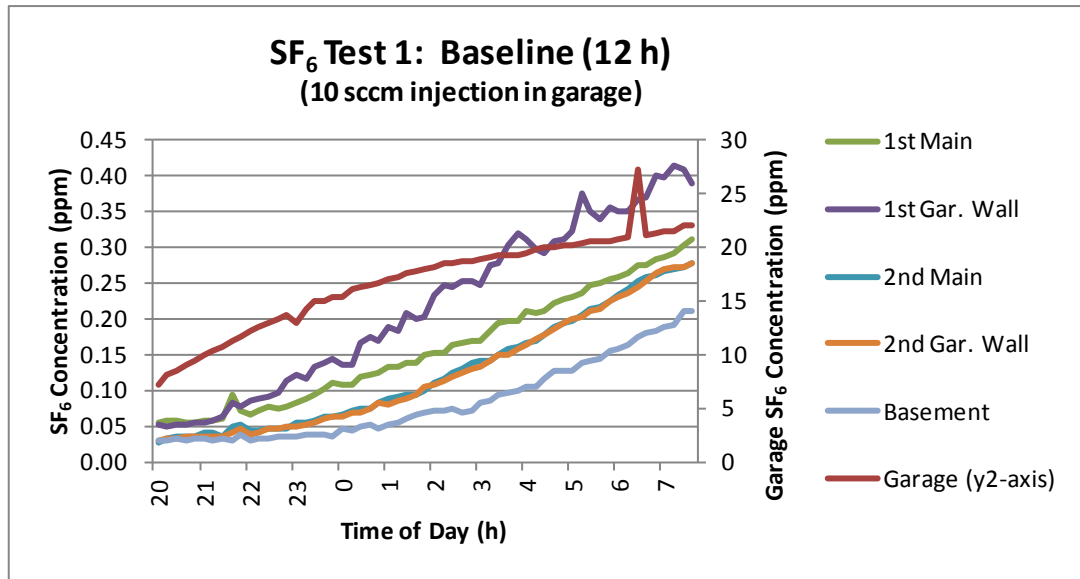
Figure 17. SF<sub>6</sub> test 1, initial Baseline tracer gas test showing that, by the end of the 24-hour test, about 1.4% of the air in the house came from the garage ( $0.3/22 = 0.014$ )

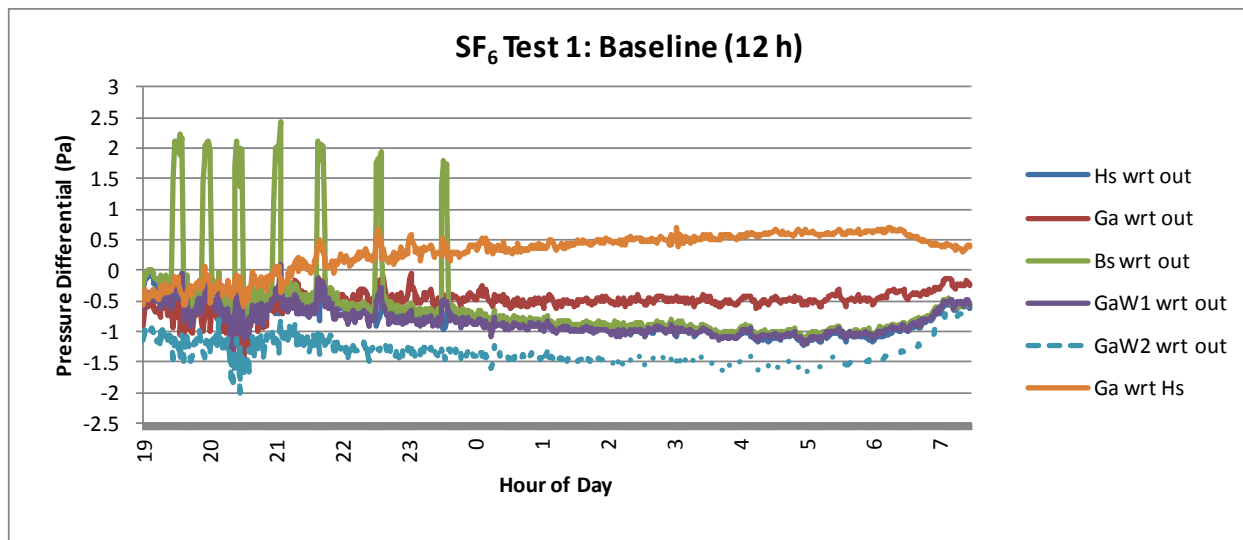
Figure 18. SF<sub>6</sub> Test 1, Baseline, monitored pressure differentials showing the garage pressure about 0.5 Pa positive with respect to the house

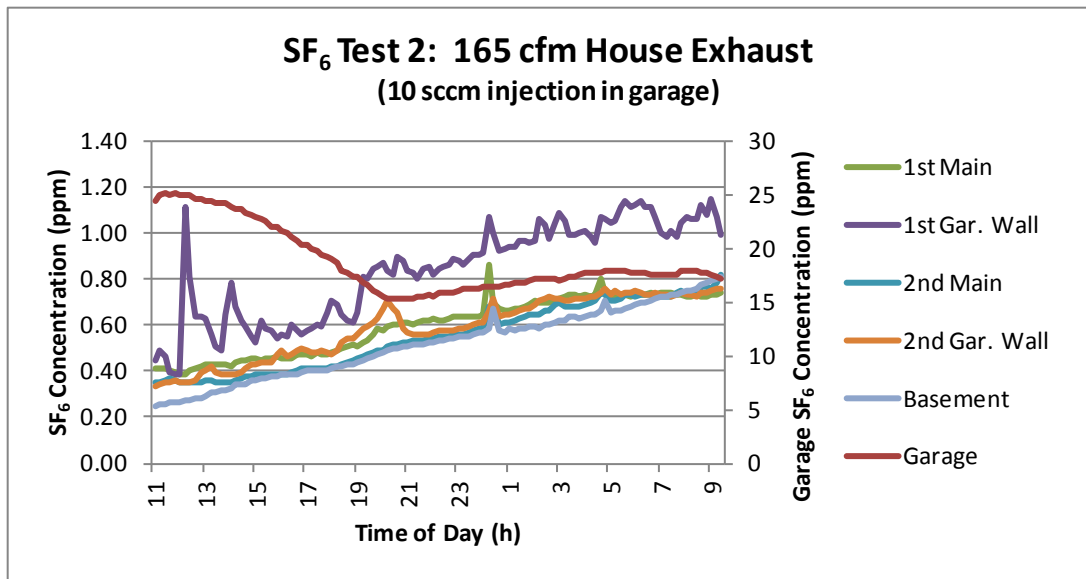
Figure 19. SF<sub>6</sub> test 2, 165 cfm House Exhaust ventilation tracer gas test showing that, by the end of the 24-hour test, 4.6%  $\pm$  1.4% of the air in the house came from the garage (0.78/17 = 0.046)

Results of the second tracer gas test are shown in Figure 19. In this test, 165 cfm of House Exhaust was operating. No mechanical ventilation operated in the garage. The test started with the garage SF<sub>6</sub> concentration where it was after the end of the baseline test. SF<sub>6</sub> injection in the garage was continuous. The test ran for about 24 hours. Wind speed was up to 4 mph during the day and less than 1 mph at night (Figure 15). Without wind, the garage pressure tracked steadily at 2 Pa positive with respect to the house (Figure 18). By the end of the test, the results showed that  $4.6\% \pm 1.4\%$  of the air in the house had come from the garage ( $0.78/17 = 0.046$ , using Eq. 4).

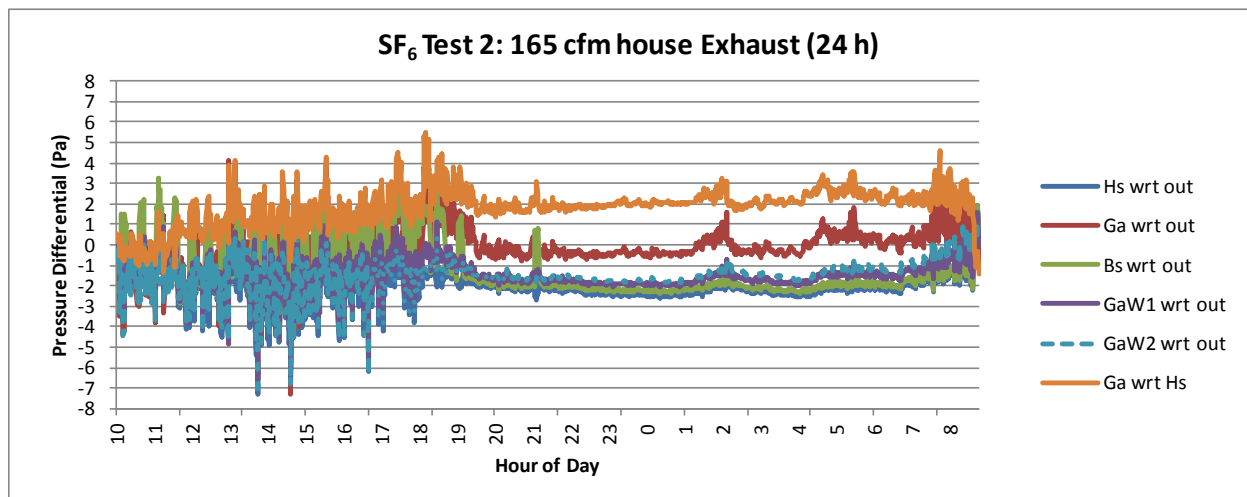
Figure 20. SF<sub>6</sub> test 2, 165 cfm House Exhaust, monitored pressure differentials showing the garage pressure about 2 Pa positive wrt the house

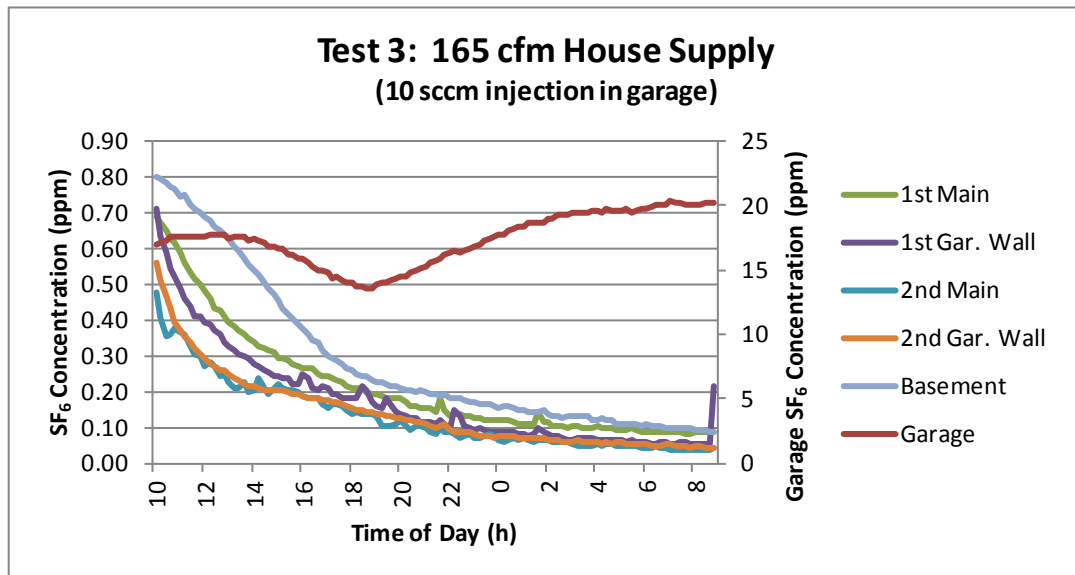
Figure 21. SF<sub>6</sub> Test 3, 165 cfm House Supply ventilation tracer gas test showing that, by the end of the 24-hour test, supply ventilation had suppressed essentially all air transfer from the garage to the house ( $0.1/20 = 0.005$ )

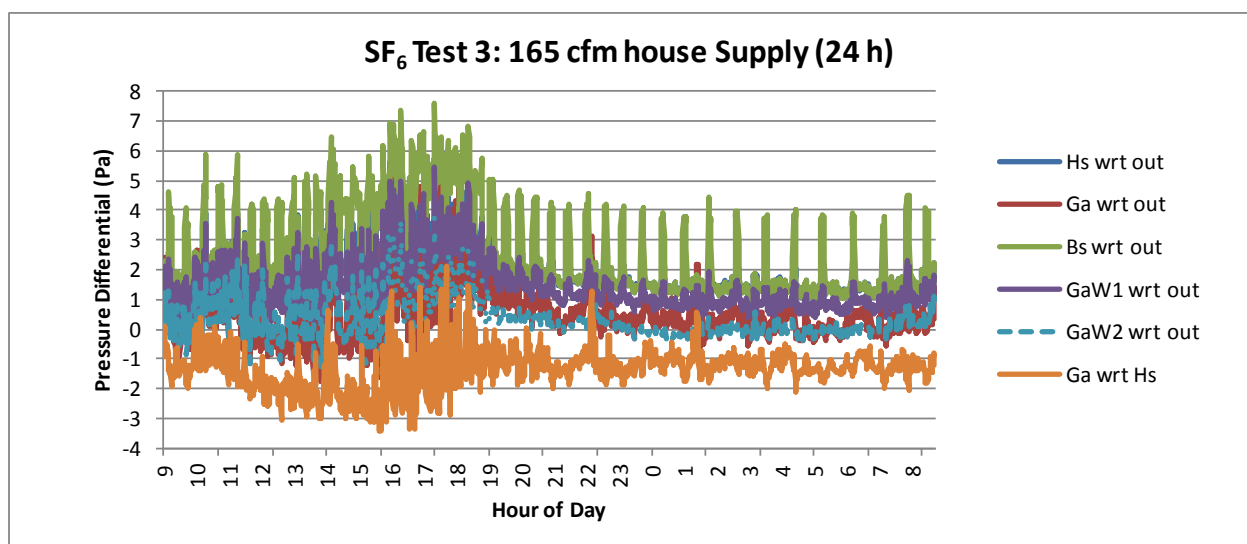
Figure 22. SF<sub>6</sub> test 3, 165 cfm House Supply, monitored pressure differentials showing the garage pressure about 1.5 Pa negative wrt the house

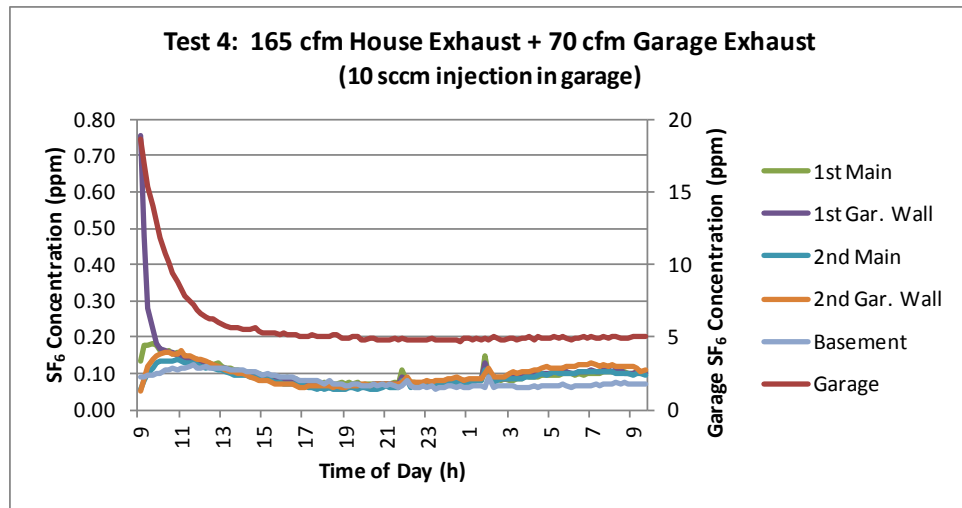
Figure 23. SF<sub>6</sub> test 4, 165 cfm House Exhaust and 70 cfm Garage Exhaust tracer gas test showed performance that was about the same as for the initial Baseline test ( $0.1/5.0 = 0.02$ )

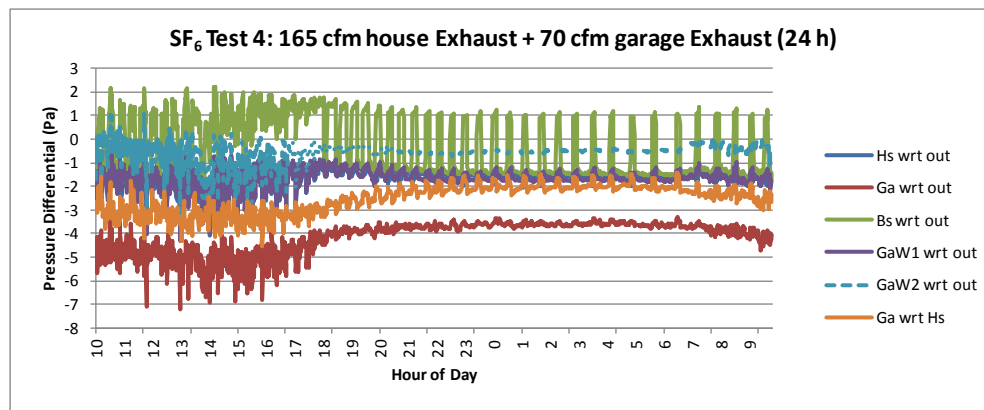
Figure 24. SF<sub>6</sub> test 4, 165 cfm House Exhaust and 70 cfm Garage Exhaust, monitored pressure differentials showing the garage pressure about 2 Pa negative wrt the house

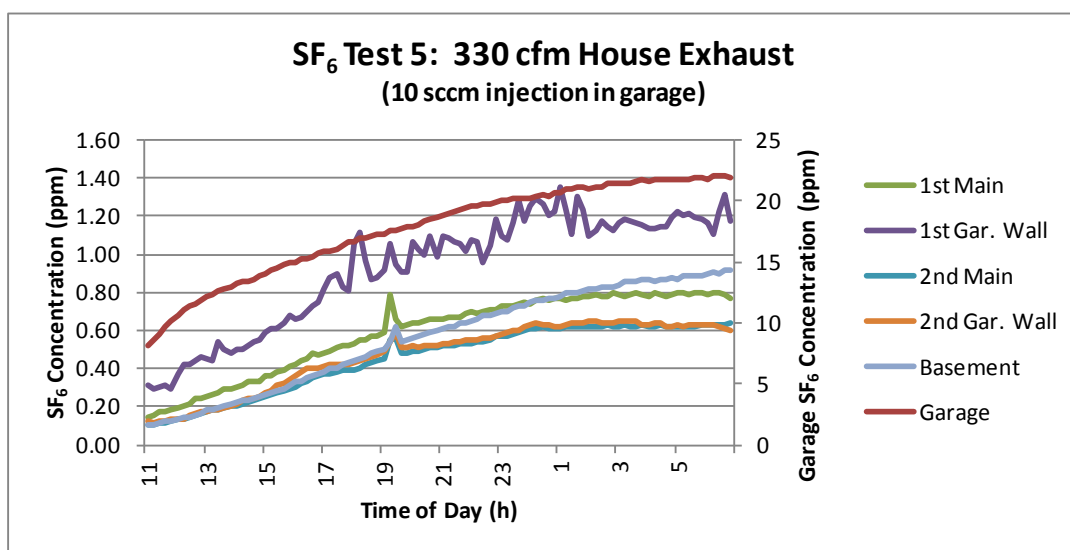
Figure 25. SF<sub>6</sub> test 5, 330 cfm House Exhaust tracer gas test showed that, by the end of the 24-hour test,  $3.2\% \pm 1.4\%$  of the air in the house had come from the garage ( $0.7/22 = 0.032$ )

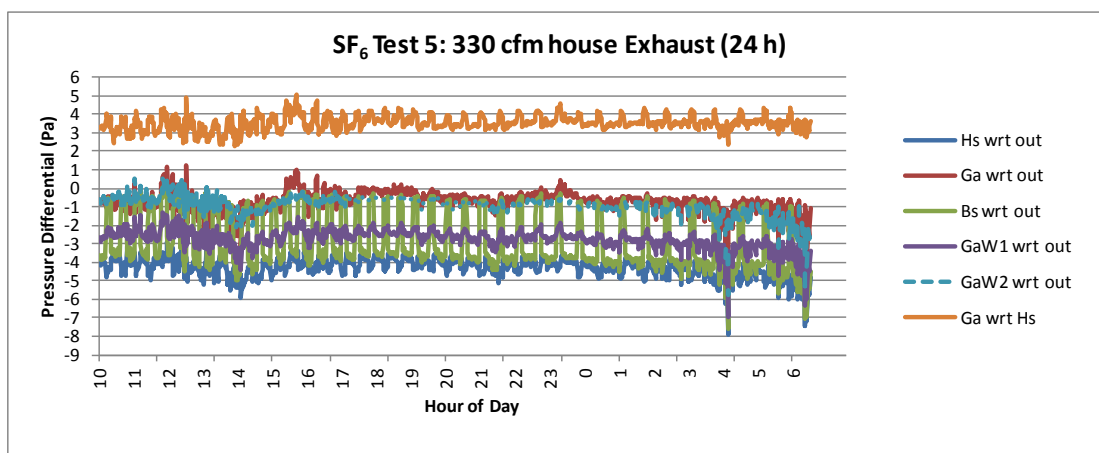
Figure 26. SF<sub>6</sub> test 5, 330 cfm House Exhaust, monitored pressure differentials showing the garage pressure about 3.5 Pa positive wrt the house

Pressure differential wrt outside was measured in the first-floor wall cavity adjacent to the garage, and in the second-floor wall cavity adjacent to the garage attic. These measurements were taken to provide indication of the relative airtightness of the outer-side air barrier compared to the inner-side air barrier. Results showed that the outer-side (garage-side wallboard) served as the primary air barrier for the first-floor wall, while the inner-side (house side wallboard) served as the primary air barrier for the second-floor wall. This is best seen in Figure 26.

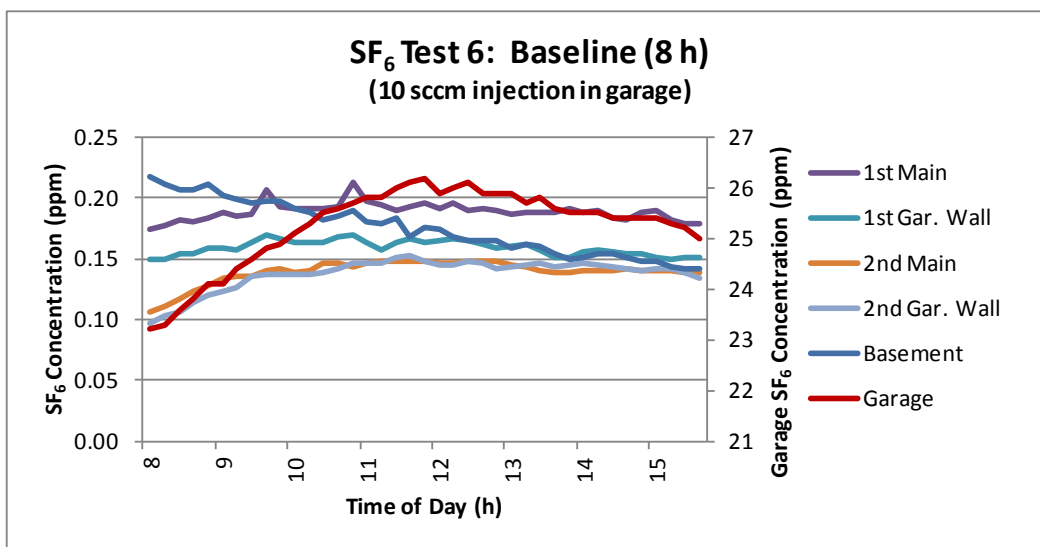
Figure 27. SF<sub>6</sub> Test 6, the final Baseline tracer gas test showed again that there was little garage-to-house air transfer across the well-sealed garage to house interface ( $0.16/25 = 0.006$ )

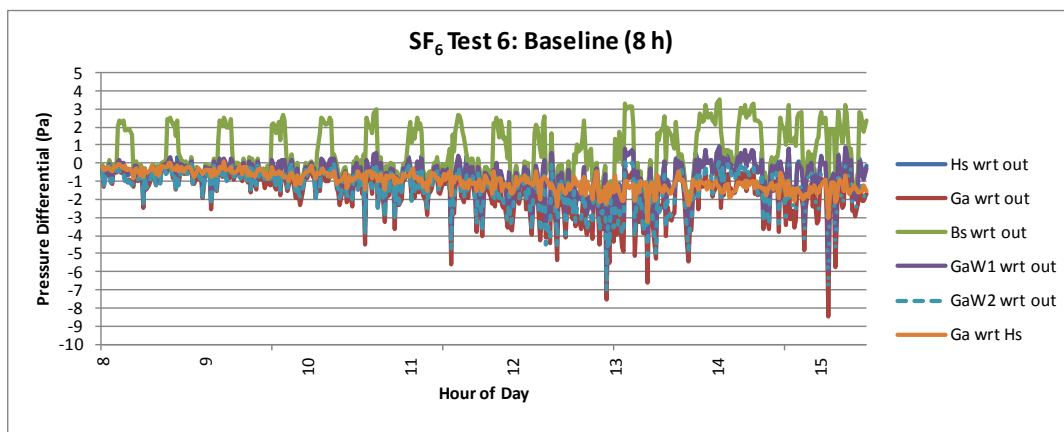
Figure 28. SF<sub>6</sub> Test 6, Baseline (8 h), monitored pressure differentials showing the garage pressure about 1.5 Pa negative wrt the house

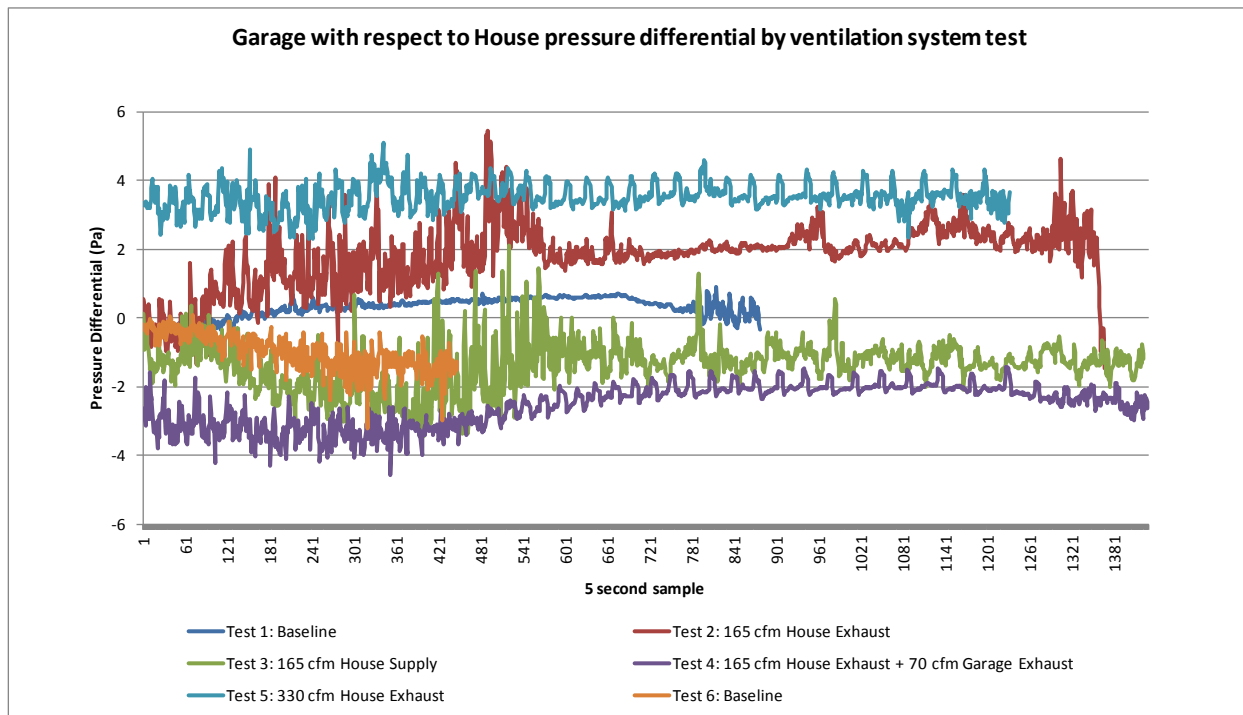
**Figure 29. Pressure differential of the garage wrt house for each tracer gas test**

Figure 29 summarizes the garage wrt house pressure differential for each tracer gas test, including the Baseline tests and each ventilation system test. As shown, Garage Exhaust and House Supply ventilation consistently kept the garage at a negative pressure wrt the house. The second Baseline test also showed this relationship, while the first Baseline test showed close to neutral pressure conditions, both of which would be indicative of balanced ventilation.

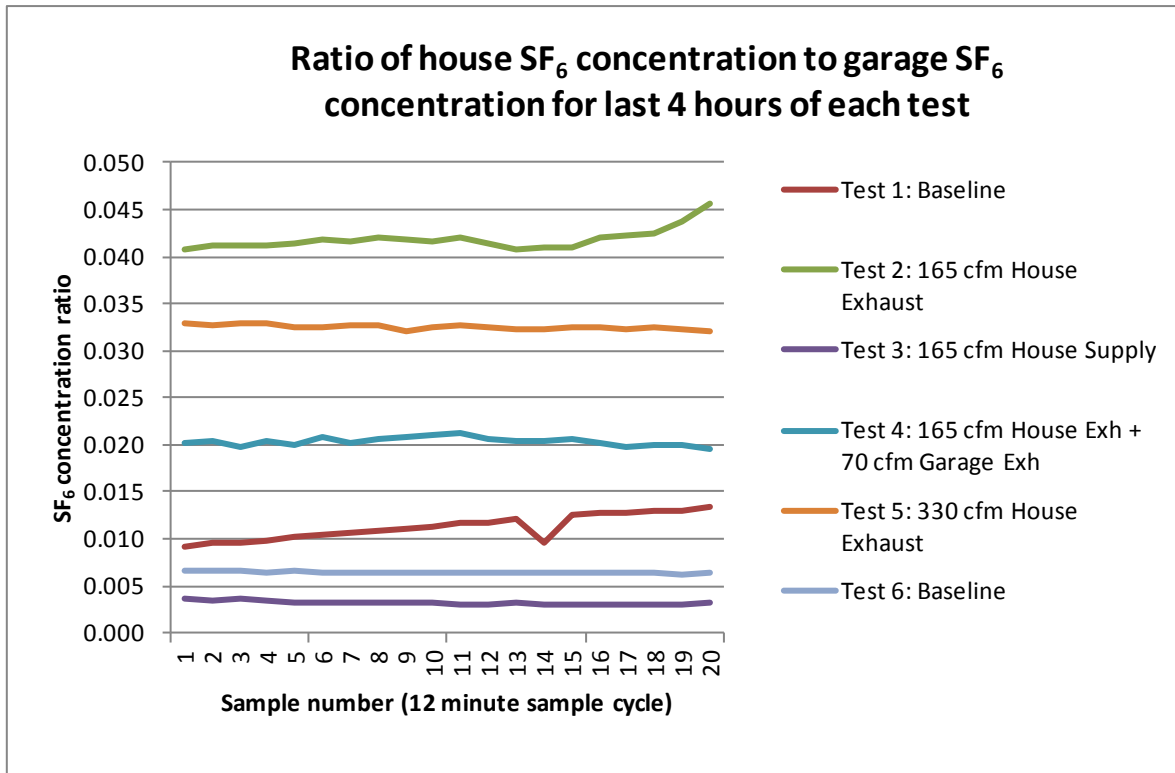
**Figure 30. Ratio of average house SF<sub>6</sub> concentration to garage SF<sub>6</sub> concentration for the last 4 hours of each test, representing the fraction of house air that came from the garage**

Figure 30 is a summary graph of the average house  $\text{SF}_6$  concentration divided by the garage  $\text{SF}_6$  over the last 4 hours of each test. This concentration ratio shows the fraction of air in the house that came from the garage. The operation of different ventilation systems showed a consistent and steady difference in the fraction of house air that came from the garage. From high to low fraction, the order was: House Exhaust, Baseline, House Exhaust+Garage Exhaust, and Supply.
