HOME PERFORMANCE WITH
ENERGY STAR

Case Study: HartmanBaldwin Design/Build Pasadena, CA

High-End Architect and Construction Company's Questions lead to Building Science

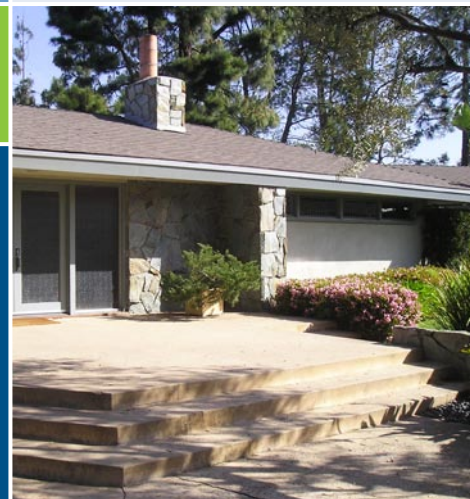
Building shell leakage was cut by 45% and duct leakage was cut by 91% in this Home Performance with ENERGY STAR retrofit by HartmanBaldwin in Pasadena, California

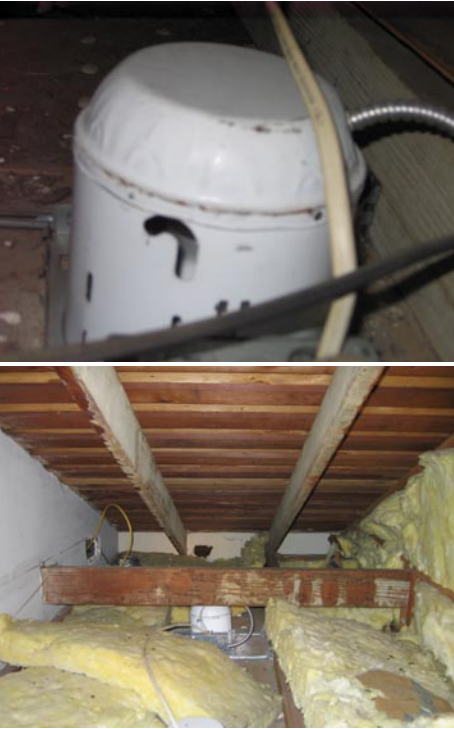
(top) Holes in 52 can (recessed) lights caused significant air leakage.

(bottom) Batt insulation above the office had been moved and not repositioned to provide adequate ceiling coverage.

To address this leakage problem, the team started with sealing the attic. They removed the existing R-13 batt insulation from the attic’s floor, which was performing at an R-5 due to its poor installation and condition. Then, they sealed the interior wall cavities that were open to the attic. “These cavities allow hot or cold air from the attic to come down inside the interior wall cavities,” says Durben.

Through an electrical safety check, the team discovered numerous electrical code violations, which were subsequently fixed in order to then properly seal the attic’s surface area. A significant air leakage problem came from the 52 non-insulated, non-airtight recessed (can) lights that allowed for conditioned air to escape up to the attic. They built air-tight boxes over each light with adequate space for fire safety, and then buried these in new blown-in cellulose at 10 to 12 inches in height for a new R-38 value.

Increased attic insulation from sloppy R-5 batt to R-38 blown cellulose

Built air-tight boxes around 52 noninsulated, non air-tight recessed can lights in ceiling

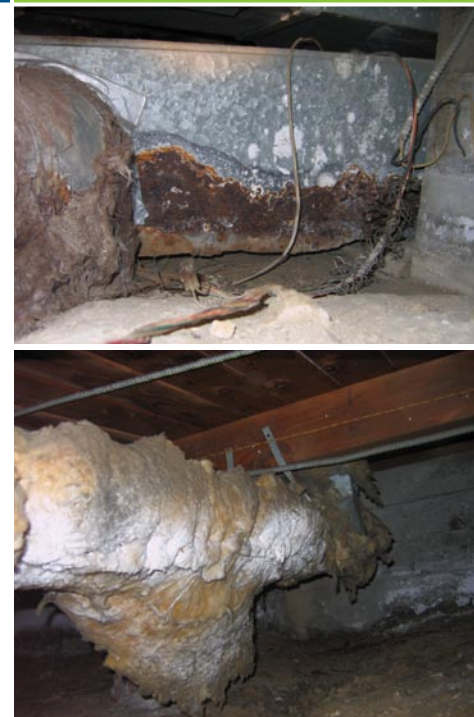
One test result proved particularly interesting. “I did the duct blaster test a couple of times,” said Durben. “I thought I must be doing something wrong because I wasn’t getting any reading. Finally, I crawled under the house to see. The bottom of the return plenum had completely rusted out.”

McCoy adds, “I have had repairmen here countless times for things, and no one ever mentioned to me that the ducts were rusted through and sitting in the dirt.”

(top) The bottom of the furnace’s return plenum was completely rusted out.

(bottom) Unidentified debris covered the duct insulation in the crawlspace.

After completing the air sealing in the attic, the team tackled the crawlspace. They removed the rusted-through ducts and debris; inspected and repaired electrical, plumbing, and gas issues; installed a vapor barrier and ventilation fan, and sealed all the vents. They also sealed all major floor penetrations, including electrical, plumbing water, waste pipes, and tub and shower access areas.

Replaced rusted out metal ducts with R-8 insulated plastic flex duct configured for short duct runs

The team installed plastic flex duct with R-8 insulation and lined the crawlspace floor with a Mylar vapor barrier. In the new design, each supply duct run is a home run to the supply plenum to ensure the correct amount of air could be delivered at the right speed to each room. This is important explains Durben because “Too much air or too little air in the room is going to be uncomfortable, and you need the air delivered at the right speed.”

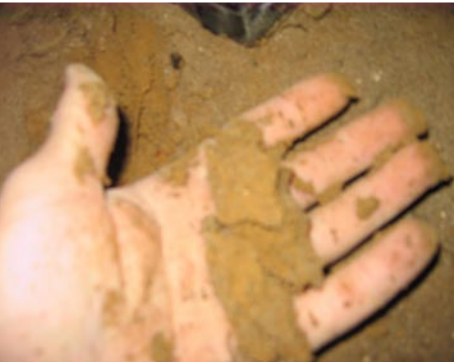
High moisture content was found in the soil of the crawlspace which had no vapor barrier covering.

Laid mylar vapor barrier over the crawlspace dirt floor and added a ventilation fan; all floor penetrations sealed
