# Short-Term Test Results: Multifamily Home Deep Energy Efficiency Retrofit

James Lyons  
*BA-PIRC*

January 2013

## **Short-Term Test Results: Multifamily Home Energy Efficiency Retrofit**

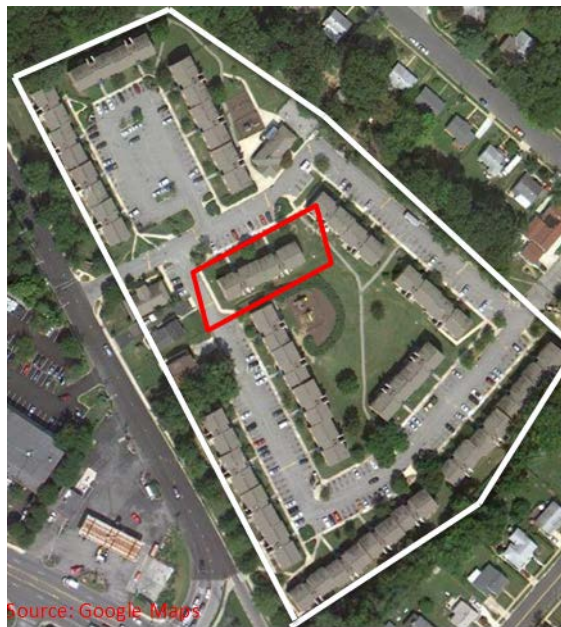
**Figure 1. Aerial view of Bay Ridge development; DER building outlined in red**

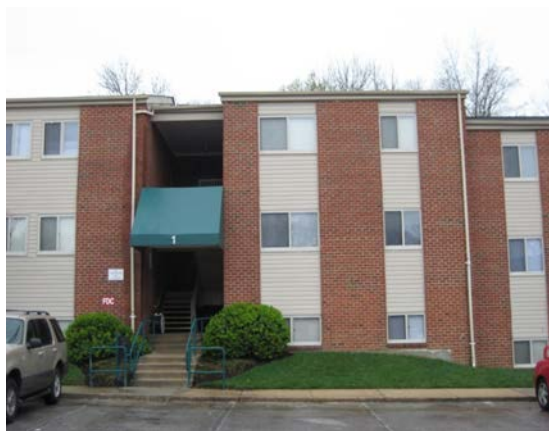
**Figure 2. Front view of three-story apartment building**

Referring to Figures 2 and 7, the guarded blower door tests were conducted on a stairwell basis. In other words, all six apartments accessed from a given stairwell and those that were “connected” through the shared mechanical room on each floor were simultaneously depressurized to  $-50$  Pa and maintained at this level while a  $\text{cfm}_{50}$  reading was recorded for each. Arranging access for this level of testing, in addition to assembling enough technicians and equipment, was a significant effort. As a result, pre- and post-retrofit testing was conducted only on a sample of apartments and stairwells, as noted in Table 3.

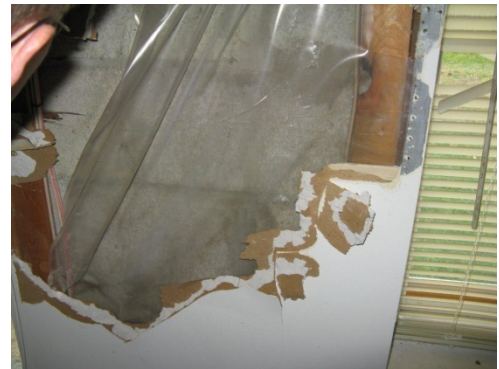
**Figure 3. Polyethylene layer on inside face of concrete masonry unit (CMU) wall assembly**

Newport's invasive investigations of the building revealed an exterior wall assembly of uninsulated CMUs with a layer of poly on the inner face of the block (see Figures 3 and 4).

Hygrothermal analysis of this assembly showed significant risk of wintertime condensation on the inner face of this poly if insulation was added to the inner side of this assembly. As a result, laminating R-5 extruded polystyrene insulation to the existing drywall on exterior walls, which had been a cost-effective measure based on initial analysis, was rejected as a potential efficiency measure.

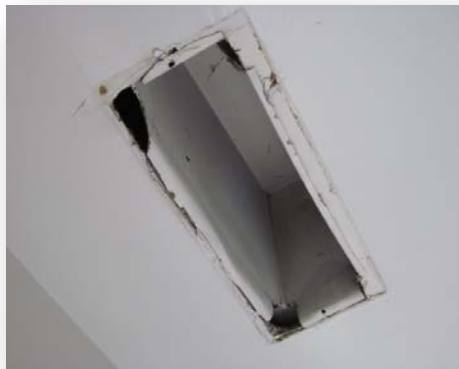
**Figure 5. Air sealing opportunity at corners of duct boot where it meets ceiling drywall**

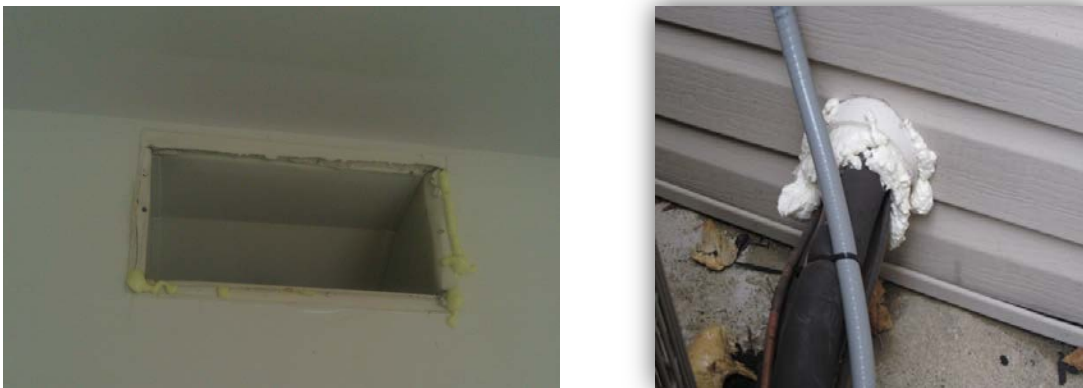
**Figure 6. Air sealing of duct register boot and an HVAC penetration**

Reducing natural infiltration was a primary strategy for the DER. The base scope included significant air sealing measures as they could be applied from within the apartment units (e.g., SPF around duct boot/drywall junction). Given typical pre-retrofit infiltration rates of 17 ACH<sub>50</sub> (guarded) based on a sample of three representative buildings, the cost effectiveness of air sealing in the base scope was found to be attractive (SIR ~5). Figure 6 shows some typical air sealing locations.

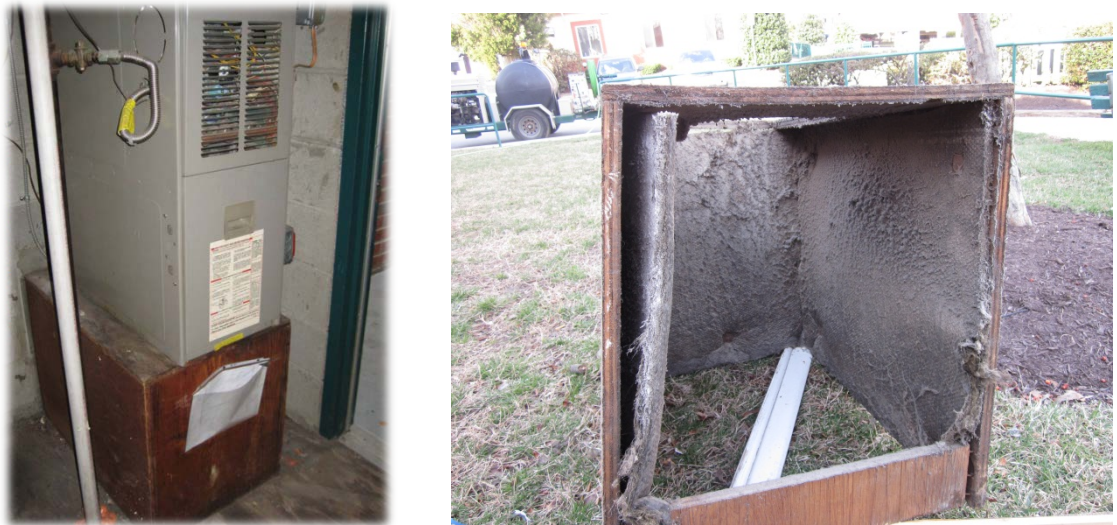
**Figure 8. Pre-retrofit HVAC return plenum**

Table 4 gives the results of pre- and post-retrofit duct blaster testing. Overall, the duct sealing efforts resulted in a significant reduction in total duct leakage (63%). The return plenums, originally constructed from plywood and in very poor condition—including signs of past water damage (Figure 8)—were also replaced with sheet metal plenums.

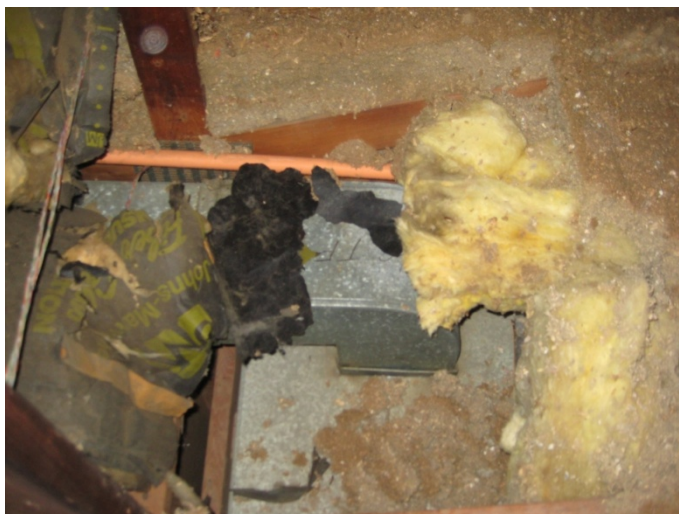
**Figure 9. Supply trunk for third-floor apartment exposed to attic (pre-retrofit condition)**

The third-floor apartments were also targeted for duct leakage reduction and improved insulation through an additional measure: sealing the top side of a bulkhead that housed the supply trunk. This bulkhead was open to the attic space in terms of air movement, and had inconsistent levels of insulation (ranging from R-19 to no insulation) placed on top of the supply trunk (see Figure 9).

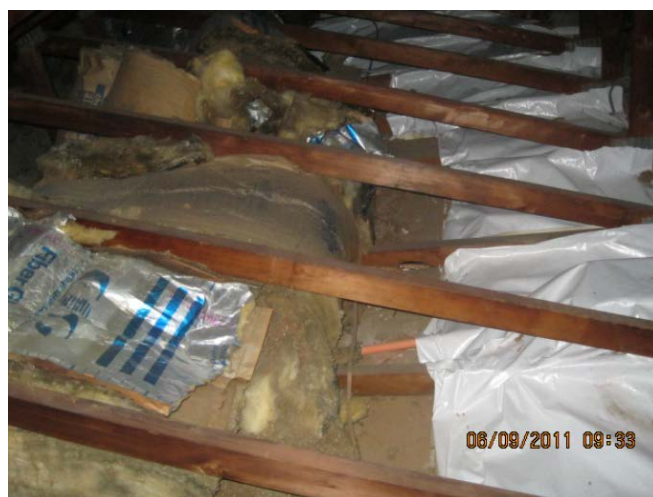
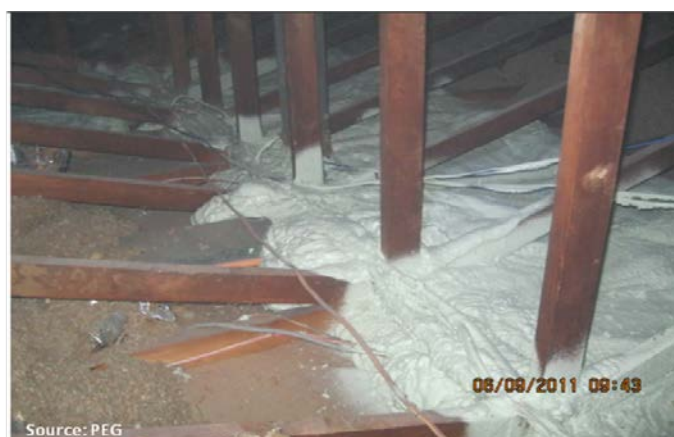
**Figure 9. Membrane application followed by SPF application to seal off top of duct bulkhead from attic**

Insulating and air sealing the open-top bulkhead shown in Figures 9 and 10 involved a two-step process specified by Patuxent Environmental Group (the base scope auditor). It involved (1) removing insulation from the bulkhead area and putting down a membrane to serve as a substrate, and then (2) applying a layer of SPF to bond the membrane to the ceiling drywall as well as cap off the ends of the bulkhead. These two steps are shown in Figure 11. This process proved to be effective when properly implemented. In some cases, however, site inspections revealed that the insulation contractors would cover the top of the bulkhead with SPF but fail to block off the ends, which would still allow significant air leakage to the attic.

Sealing off this bulkhead also contributed to the whole-dwelling air leakage reductions for third-floor apartments noted in Table 3.

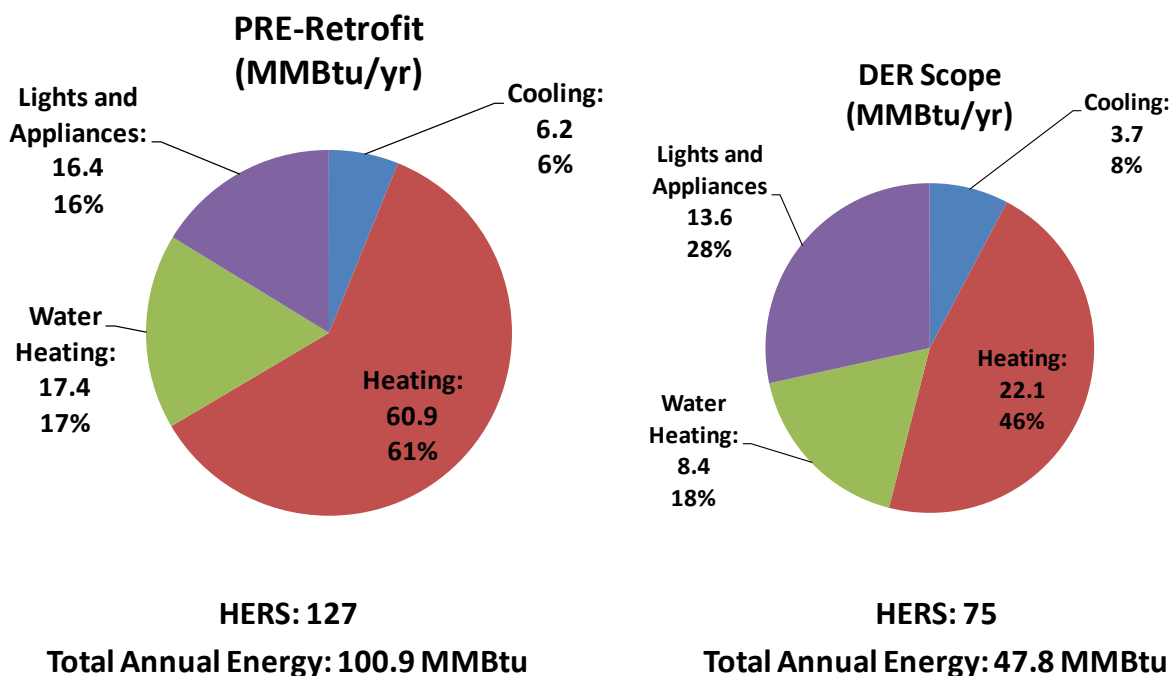
Figure 10. Energy end use reductions in the DER design

Despite these challenges in specifying workable efficiency upgrade measures, the Bay Ridge DER is estimated to achieve a 52% reduction in energy use compared to the pre-retrofit building. The measures used to achieve this reduction are listed in Table 2. Figure 12 shows the distribution of these savings across energy end uses.
