BUILDING AMERICA TOP INNOVATIONS 2013 PROFILE

Window Replacement, Rehabilitation, & Repair Guide

PNNL-SA-98660 September 2013

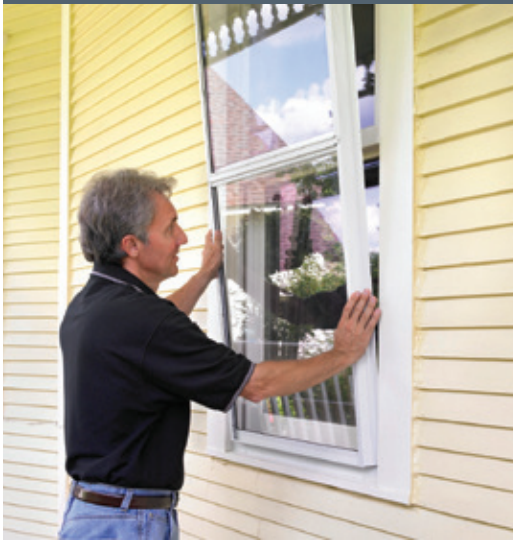
(Top left) Low-E storm windows are one option for improving the thermal performance of existing windows.

If the windows are in fairly good working order with no rotting wood or broken parts and no water intrusion issues and the only concerns are heat loss and air leakage, another option to consider is storm windows. Interior storm windows come in two varieties—temporary and permanent. Temporary storm windows are installed seasonally in the winter and removed during the summer, permanent storm windows are installed permanently and stay in place to provide an air sealing and insulating benefit year round. They typically have panels that can slide open and closed. Condensation potential can be minimized by ensuring that the interface between the interior storm and the window frame is as air tight as possible, that potential air paths like pulleys for sash weights are sealed, and if necessary that a slight amount of ventilation be provided to the outside by shimming open the outside window. Exterior storm windows are also available in permanent and seasonally installed varieties. To minimize condensation potential the inside window should be made as airtight as possible and the storm window should have weep holes to add the slight ventilation needed to mitigate condensation. Storm windows with low-emissivity coatings are available and should be selected wherever possible to reap the additional benefits of low-e glass, which include reduced heat loss in the winter and lower heat gain in the summer.

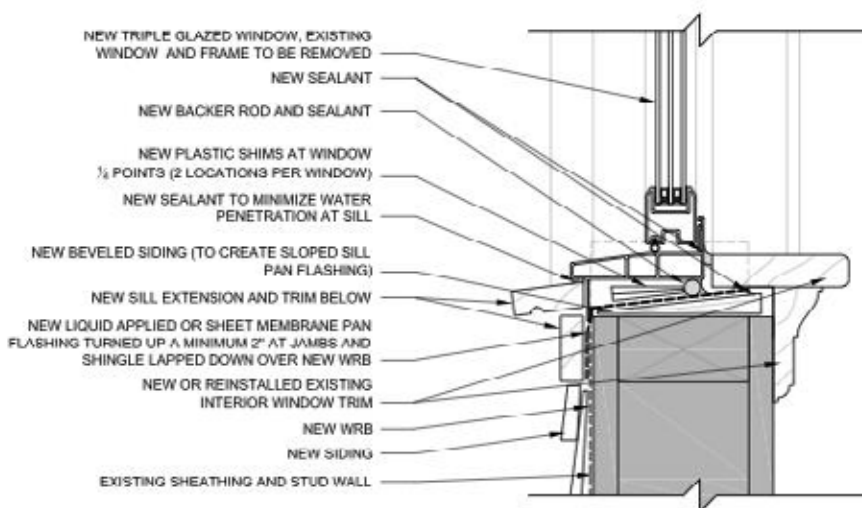
This diagram shows the sill detail for a replacement window in conjunction with siding replacement.

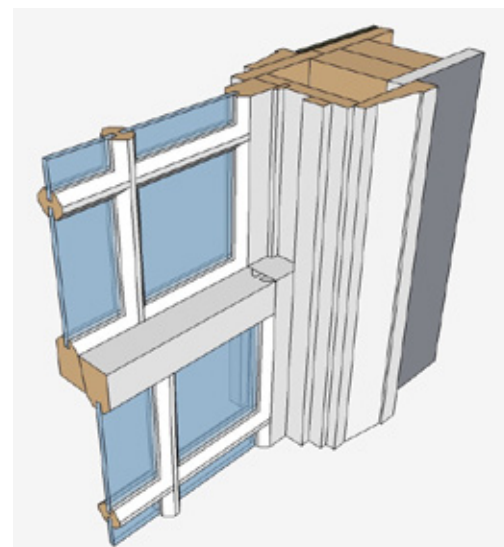
Air sealing of the jambs and framing is an important part of window rehabilitation.
