FEDERAL ENERGY MANAGEMENT PROGRAM

Data Center Airflow Management Retrofit

Technology Case Study Bulletin: September 2010

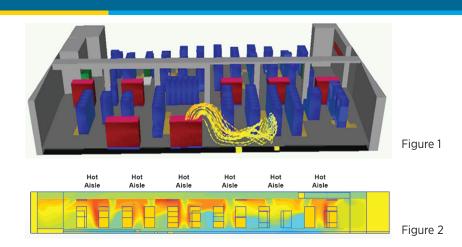
Figure 1: Data center CFD model of return airflow short circuit (Courtesy: ANCIS) Figure 2: Data center CFD model - airflow cross section (Courtesy: ANCIS)

Data center operators can benefit from airflow visualization models created by using computational fluid dynamics (CFD). Understanding airflow within data centers is complicated because under-floor air distribution and unguided pathways often result in unintended turbulences and vortices. These turbulences and vortices limit cooling capacity and waste energy. A CFD model of the data center can help identify detrimental airflow short-circuits, mixing, imbalances, and hotspots. Examples of CFD modeling at LBNL are provided in Figures 1 and 2.

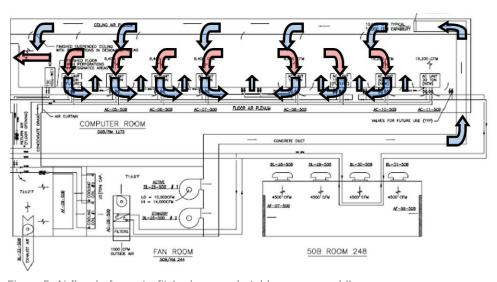
Figure 5: Airflow before retrofit (red arrows=hot; blue arrows=cold)

- Ceiling plenum became return airflow pathway.
- Extended CRAC intakes into new overhead hot-air return plenum.
 - Duct CRAC units to ceiling plenum (see Figure 4).
- Redirected supplementary cooling to under floor.
 - Relocated existing overhead supply to under-floor plenum (see Figures 5 and 6).
- Installed isolation curtains.
 - Added strip curtains to hot aisles (see Figure 7).

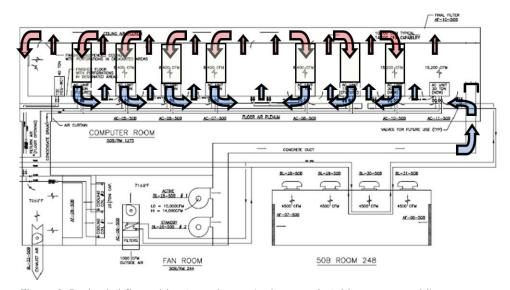
Figure 6: Revised airflow with return plenum (red arrows=hot; blue arrows=cold)

Cold and hot airflow mixing was significantly reduced by redirecting cooling air from an existing overhead supply system to the under-floor cooling plenum already in use by the CRAC units. Strip curtains improved isolation of cold and hot airstreams.

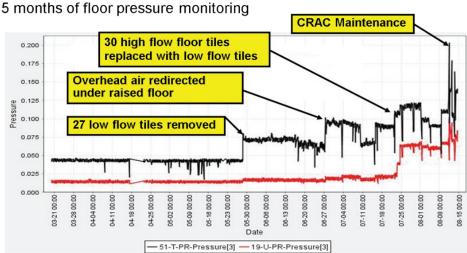
Figure 8: Floor tiles; before and after retrofit

Under-floor air distribution was examined and optimized for pressure and flow distribution. Installation of many wireless temperature and pressure sensors aided the optimization process (refer to DOE Wireless Sensors Improve Data Center Efficiency Technology Case Study Bulletin). The following improvements were made to the tile configuration (see Figure 8):

- 27 perforated floor tiles removed.
- 30 floor tiles converted from highto low-flow.
- 4 floor tiles converted from lowto high-flow.
