## Failure Modes of CPV Modules and How to Test for Them

19-Feb-10

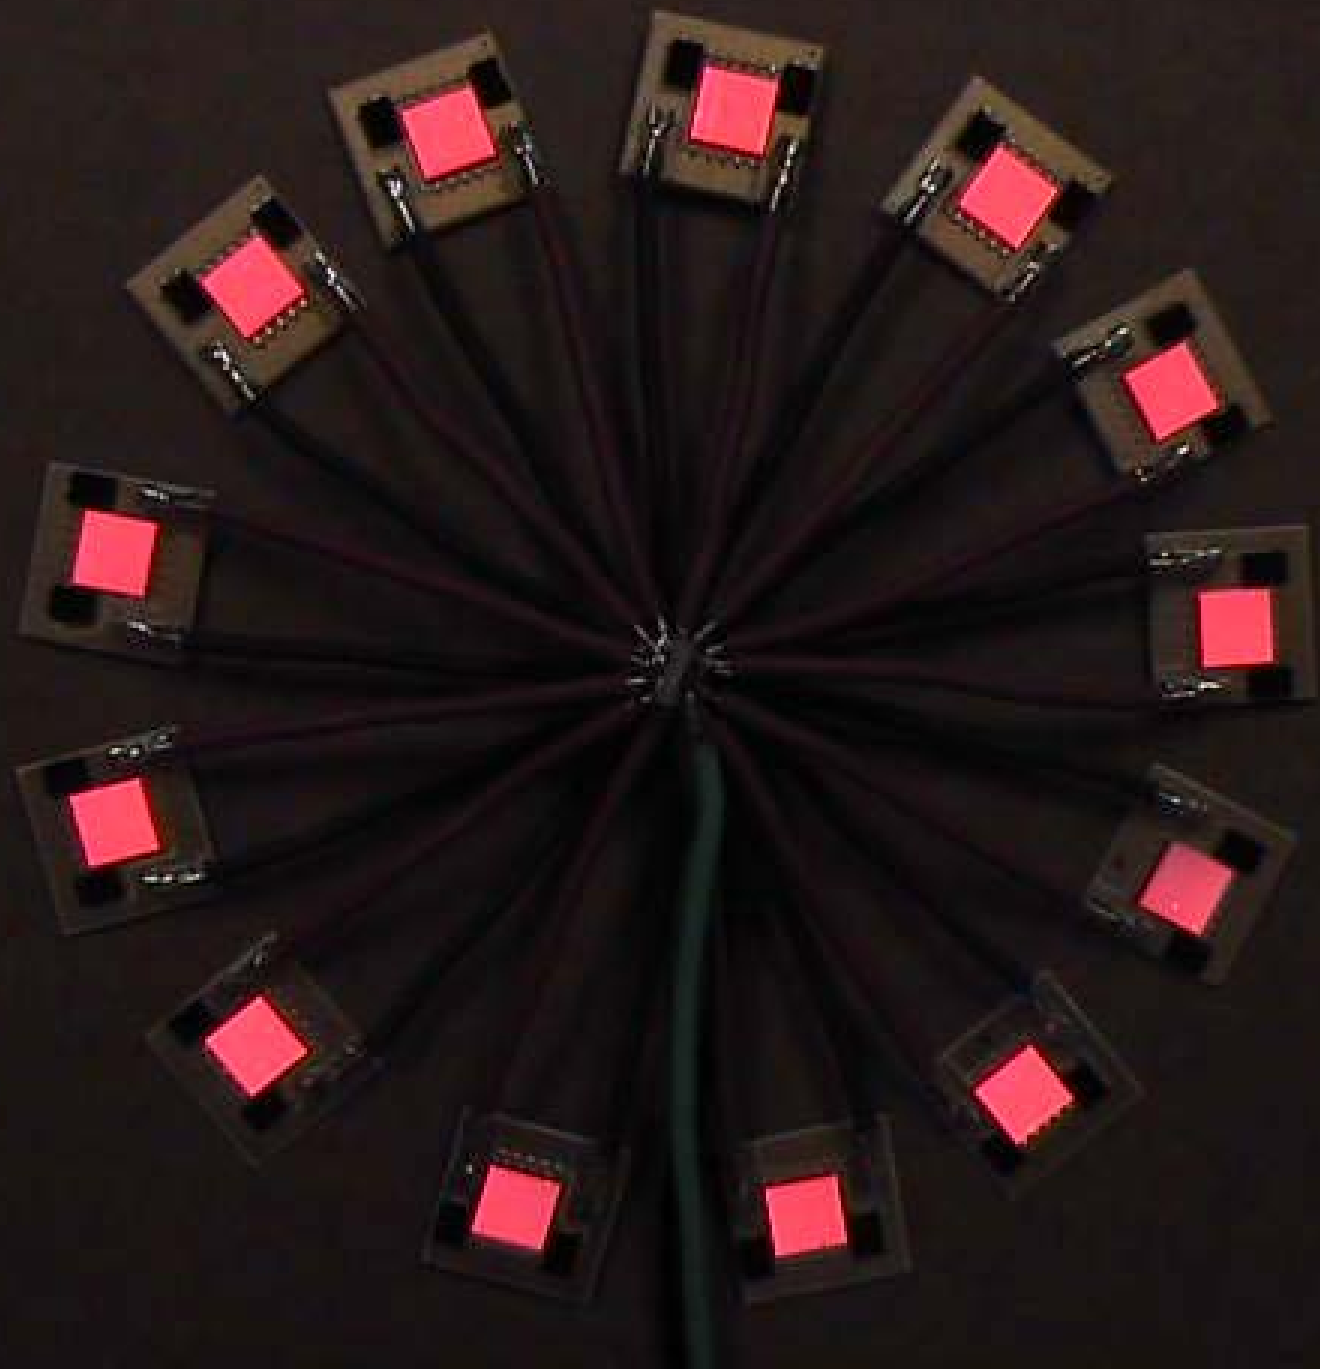
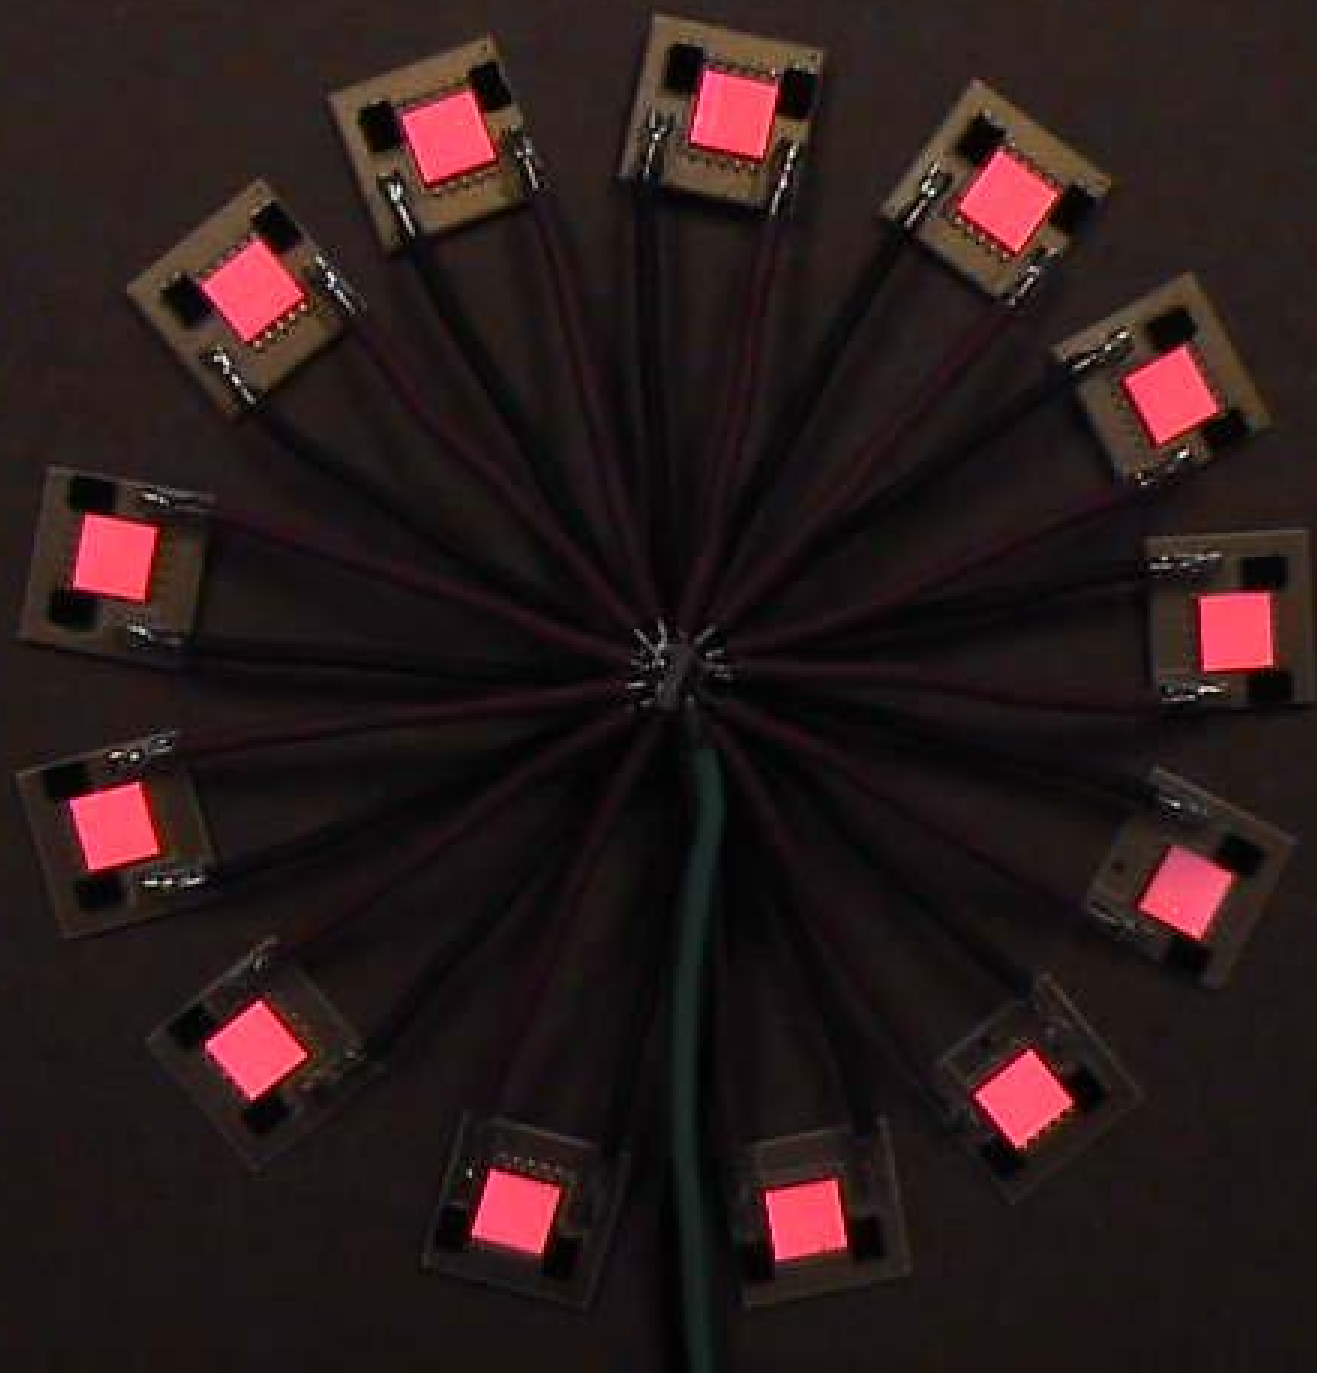
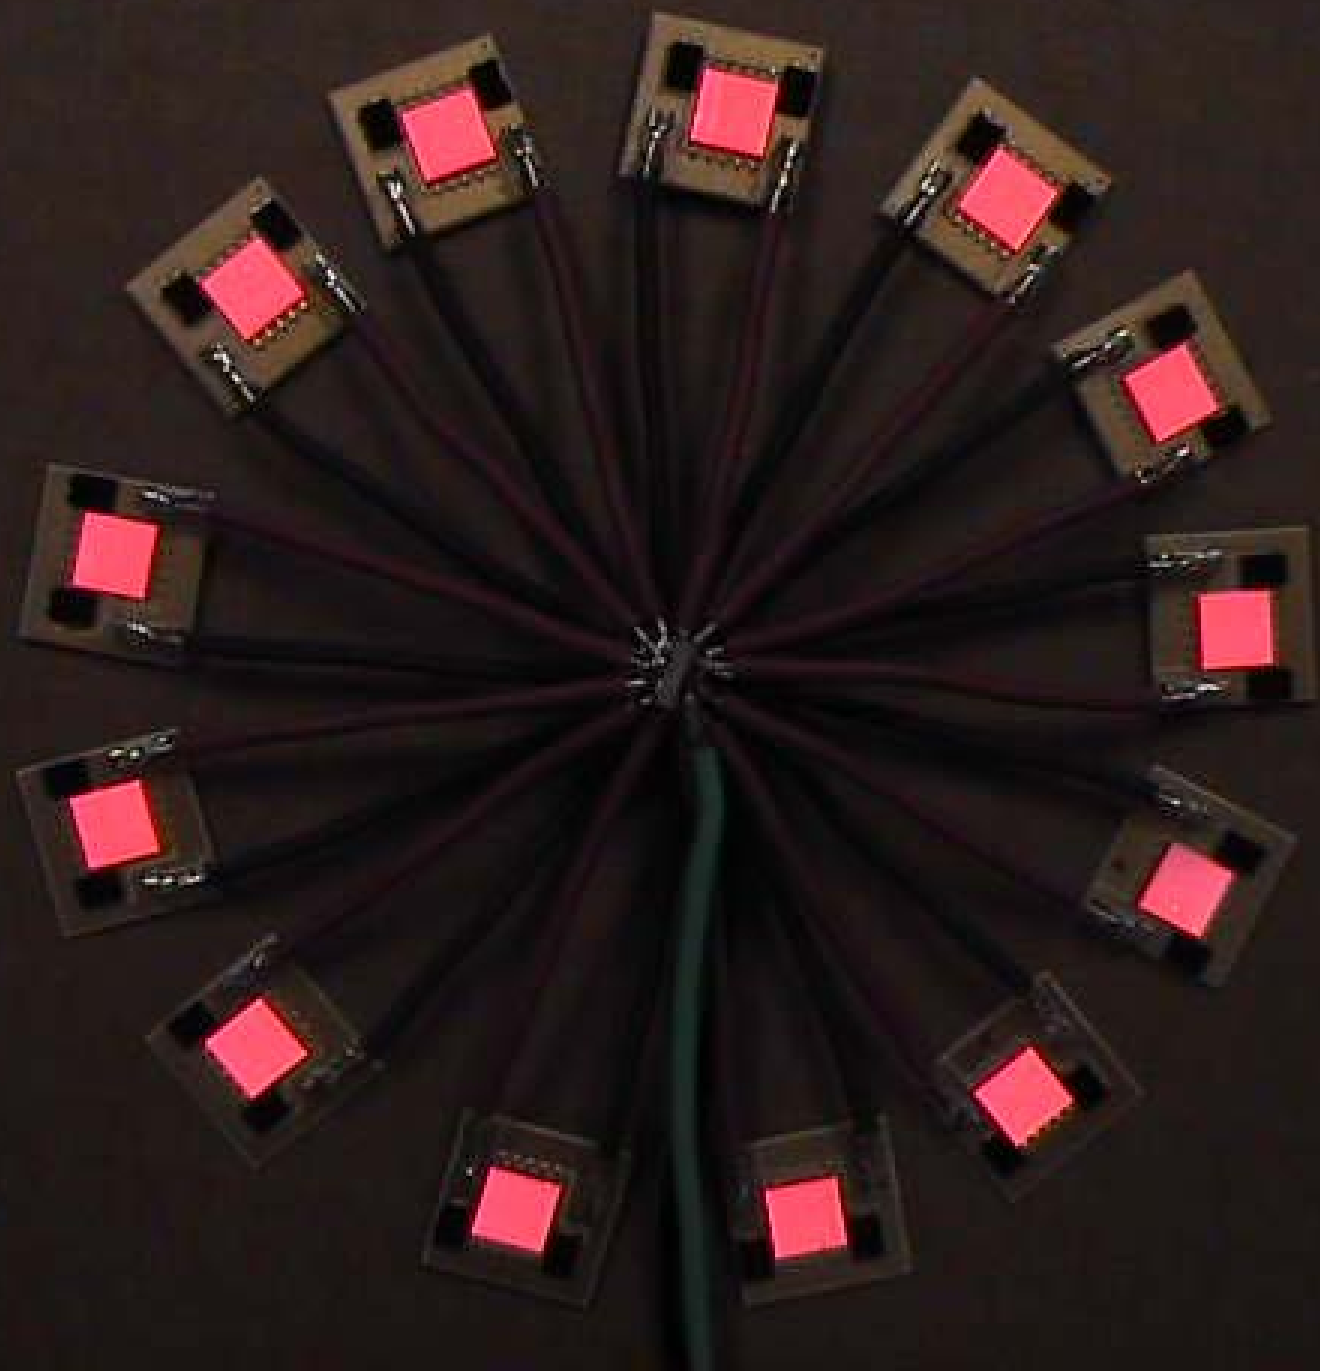
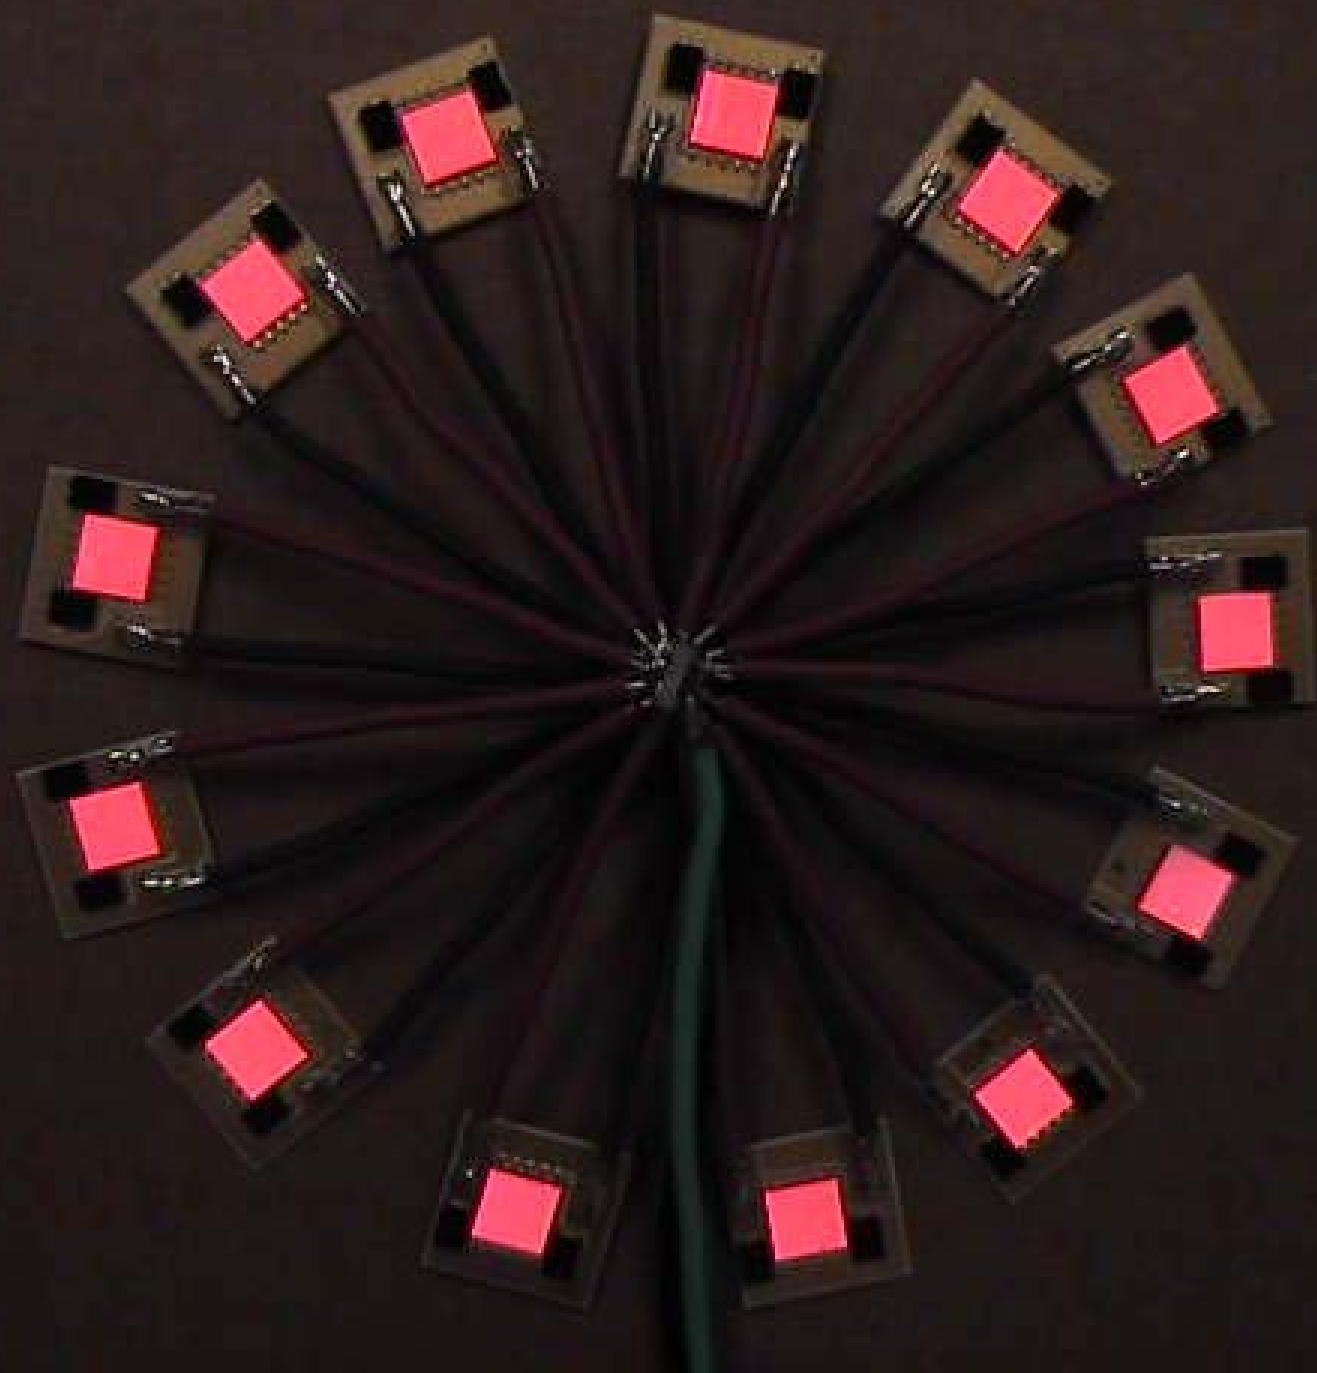
- The following slide sequence shows a baker's dozen of Rxs wired in parallel.
- A fixed voltage at 3 A total regulated current is applied in the forward direction.

- Each device sees the same voltage, but draws a slightly different current due to natural variations in the forward IV characteristics of the cells.
- The assembly is then allowed to heat up.

- As this happens, eventually one of the devices will heat a bit more than the others.
- This, in turn, causes a shift towards lower voltage of the IV characteristic of the hotter device.

- Which leads to an increase in current flow through that device.
- Which leads to it getting even hotter due to joule heating.
- Which causes the IV curve to shift even further.

- Etc., etc.
- Eventually, a single device in the array will draw the lion's share of the current.
- If this is allowed to continue, that device will eventually overheat and fail.

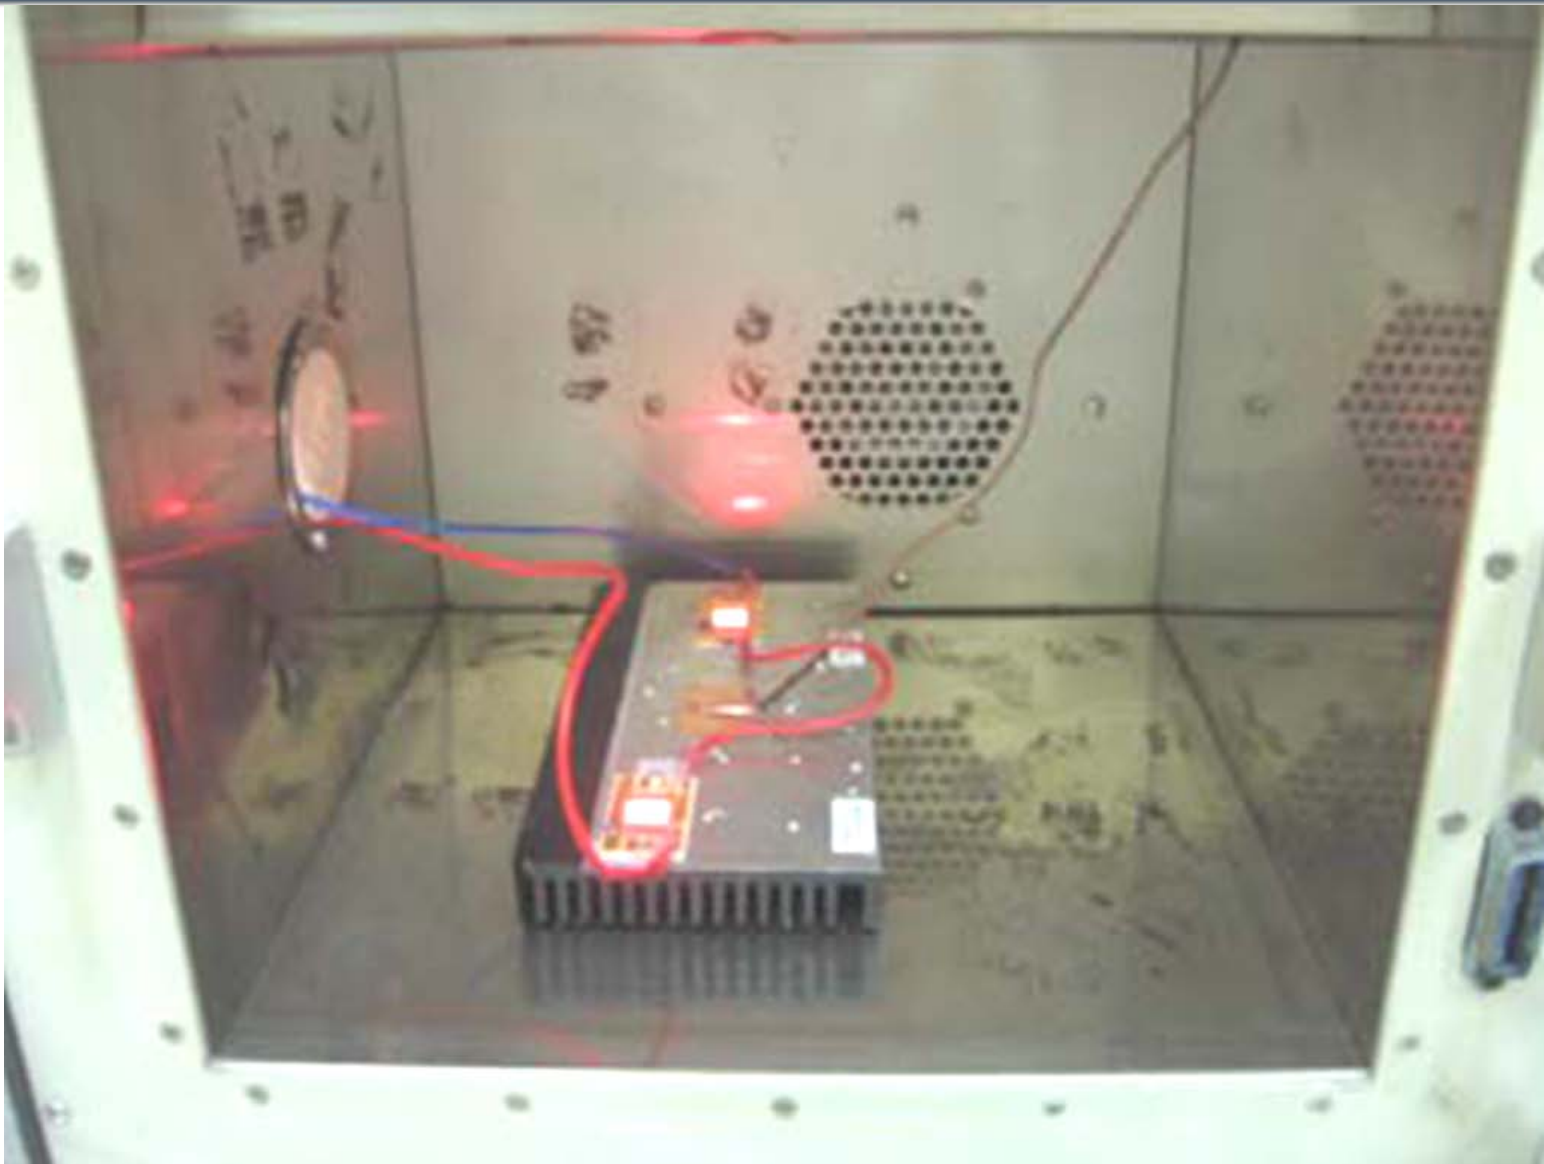
# Powered Thermal Cycling

- IEC 62108 section 10.6 calls for a periodic forward bias current of  $1.25 \times I_{sc}$  through the cell (to simulate the optical thermal load in the application) while the device under test is cycled between -40 to 110°C CELL temperature.
- If one misses the fine points of this test and simply applies the current bias without monitoring (and controlling on) cell temperature some unexpected results may obtain.
  - Thermal Runaway.
  - Very high cell temperatures.
  - Unrealistic temperature gradients.
  - Receiver substrate failures.
